# TECHNICAL INSTRUCTIONS FOR SAFETY RECALL G0R FRONT PASSENGER AIRBAG INFLATOR MODULE CERTAIN 2009-2010 MODEL YEAR COROLLA

**Updated 7-17-18**

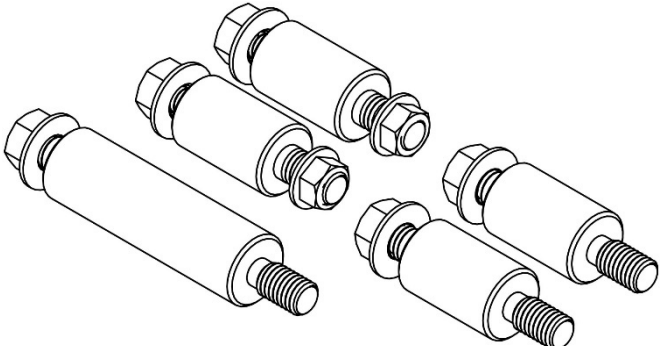
| Image | Name | Quantity |
|---|---|---|
| | Adaptor set* | 1 |

\*The adaptor set was sent to dealers at the start of this campaign.

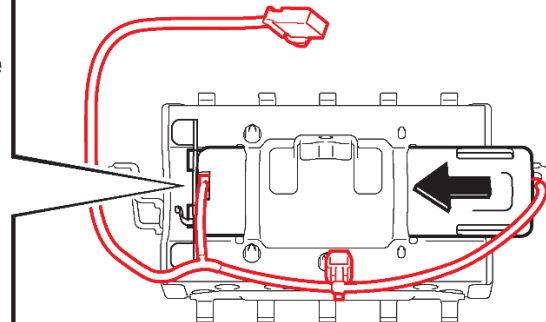
- d) Fully insert the inflator and ensure that the inflator is correctly oriented as shown.  
**NOTE: DO NOT pinch the wiring between the bracket and the inflator.**

**DO NOT**  
pinch the wire

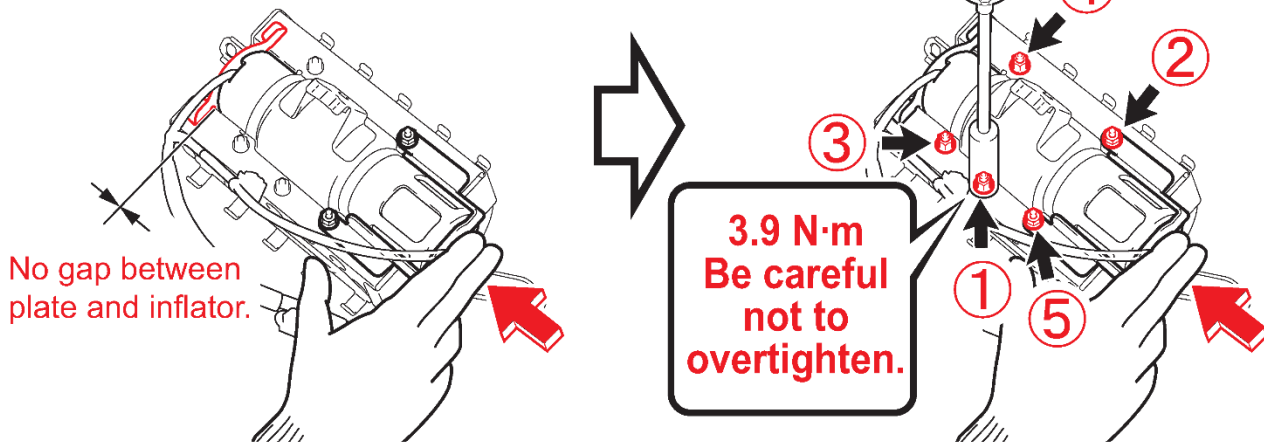
# OK

- a) Tighten the 5 nuts evenly in several increments in the sequence shown. Use a socket driver or torque wrench to tighten the nuts.

Torque: 35in. lbf (3.9N·m)

- There will be some resistance when tightening the nuts because they are self-locking, confirm the nuts are tightened correctly.
- **DO NOT** use a power tool, T-handle, or ratchet when tightening the nuts to avoid over torquing and deforming the studs.
- You may need to turn the airbag to the left or right with in the mounting bracket to access the center nut.
