# IMPORTANT UPDATE

## TECHNICAL INSTRUCTIONS FOR SAFETY RECALL G0P FRONT PASSENGER AIRBAG INFLATOR MODULE CERTAIN 2009 –2013 MODEL YEAR MATRIX

**Updated 4-18-18**

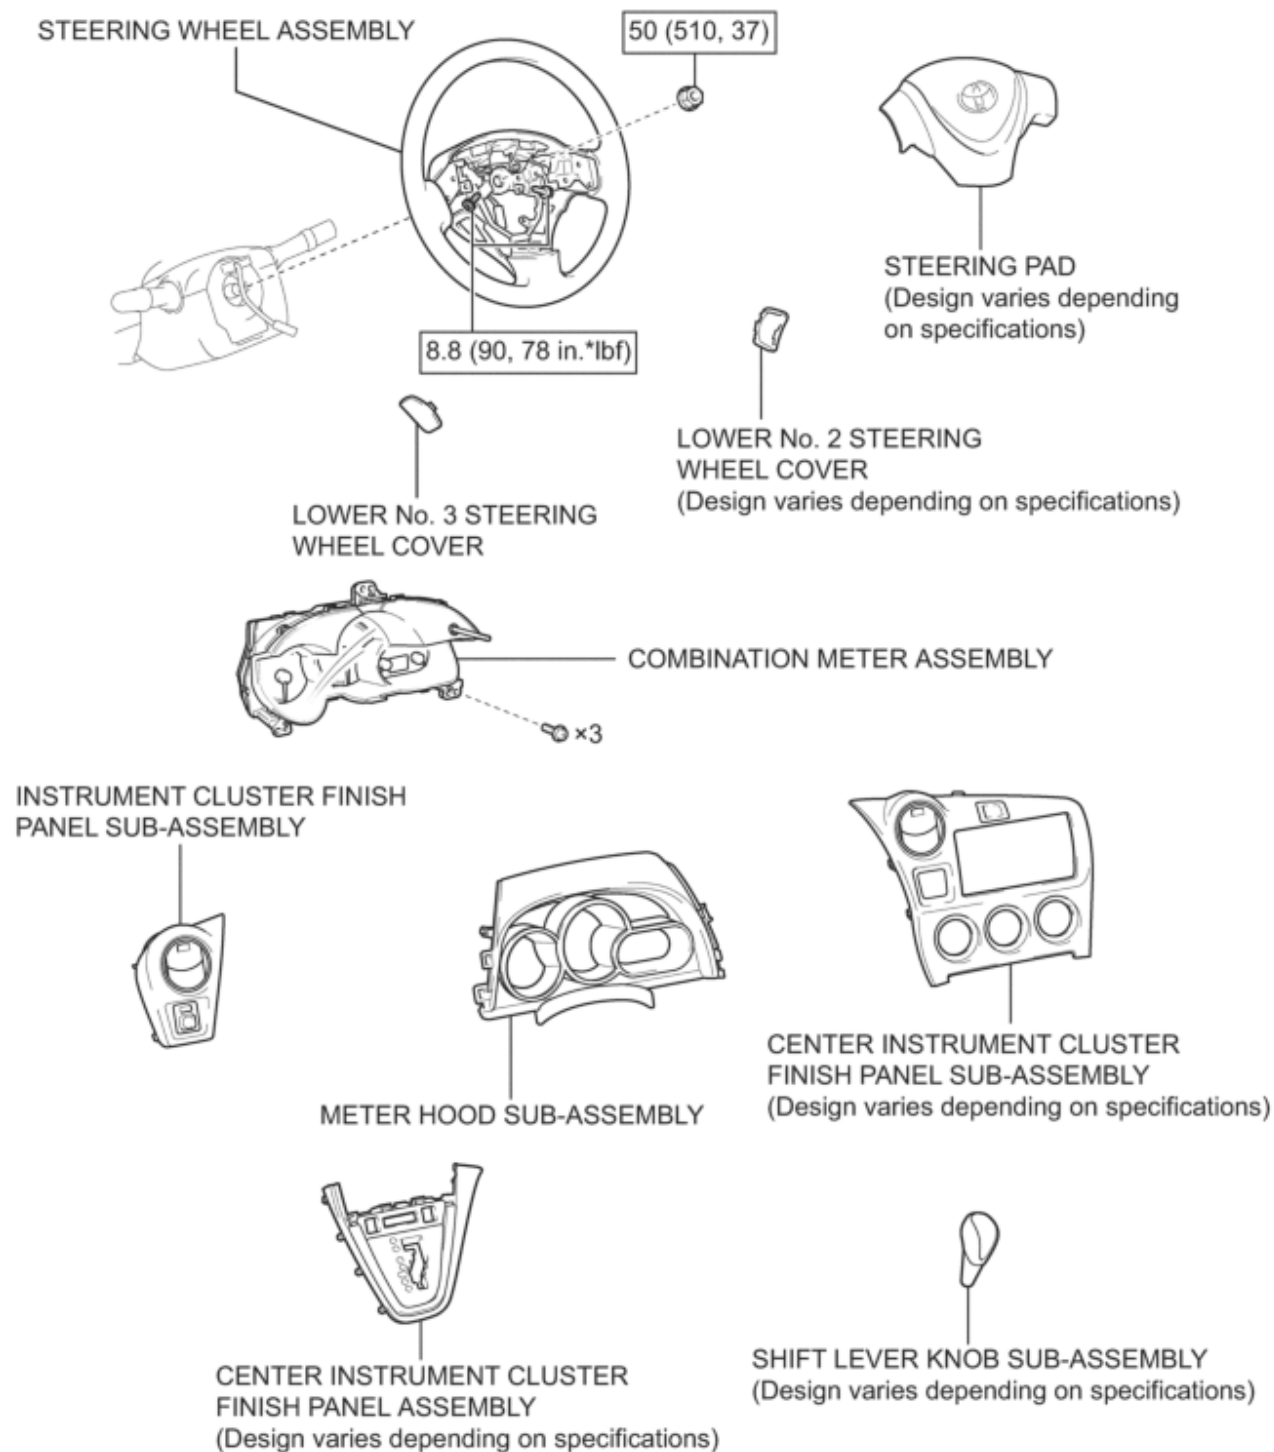
**N\*m (kgf\*cm, ft\*lbf)** : Specified torque

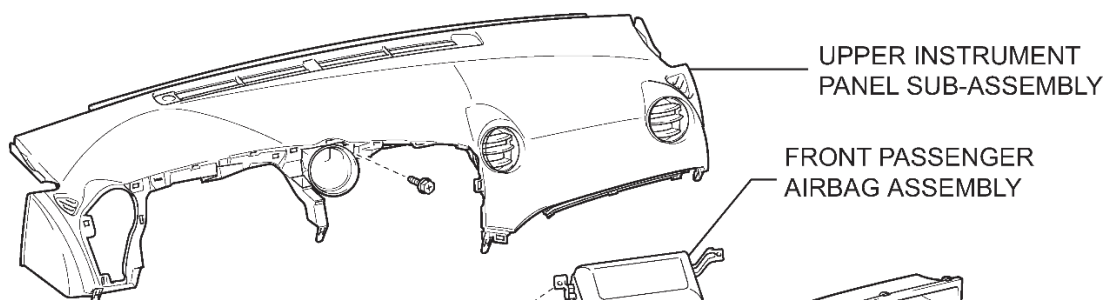
FRONT PASSENGER  
AIRBAG ASSEMBLY

No. 1 INSTRUMENT PANEL  
BOX DOOR SUB-ASSEMBLY

GLOVE COMPARTMENT  
DOOR ASSEMBLY

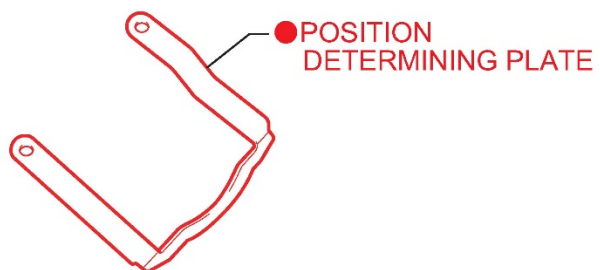
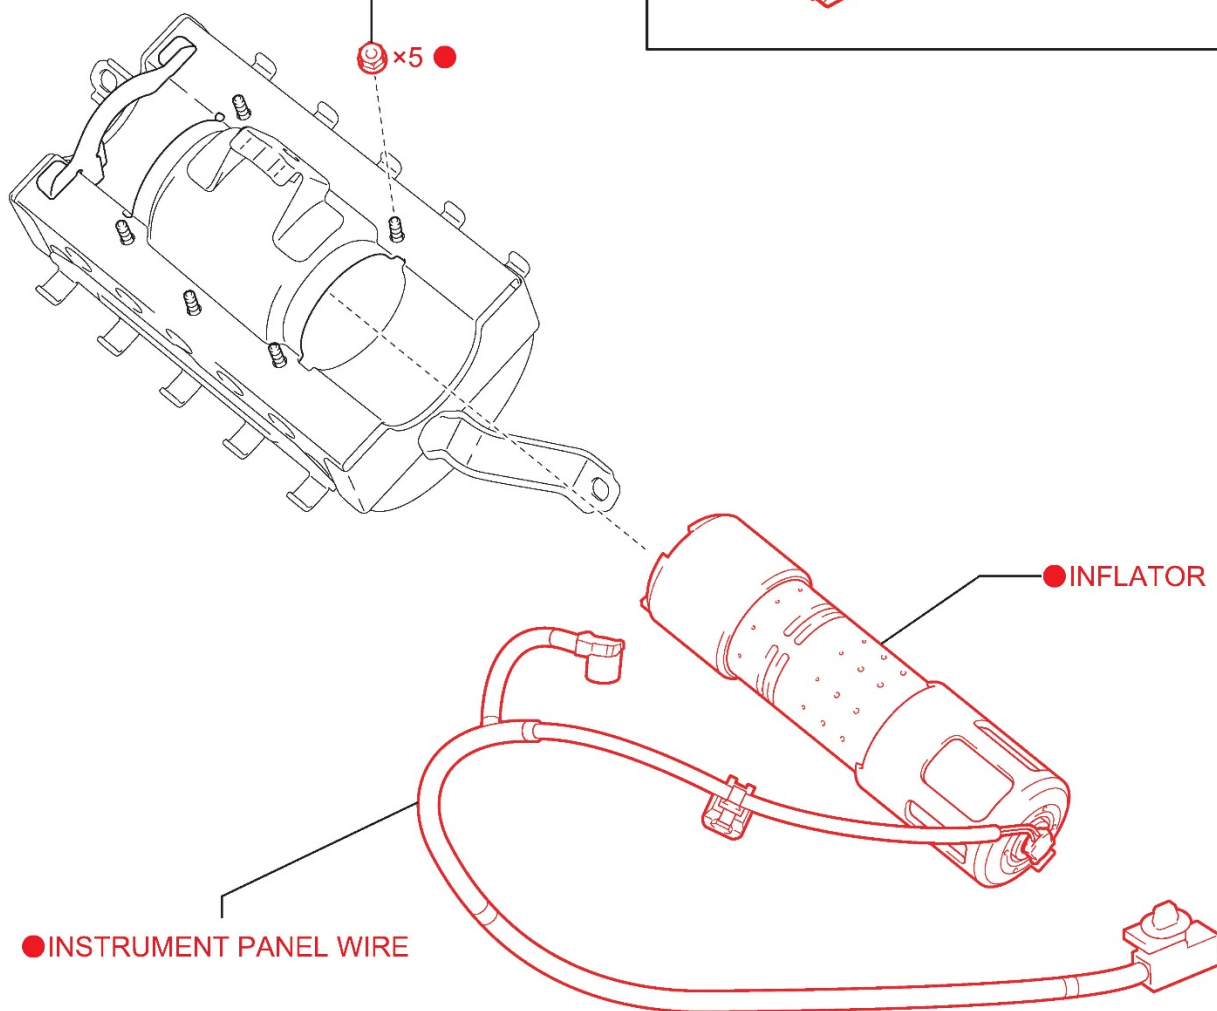
for MATRIX:

**3.9 N·m (40, 35 in.\*lbf)**  
**Be careful not to**  
**overtighten.**

● : Replacement part

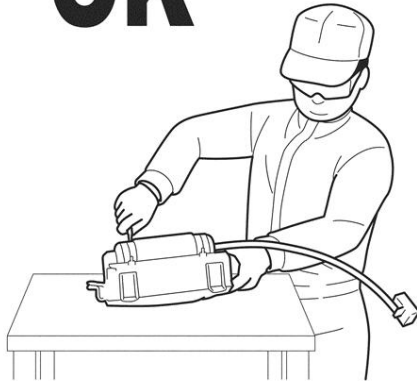
# OK

- Carefully place the airbag on the bench inflator side up.

- Avoid standing directly over the inflator.

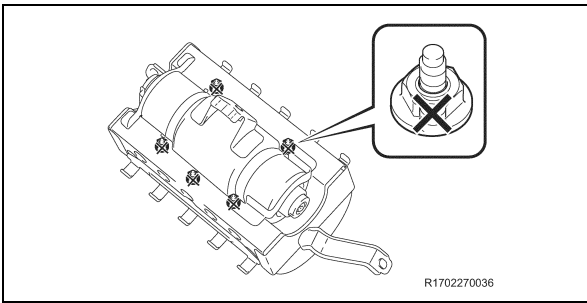
- Use a screwdriver to release the lock button.
- Disconnect the connector.
- Disconnect the wire harness clamps.

**NOTE: Disconnect the connector where the fixed stop plate is located.**

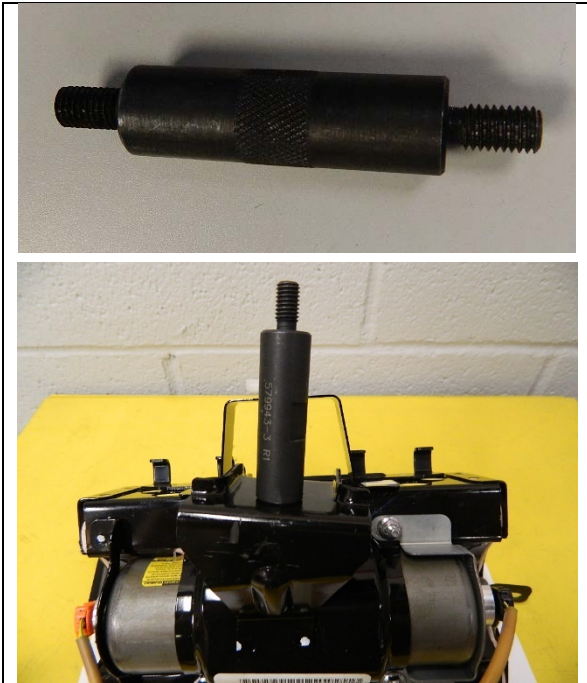
d) Mark all 5 nuts so they will not be reused.

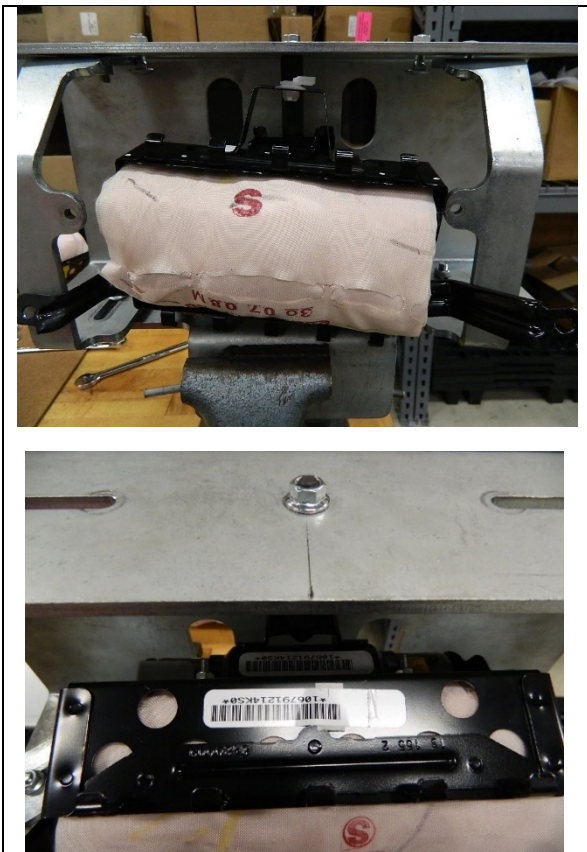
e) Use the long adaptor shown.

f) Thread the adaptor into the airbag as shown.  
**Note: Use the same mounting nut on the airbag that attaches the airbag to the vehicles cross tube.**

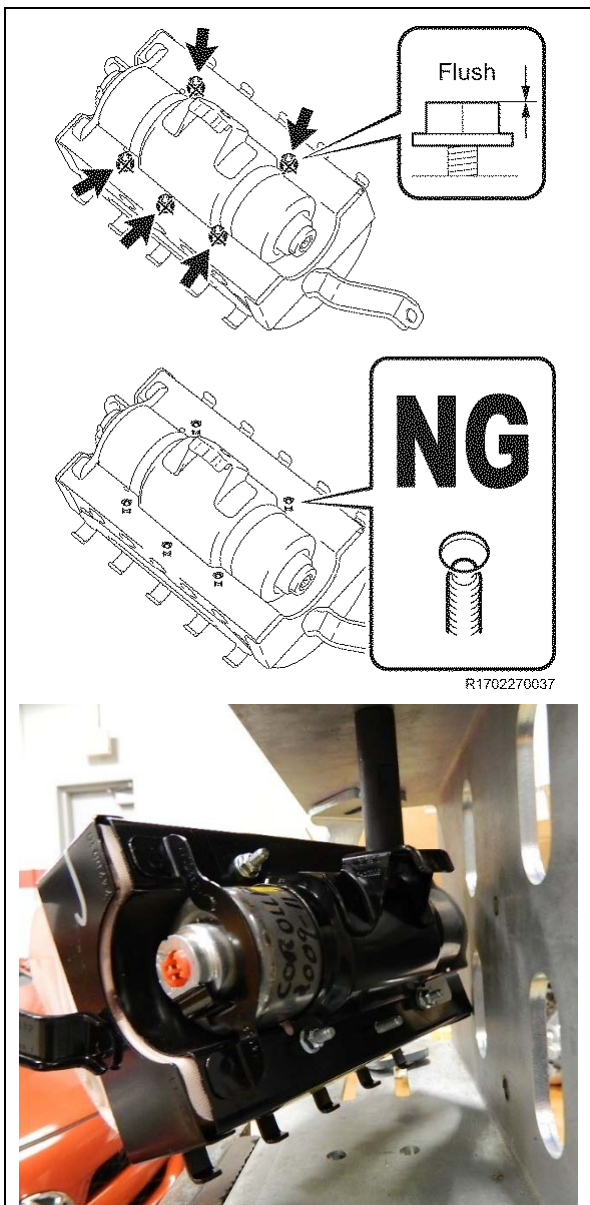
g) Mount the airbag into the mounting bracket as shown. Pass the stud on the adaptor through the hole in the middle of the bracket with the nut.

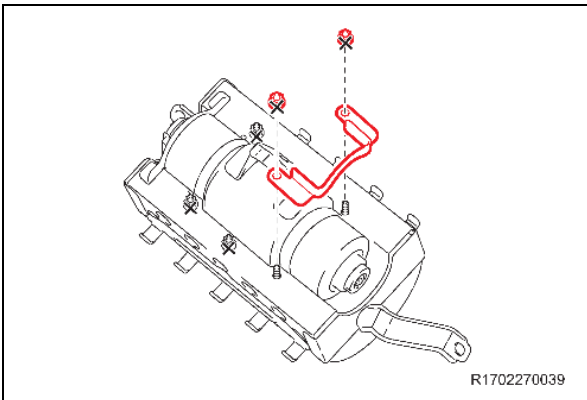
- a) Loosen the 5 nuts until the nuts are at the top of the studs as shown, through the openings in the mounting bracket.

**Note:** The airbag may need to be turned to the left or right to access the center nut.

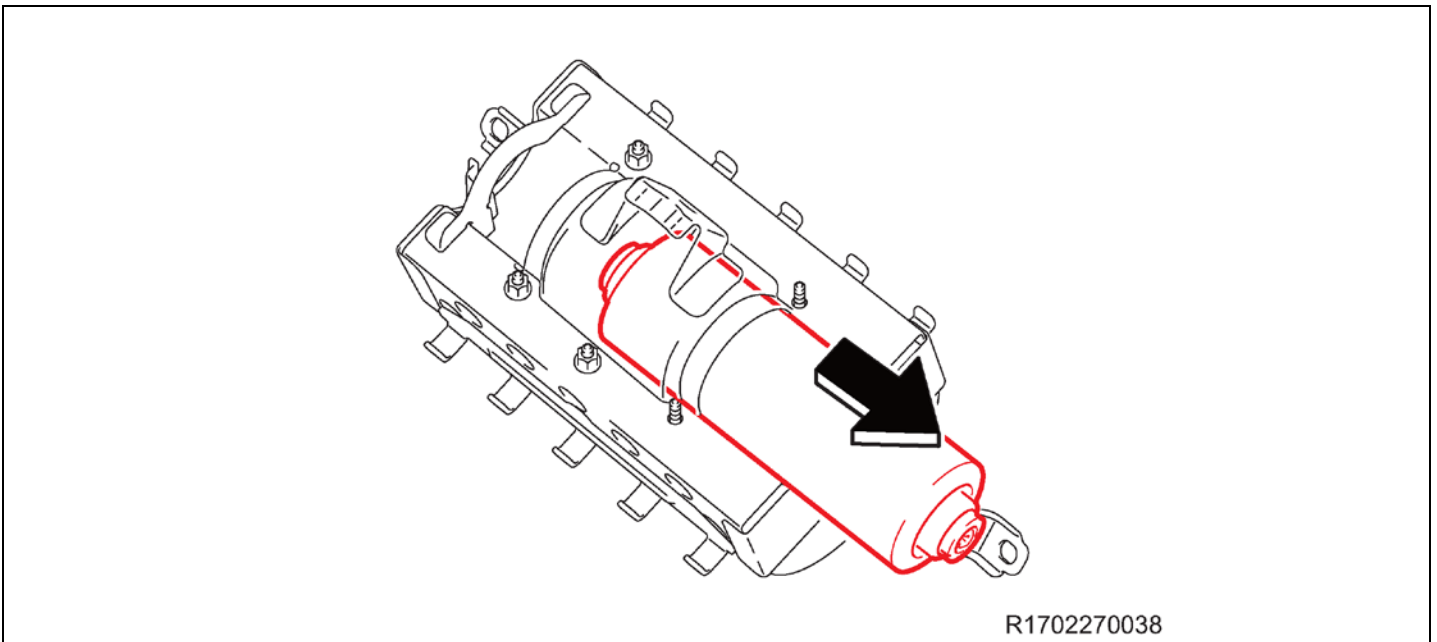
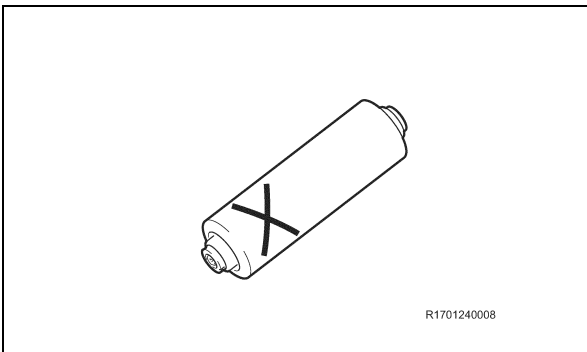
- a) Gently push in the studs until the nuts make contact with the housing to loosen the inflator for removal.

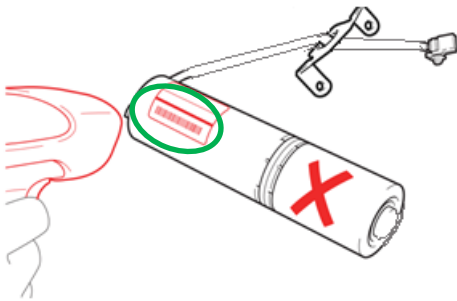
Step a) Old Inflator (bar code)

- Scan the **OLD** inflator bar code.
- Scan the **NEW** inflator QR code.

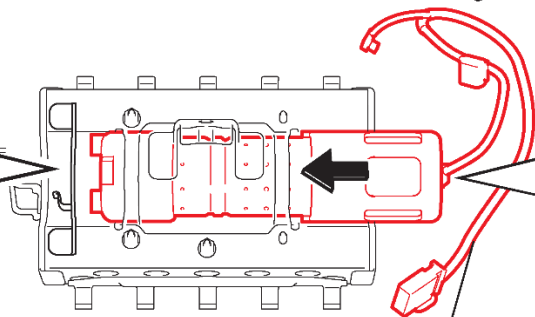
- a) Carefully slide the new inflator into the airbag assembly and align as shown.

- DO NOT** connect the inflator harness at this time. It is **CRITICAL** to first confirm that the inflator is installed in the correct position before connecting the harness.

**DO NOT insert fully.**

Check orientation

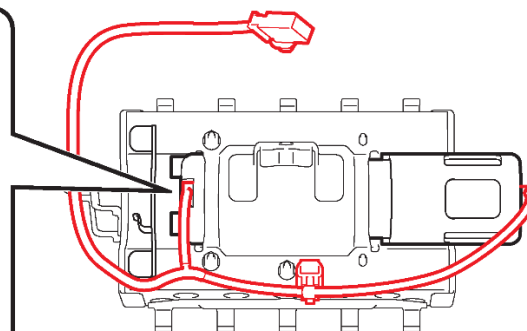
### ALIGN CONNECTORS

- b) Connect the connector to the inflator and ensure that the connector lock is fully engaged as shown.  
c) Route and secure the wire harness as shown.

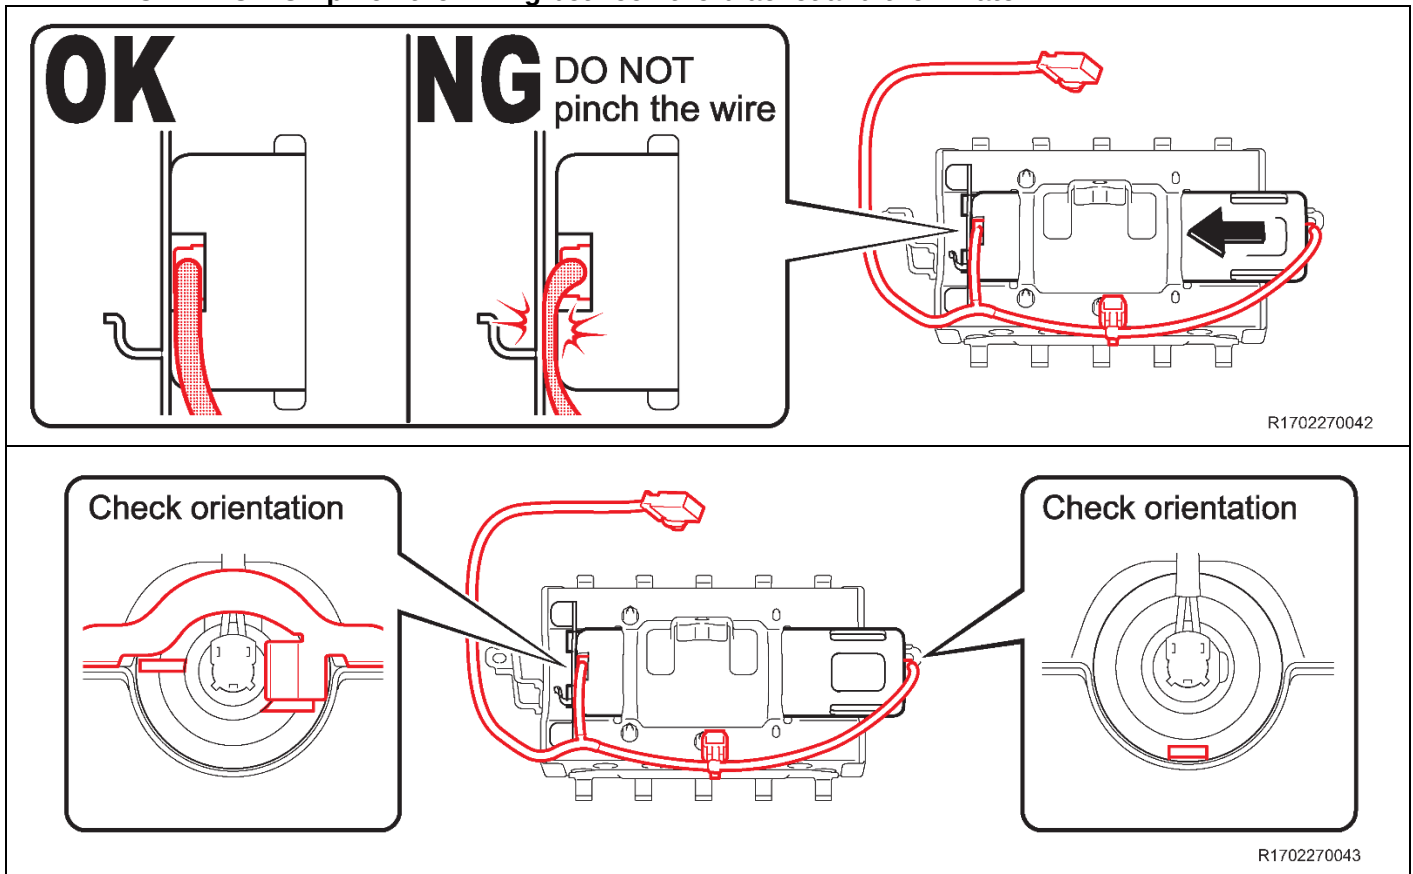
- d) Fully insert the inflator and ensure that the inflator is correctly oriented as shown.

**NOTE: DO NOT pinch the wiring between the bracket and the inflator.**

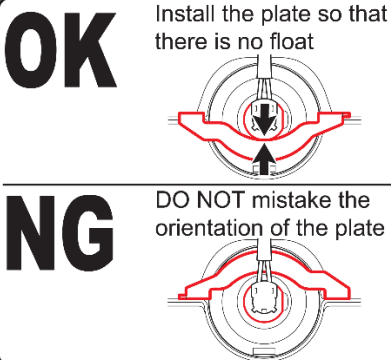
for MATRIX:

Install temporarily by hand.

- e) Install the **NEW** stopper plate.  
f) Install 2 **NEW** nuts by hand.

**NOTE: Ensure that the stopper plate is the one from the bracket kit and installed in the correct orientation.**

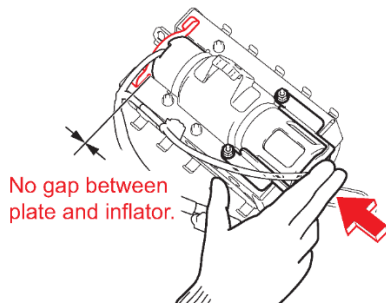
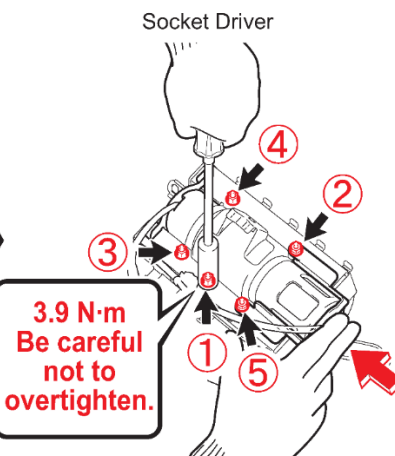
- a) Tighten the 5 nuts evenly in several increments in the sequence shown. Use a socket driver or torque wrench to tighten the nuts.

Torque: 35in. lbf (3.9N·m)

- There will be some resistance when tightening the nuts because they are self-locking, confirm the nuts are tightened correctly.
- **DO NOT** use a power tool, T-handle, or ratchet when tightening the nuts to avoid over torqueing and deforming the studs.
- You may need to turn the airbag to the left or right with in the mounting bracket to access the center nut.

**These tools cause overtightening !**

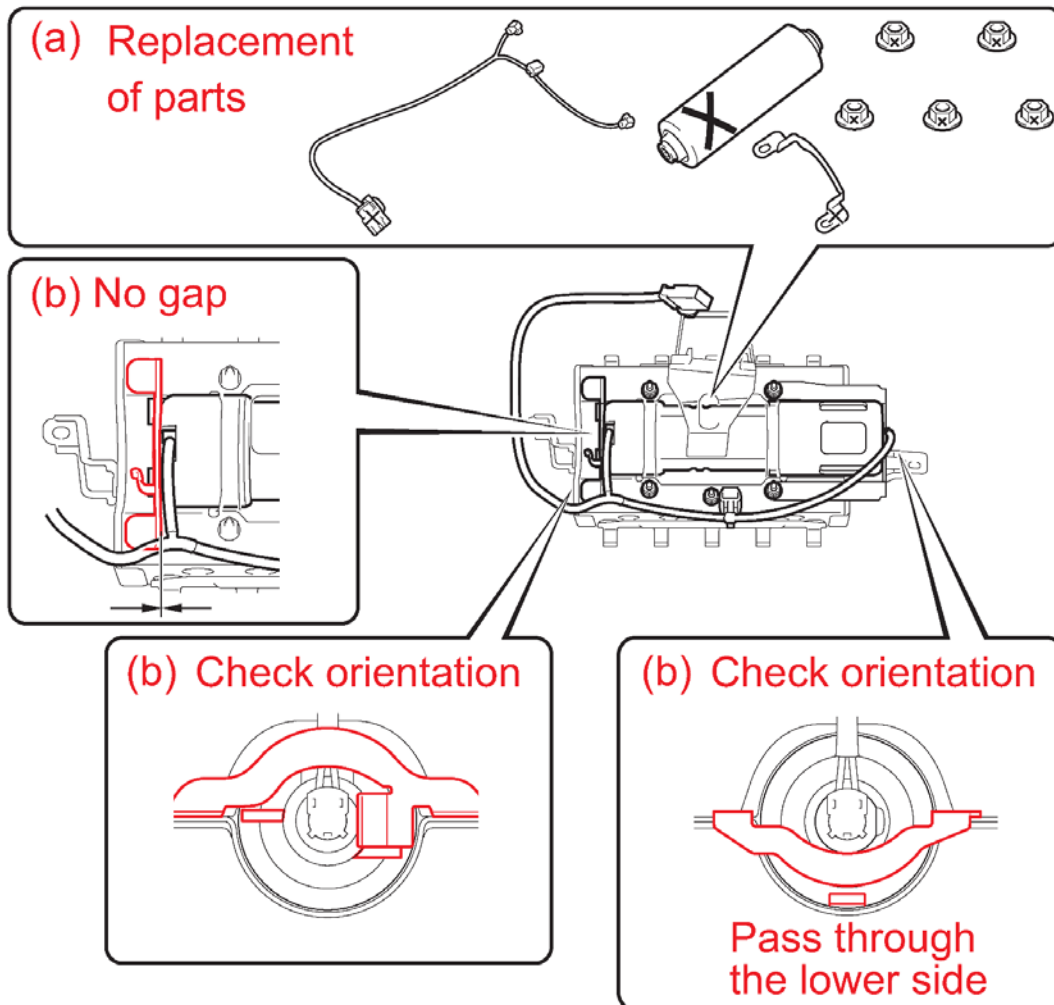
- a) Confirm the **NEW** inflator and 5 **NEW** nuts have been installed.
- b) Confirm the position of the inflator and position determining plates are correct.
- c) Confirm the routing of the inflator wire harness.
