TECHNICAL INSTRUCTIONS

SAFETY RECALL GLG

FRONT PASSENGER AIRBAG INFLATOR REPLACEMENT

CERTAIN 2010 MY IS 250/350 CONVERTIBLE

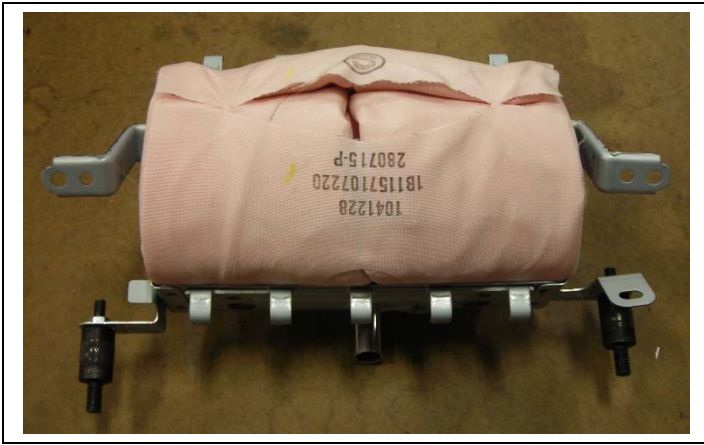
- a) Mark the 5 self locking nuts to prevent reuse.

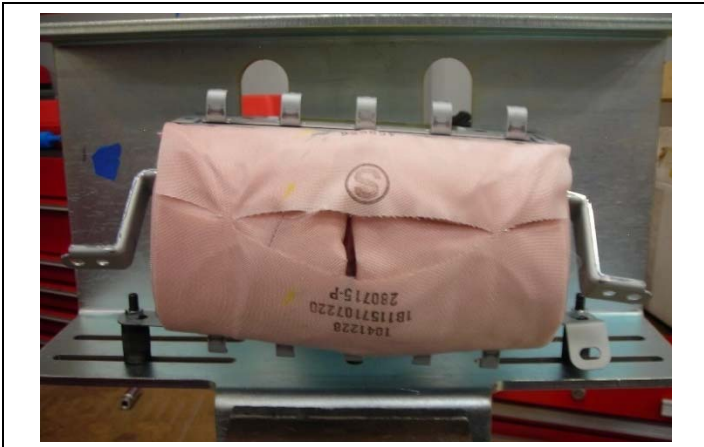
- b) Mount the adaptors (579943-3R3) to the airbag as shown.

NOTE: The 6mm stud mounts to the airbag.

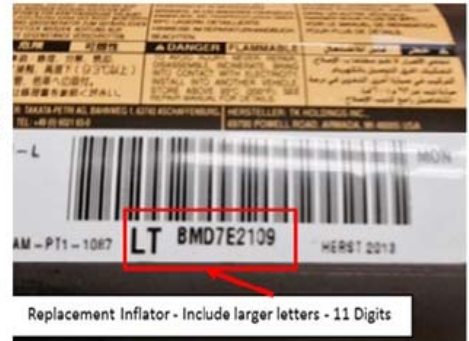
The first two characters of the Replacement Inflator Serial code will be either 'LT' or 'LR'.

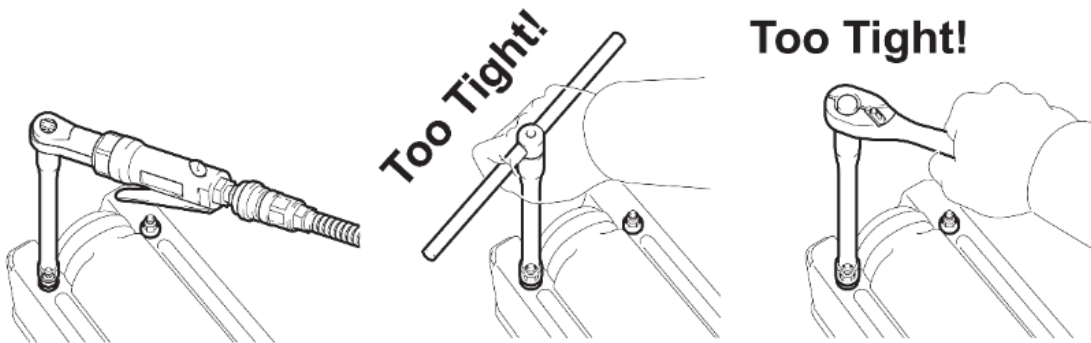
k) Tighten the 5 nuts evenly in several increments in the sequence shown. Use a socket driver or torque wrench to tighten the nuts.

- There will be some resistance when tightening the nuts because they are self-locking, confirm the nuts are tightened correctly.
- **DO NOT** use a power tool, T-handle, or ratchet when tightening the nuts to avoid over torqueing and deforming the studs.
- You may need to slide the airbag to the left or right with in the mounting bracket to access the center nut.

These tools cause overtightening !
