# TECHNICAL INSTRUCTIONS FOR SAFETY RECALL G0P/G0R/H0A FRONT PASSENGER AIRBAG INFLATOR MODULE CERTAIN 2010-2016 MY 4Runner

### UPDATE 1-11-2019

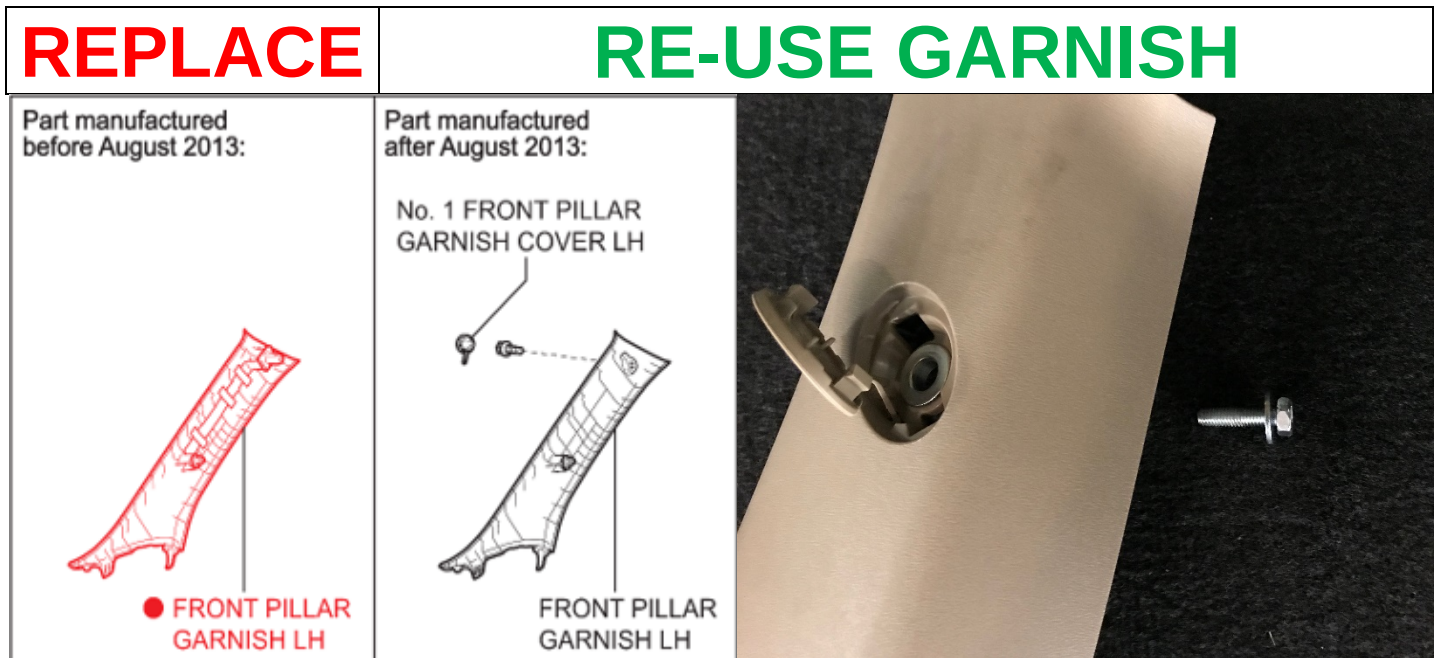
\*\*Only 2010 to Certain 2013 Model Year 4Runner vehicles require A-Pillar garnish replacement. If you have a 2013 – 2016 4Runner that contains an A- Pillar garnish that is bolted in at the top, the A-Pillar **DOES NOT** require replacement. See photos below for reference.

**NOTE:** The left front A-Pillar garnish needs to be replaced on vehicles manufactured prior to August 2013. Only one garnish is required per vehicle depending upon color code. The kit contains the garnish and the non-reusable clip. (see parts information)

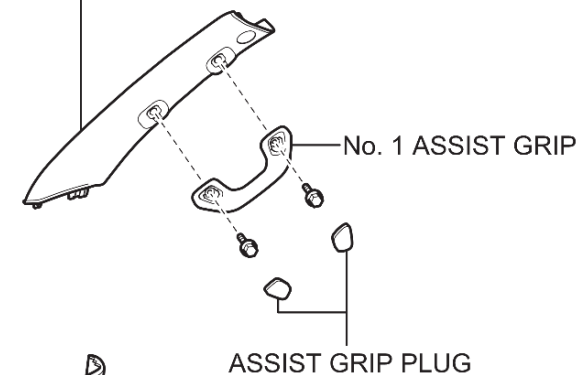
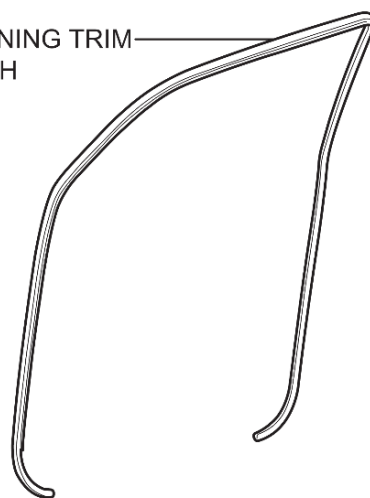
R1703160011

Part manufactured  
before August 2013:

Part manufactured  
after August 2013:

● FRONT PILLAR  
GARNISH LH

No. 1 FRONT PILLAR  
GARNISH COVER LH

FRONT PILLAR  
GARNISH LH

FRONT DOOR OPENING TRIM  
WEATHERSTRIP LH

COWL SIDE TRIM BOARD LH

DOOR SCUFF PLATE ASSEMBLY LH

● Replacement part
