# IMPORTANT UPDATE

## TECHNICAL INSTRUCTIONS FOR SAFETY RECALL GOP FRONT PASSENGER AIRBAG INFLATOR MODULE CERTAIN 2009 –2012 MODEL YEAR Matrix

**Updated 8-31-17**

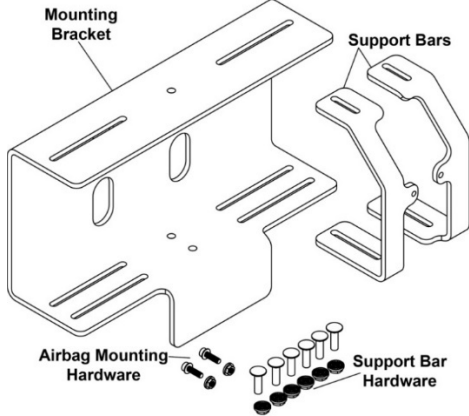
Airbag Mounting Bracket & hardware	1

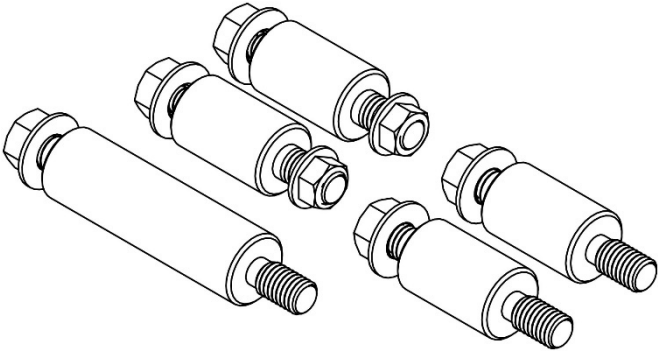
Adaptor set*	1

\*The adaptor set was sent to dealers at the start of this campaign.

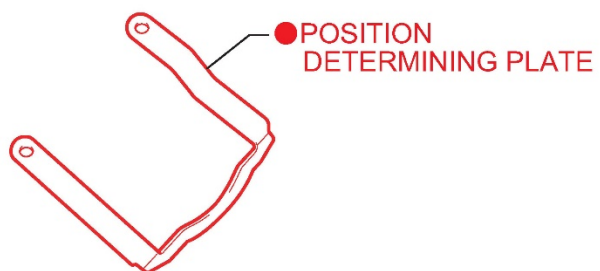
for MATRIX:

**3.9 N·m (40, 35 in.\*lbf)**  
**Be careful not to**  
**overtighten.**

● : Replacement part

R1702270035

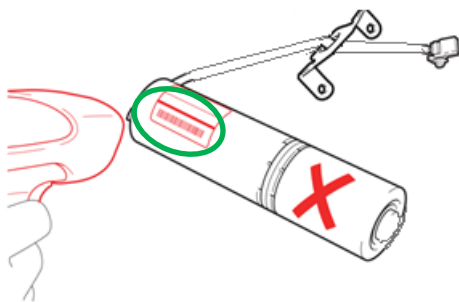
### Step a) Old Inflator (bar code)

- Scan the **OLD** inflator bar code.
- Scan the **NEW** inflator QR code.

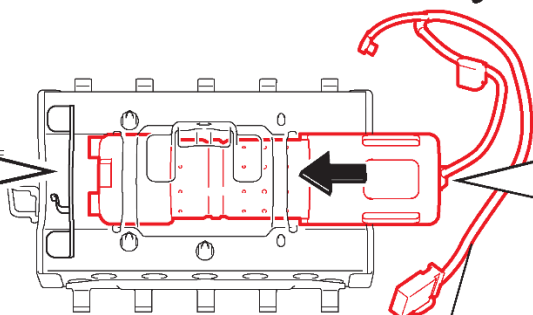
R1702270040

- a) Carefully slide the new inflator into the airbag assembly and align as shown.

- DO NOT** connect the inflator harness at this time. It is **CRITICAL** to first confirm that the inflator is installed in the correct position before connecting the harness.

**DO NOT** insert fully.

Check orientation

Upper side

Bottom

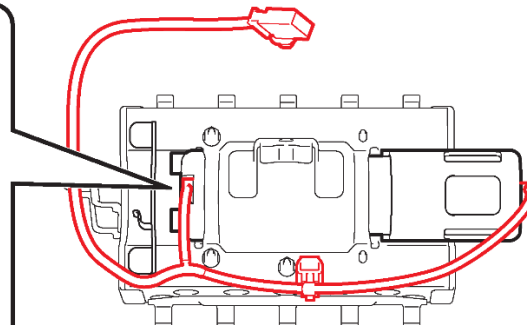
R1702270041

- b) Connect the connector to the inflator and ensure that the connector lock is fully engaged as shown.  
c) Route and secure the wire harness as shown.

**ALIGN CONNECTORS**

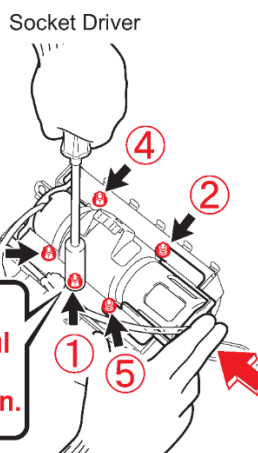
R1702270046

- a) Tighten the 5 nuts evenly in several increments in the sequence shown. Use a socket driver or torque wrench to tighten the nuts.

Torque: 35in. lbf (3.9N·m)

- There will be some resistance when tightening the nuts because they are self-locking, confirm the nuts are tightened correctly.
- **DO NOT** use a power tool, T-handle, or ratchet when tightening the nuts to avoid overtorqueing and deforming the studs.
- You may need to turn the airbag to the left or right with in the mounting bracket to access the center nut.

**OK**

3.9 N·m  
Be careful  
not to  
overtighten.

**Too Tight!**

**These tools cause overtightening !**
