## TECHNICAL INSTRUCTIONS FOR SAFETY RECALL G0R FRONT PASSENGER AIRBAG INFLATOR CERTAIN 2008 – 2010 MY SCION xB

**UPDATED 4-18-2018**

The subject vehicles are equipped with front passenger airbag inflators produced by Takata. According to Takata, the propellant in these inflators may degrade after prolonged exposure to high absolute humidity and fluctuating high temperatures. Degraded propellant can cause inflator rupture during airbag deployment. In the event of an inflator rupture, metal fragments could pass through the airbag cushion material, striking the vehicle occupants, and result in serious injury or death.

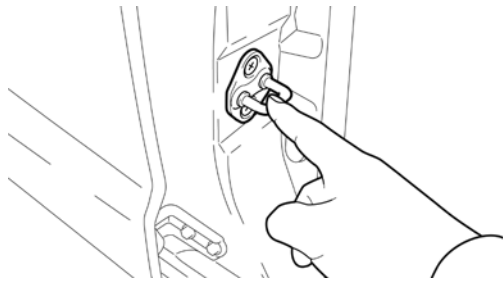
R1508210026

**NG** DO NOT  
measure resistance.

3. **DO NOT MEASURE RESISTANCE**

- a) **DO NOT** measure resistance of airbag components, this may cause accidental activation.

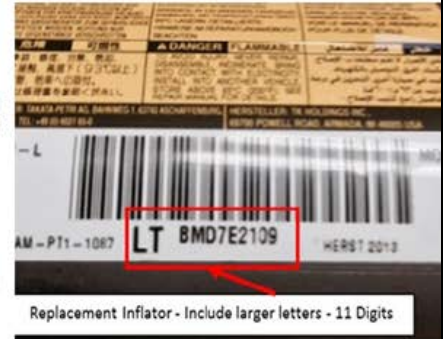
### Replacement Inflator

The first two characters of the **Replacement Inflator Serial code** will be either 'LT' or 'LR'.
