# IMPORTANT UPDATE

### SAFETY RECALL GLG/GLH and HLA

### FRONT PASSENGER AIRBAG MODULE

**CERTAIN 2006 – 2013 MY IS 250/350 and 2008 – 2013 MY IS F**

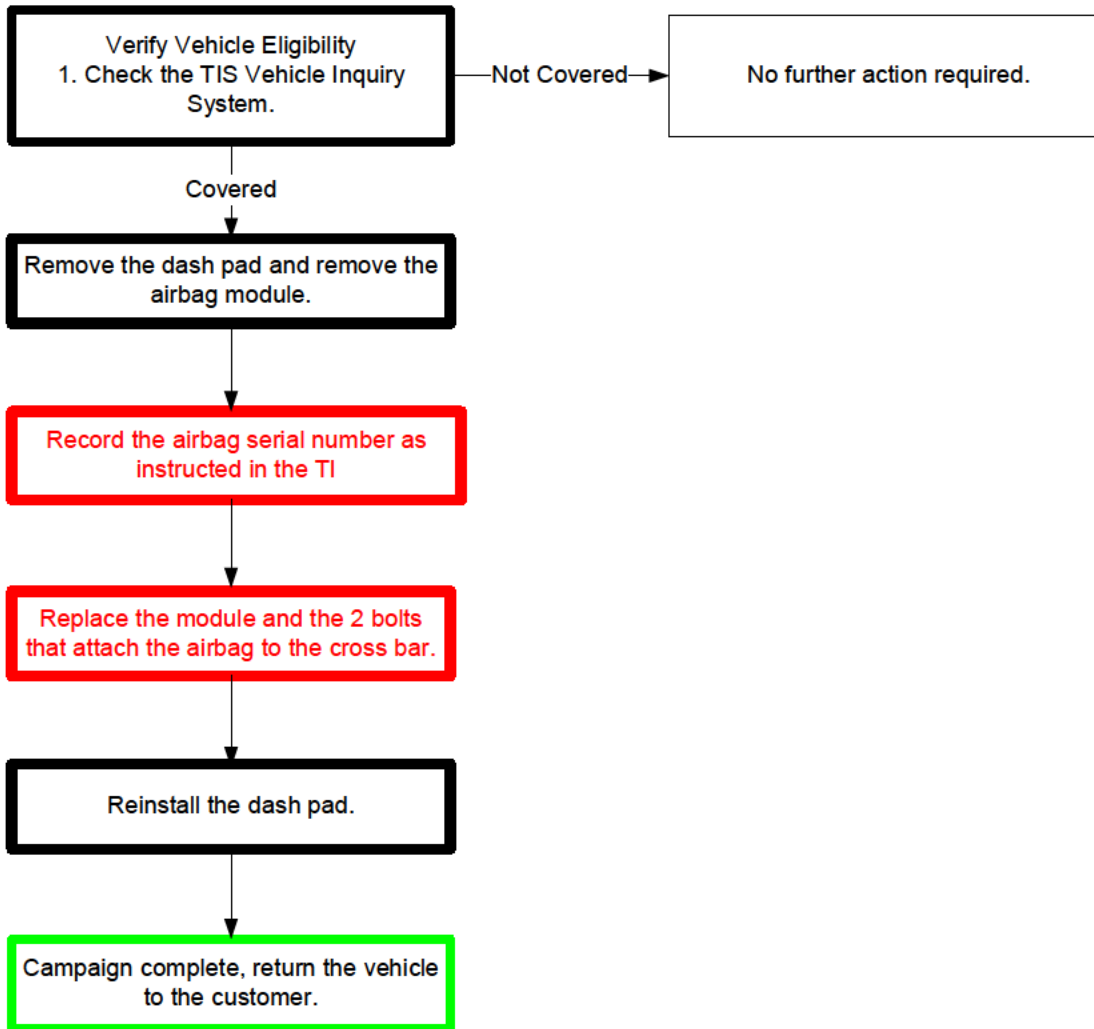
## I. OPERATION FLOW CHART

The flow chart is for reference only. **DO NOT** use it in place of the full technical instructions. Follow **ALL** steps as outlined in the full technical instructions to confirm the campaign is completed correctly.

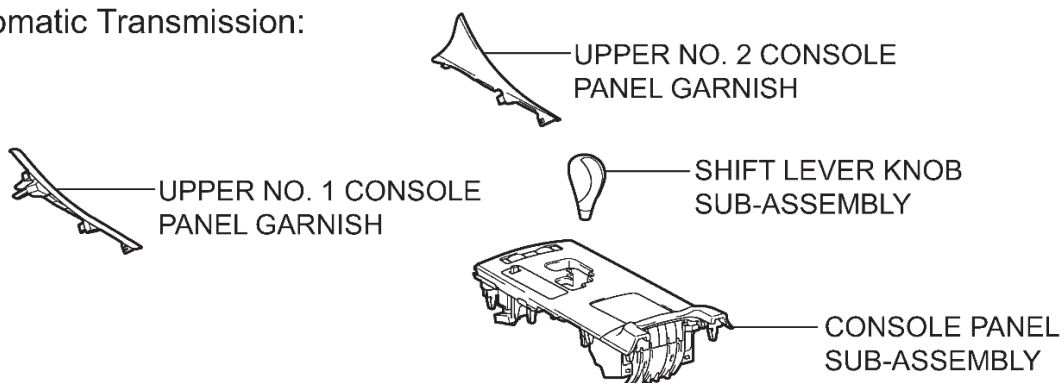
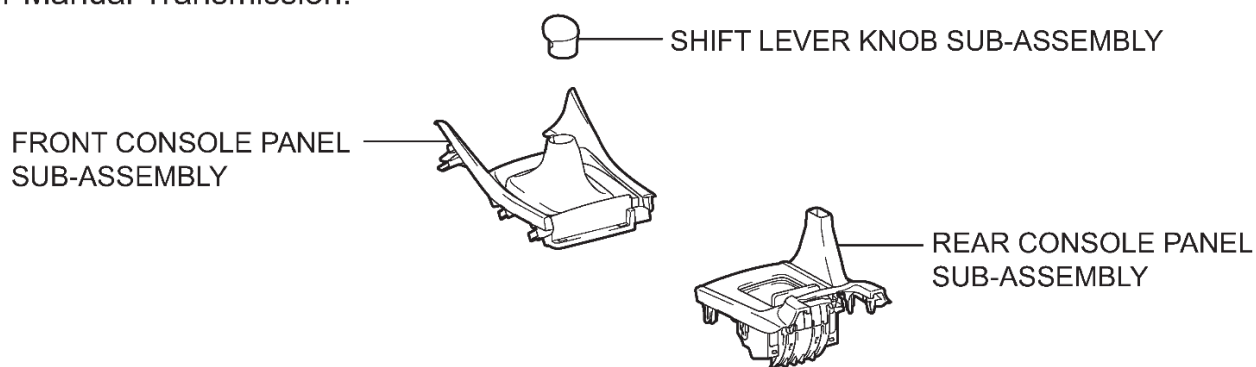
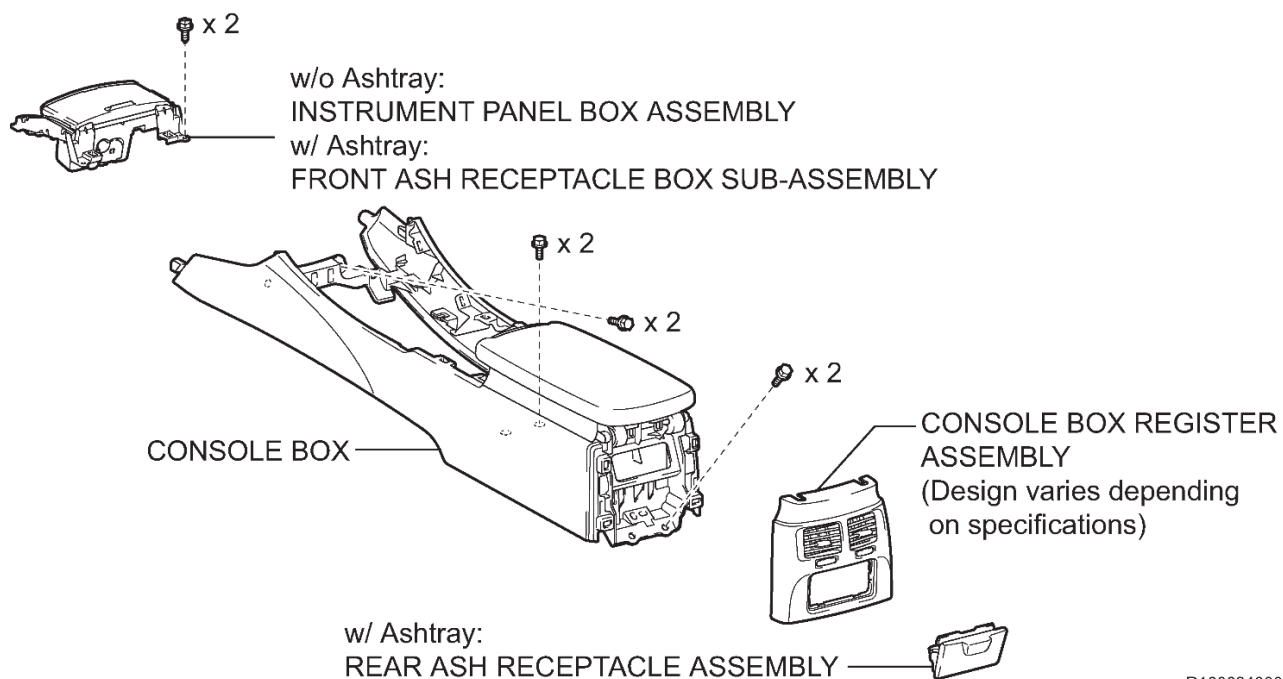
## VII. FRONT PASSENGER AIRBAG REMOVAL COMPONENTS

for Automatic Transmission:

for Manual Transmission:

20 (204, 15) 【New bolt : Shorter than old bolt】

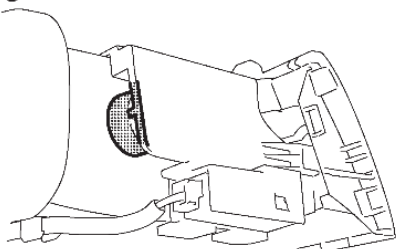
Back side of part manufactured  
before August 2008:

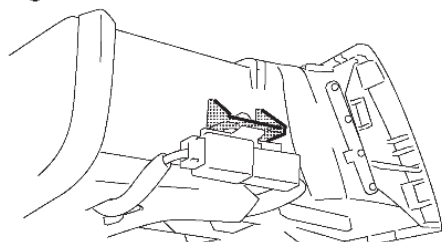
Back side of the part manufactured  
after August 2008:

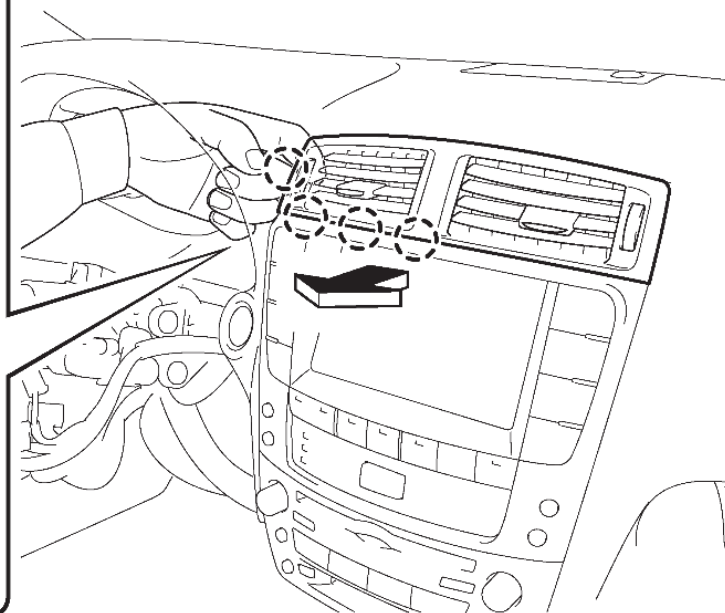
R1606100013F01

Using your finger on the left side push out at the point shown to disengage the 4 claws.

○ : Claw

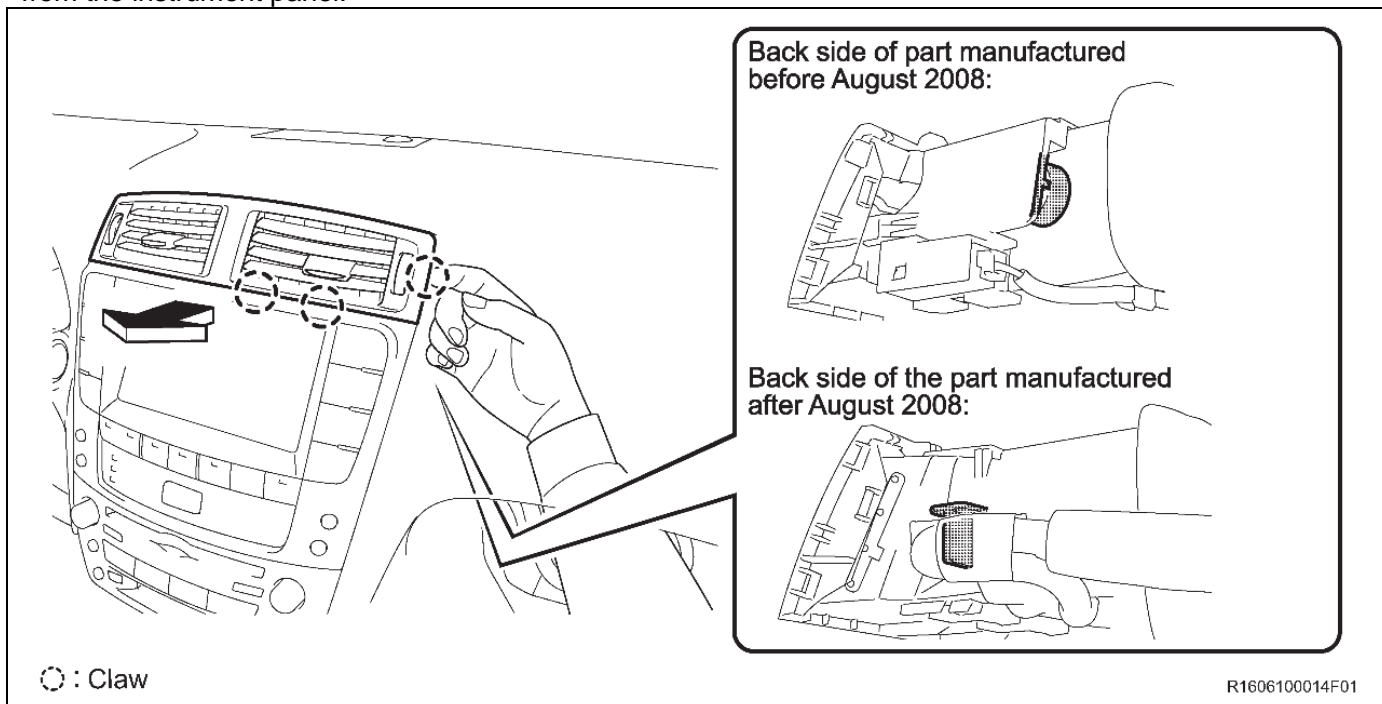
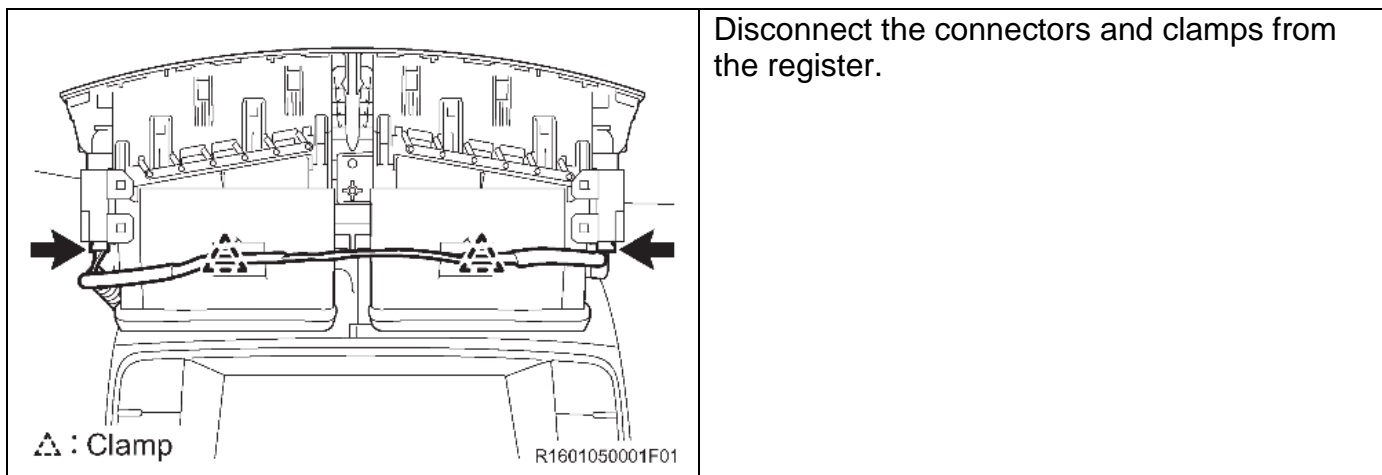
Using your finger on the right side push out at the point shown to disengage the 3 claws and remove the register from the instrument panel.

**NOTE: DO NOT** contact the positioning tabs while removing the instrument panel as the panel could be damaged.

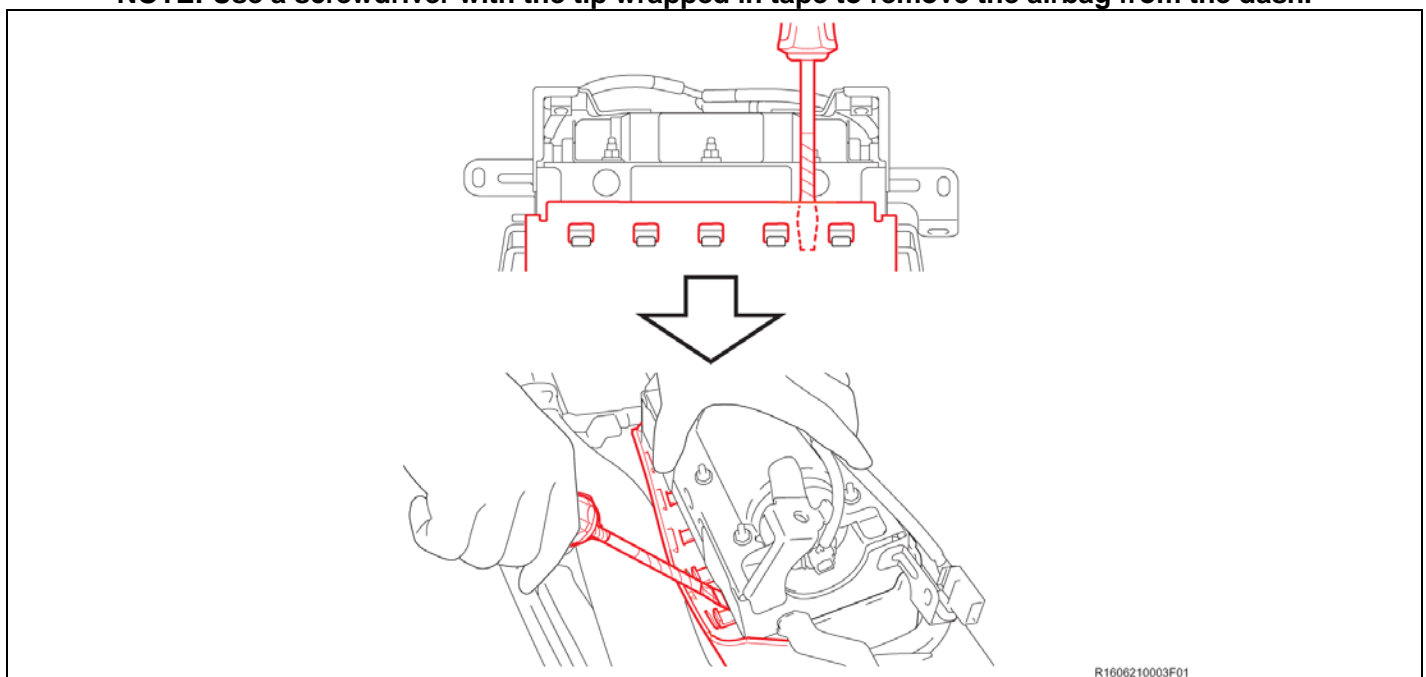
- c) Remove the 4 bolts, disengage the straps, and then remove the airbag assembly.

**NOTE: Use a screwdriver with the tip wrapped in tape to remove the airbag from the dash.**

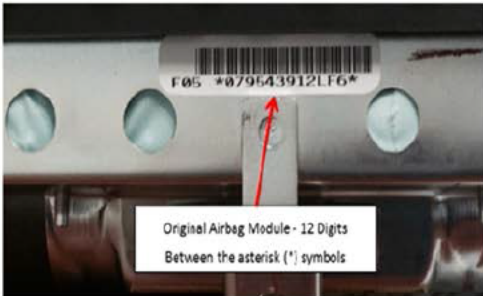
#### Airbag Serial Number Label Example

- The airbag serial number is **ALWAYS** the 12 **DIGITS** located between the asterisks.
- The 3 digits before the asterisk **ARE NOT** part of the serial number, and **SHOULD NOT** be entered or an inaccurate response may be returned.

Original Airbag Module - 12 Digits Between the asterisk (\*) symbols

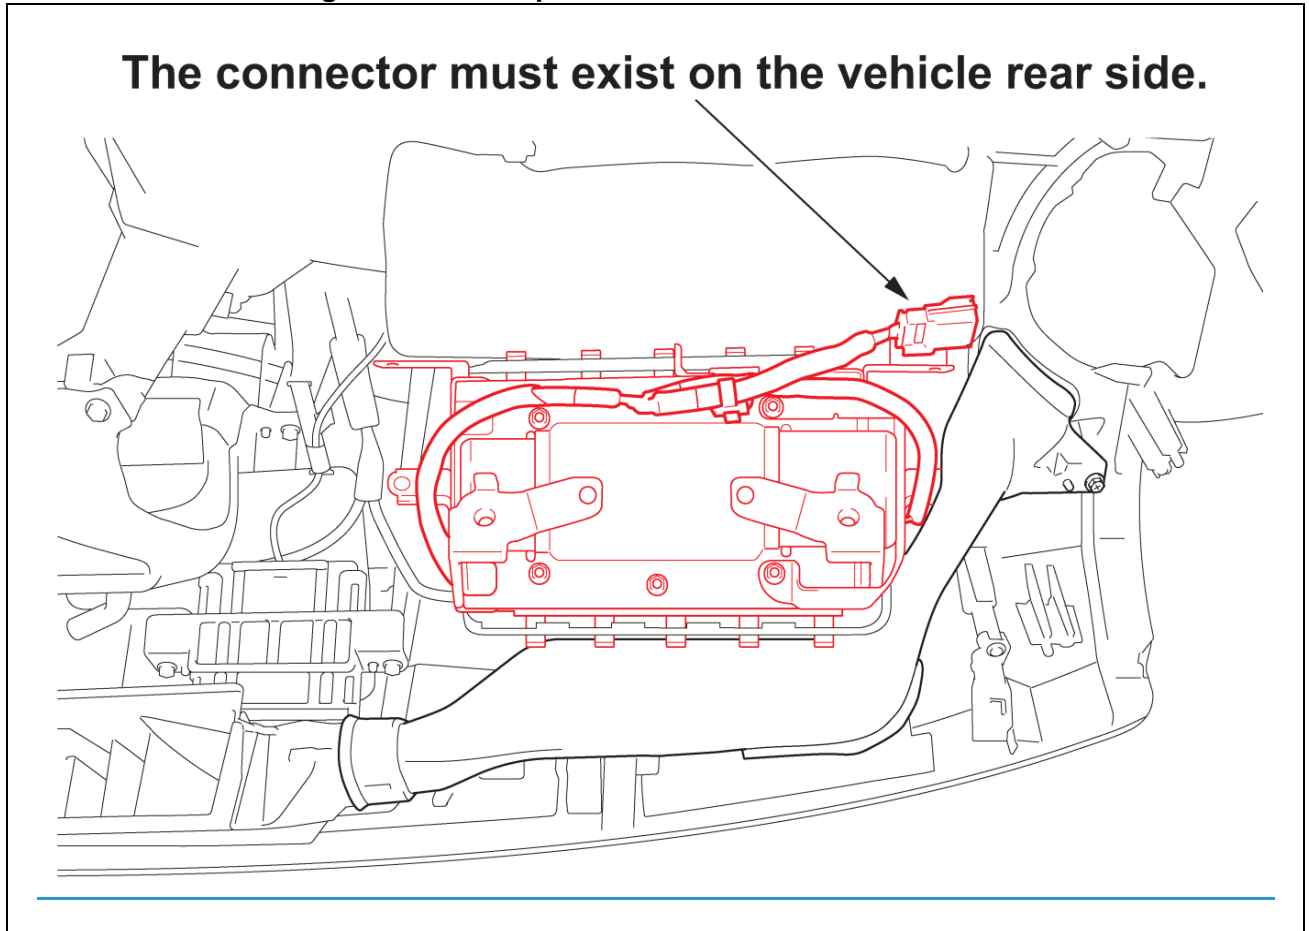
- a) Position the airbag assembly in the instrument panel, engage the straps, and then install the 4 bolts.

**NOTE:** Ensure the airbag connectors is positioned as shown

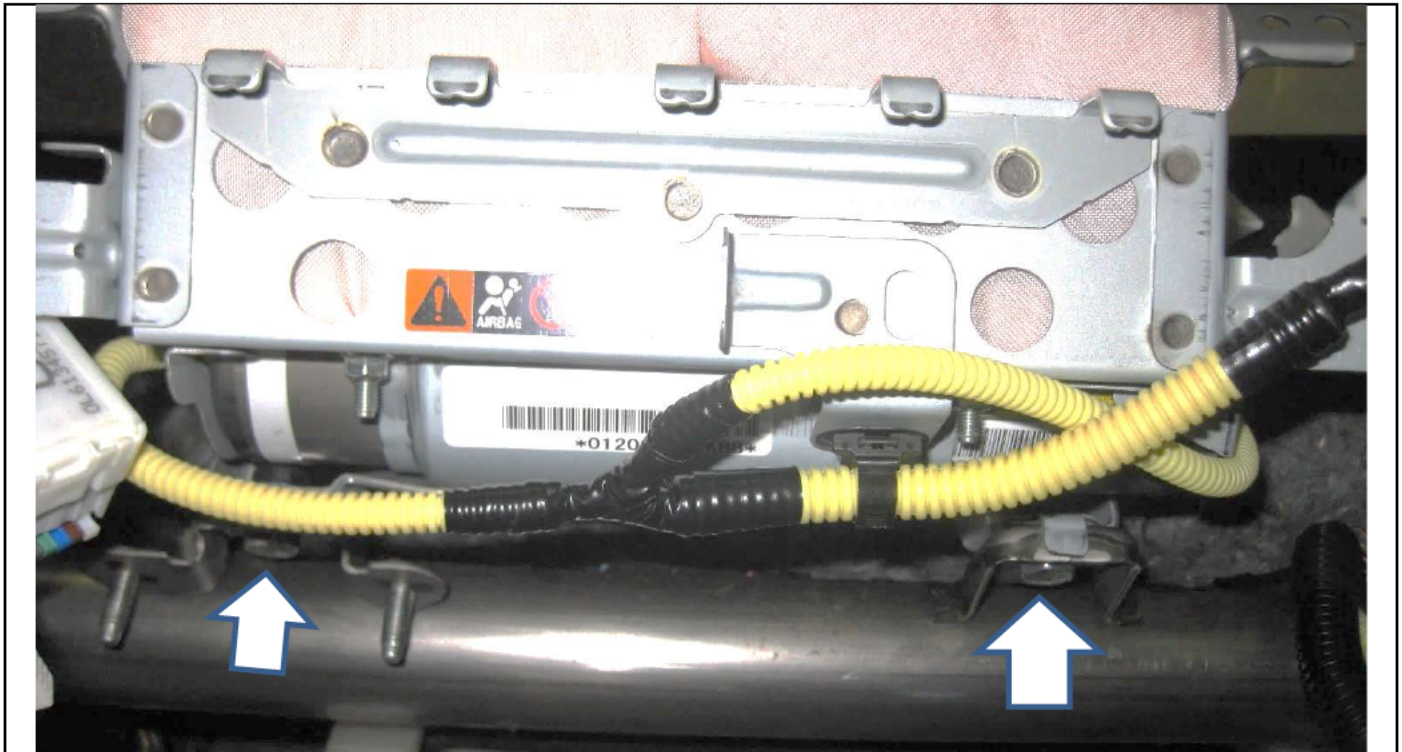
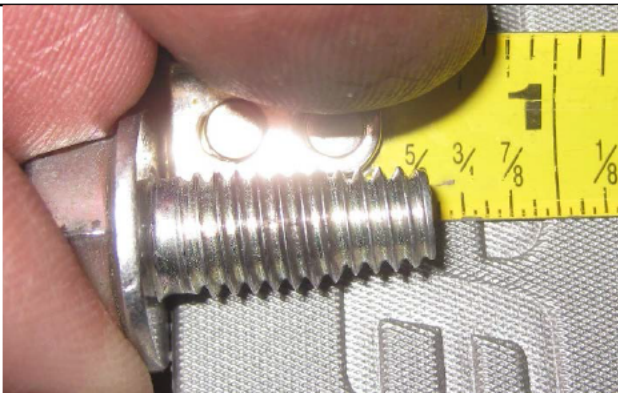
During dash reinstallation ensure to install 2 NEW bolts (p/n 90119-A0165) that attach the airbag to the cross tube. The original bolts are now too long and could contact the inflator resulting in an incorrect torque value.

During dash removal, discard the 2 bolts that attach the airbag to the cross tube.  
NEW bolts will be installed during reassembly.

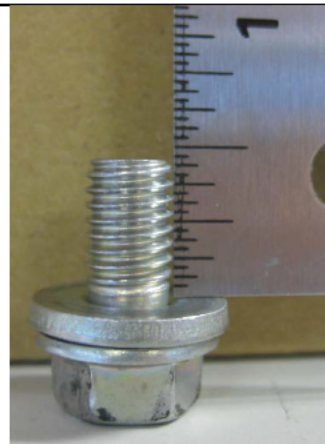
**Original Bolt**  
**DO NOT REUSE**  
**Length 0.625" or 16 mm**

**Replacement Bolt**  
**(p/n 90119-A0165)**  
**Length 0.472" or 12 mm**
