**TECHNICAL INSTRUCTIONS  
FOR  
SAFETY RECALL G0P  
FRONT PASSENGER AIRBAG INFLATOR MODULE  
CERTAIN 2011 MODEL YEAR SIENNA**

The subject vehicles are equipped with front passenger airbag inflators produced by Takata. The propellant in these inflators may degrade after prolonged exposure to high absolute humidity and fluctuating high temperatures. Degraded propellant can cause inflator rupture during airbag deployment. In the event of an inflator rupture, metal fragments could pass through the airbag cushion material, striking the vehicle occupants, and result in serious injury or death.

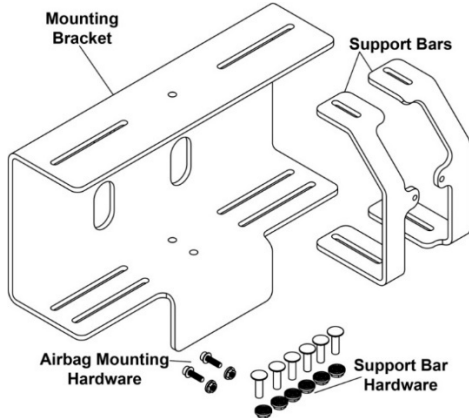
Airbag Mounting Bracket & hardware	1

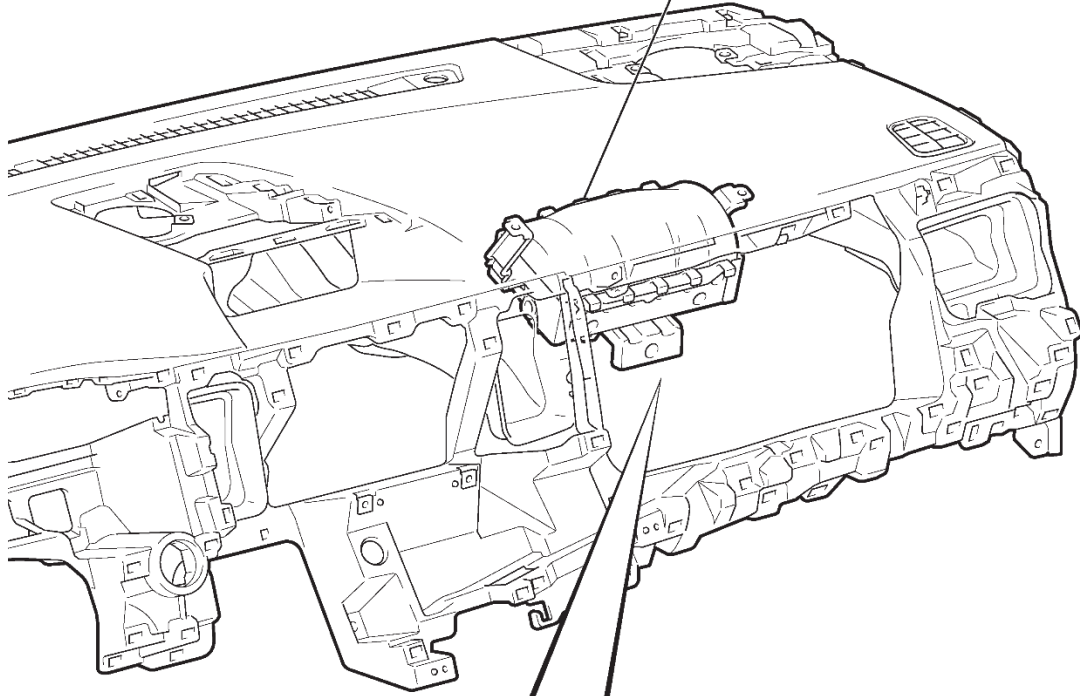
**3.9 N·m (40, 35 in.\*lbf)**  
**Be careful not to**  
**overtighten.**

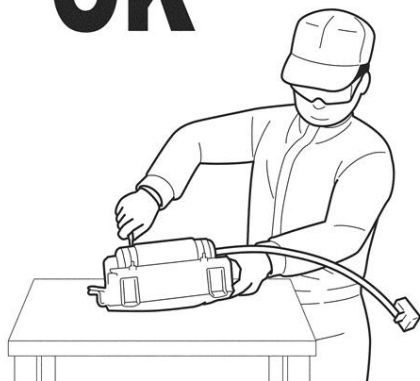
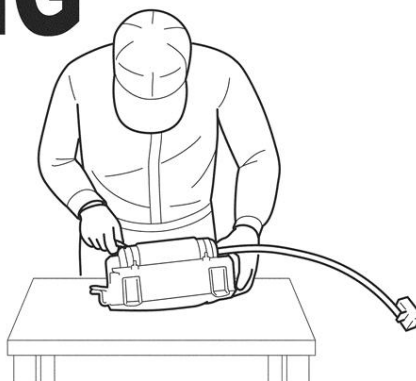
R1301230008E

- a) Carefully place the airbag on the bench inflator side up.

**NOTE: Place clean sheet(s) of paper on the bench to protect the airbag.**

- b) Avoid standing directly over the inflator.

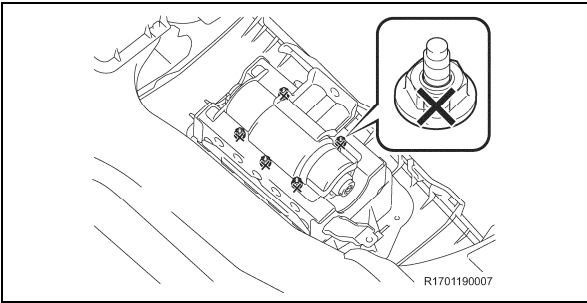
- a) Use a screwdriver to release the lock button on each end of the inflator.
- b) Disconnect both connectors.
- c) Disconnect the 2 wire harness clamps.
- d) Remove and discard the harness.

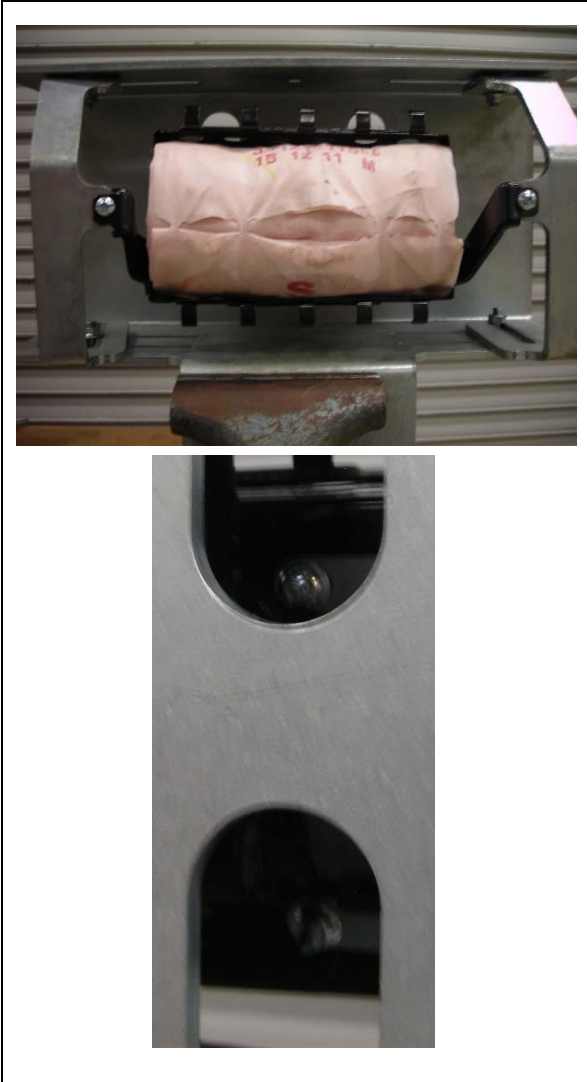
e) Mark all 5 nuts so they will not be reused.

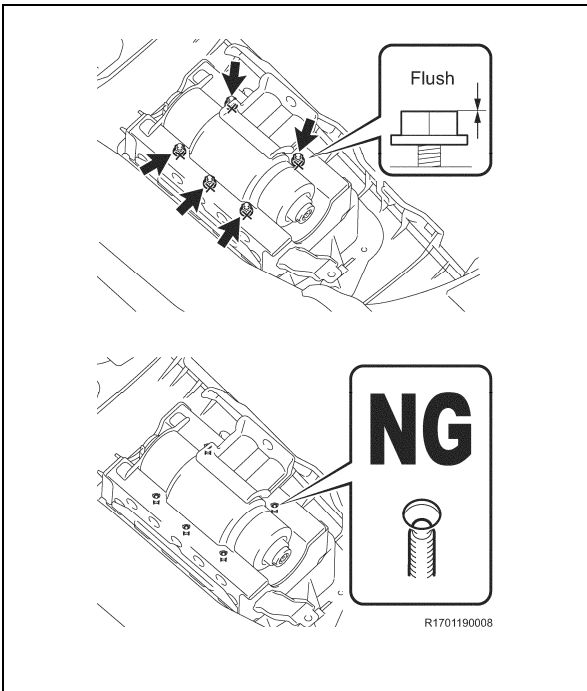
f) Mount the airbag into the mounting bracket as shown.

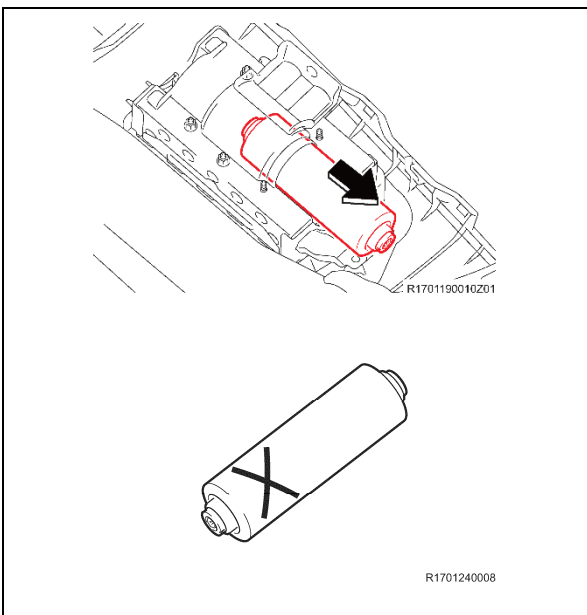
- a) Gently push the inflator in the direction shown.

- b) Remove the inflator from the airbag assembly and place it on a safe work surface.
- c) Mark the old inflator so it is not reused.

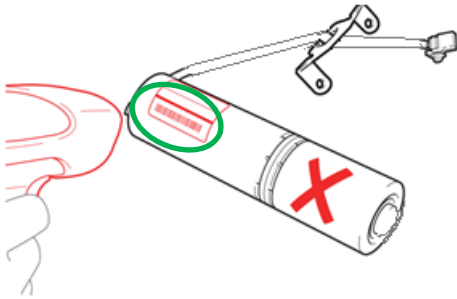
### Step a) Old Inflator (bar code)

- Scan the **OLD** inflator bar code.
- Scan the **NEW** inflator QR code.

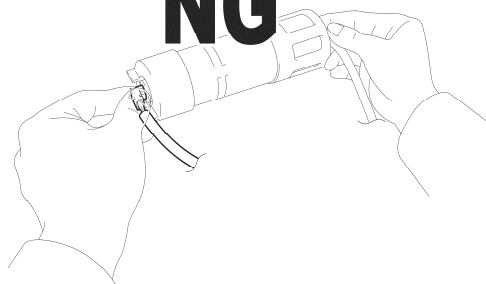
R1701280003

- DO NOT** connect the inflator harness at this time. It is **CRITICAL** to first confirm that the inflator is installed in the correct position before connecting the harness.

DO NOT CONNECT PREMATURELY  
CANNOT DISCONNECTED

**NOTE:** Once connected the inflator harness cannot be disconnected without damaging the connector, and would require that the inflator and harness be replaced.

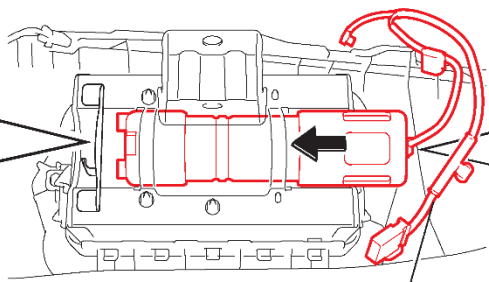
R1702010006H

- a) Carefully slide the new inflator half way into the airbag assembly and align as shown.

**DO NOT** insert fully.

Instrument panel wire

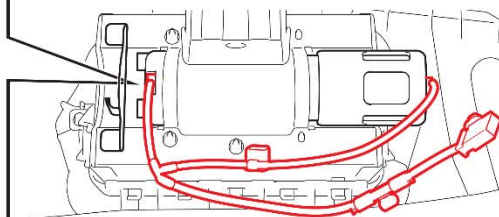
R1702010008H

- b) Connect the connector to the inflator and ensure that the connector lock is fully engaged as shown.

### ALIGN CONNECTORS

Wire Harness Side:

Inflator Side:

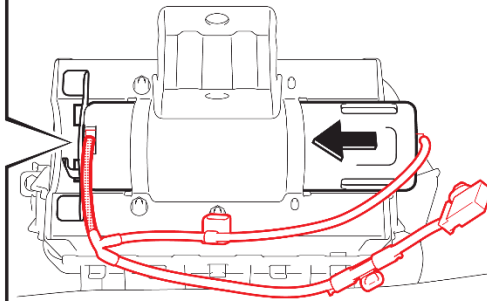
R1702010007H

- a) Fully insert the inflator and ensure that the inflator is correctly oriented as shown.

**NOTE: DO NOT pinch the wiring between the bracket and the inflator.**

DO NOT  
pinch the wire

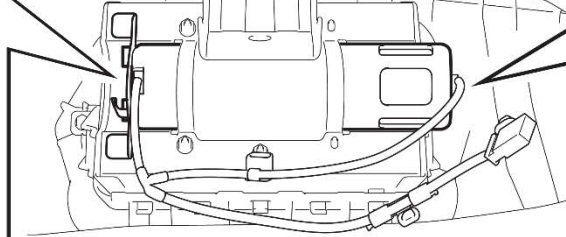
R1701280029H

**NOTE: Ensure the inflator is correctly oriented.**

Check orientation

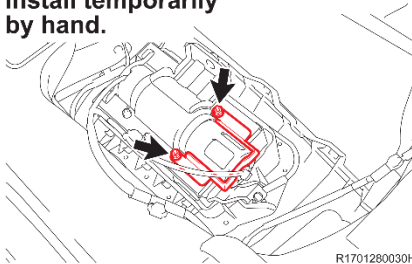
R1701280030H

Install temporarily  
by hand.

- b) Install the **NEW** stopper plate.  
c) Install 2 **NEW** nuts by hand.

**NOTE: Ensure that the stopper plate is the one from the kit and installed in the correct orientation.**

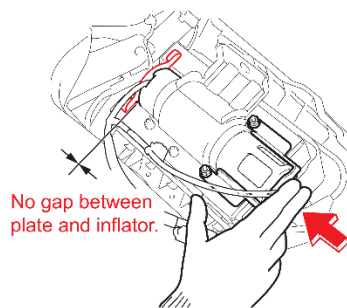
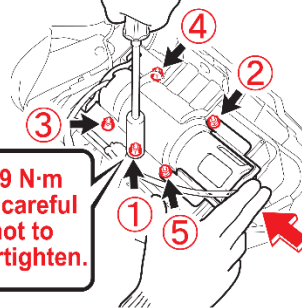
R1702010002H

- a) Tighten the 5 nuts evenly in several increments in the sequence shown. Use a socket driver or torque wrench to tighten the nuts.

Torque: 35in. lbf (40 kgf.cm, 3.9N·m)

- There will be some resistance when tightening the nuts because they are self-locking, confirm the nuts are tightened correctly.
- **DO NOT** use a power tool, T-handle, or ratchet when tightening the nuts to avoid overtorqueing and deforming the studs.
- You may need to turn the airbag to the left or right with in the mounting bracket to access the center nut.

Socket Driver

**These tools cause overtightening !**

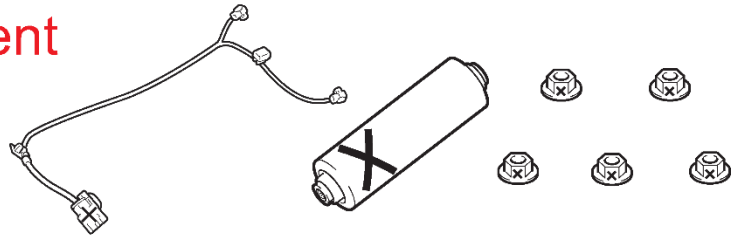
- a) Confirm the **NEW** inflator and 5 **NEW** nuts have been installed.
- b) Confirm the position of the inflator and position determining plates are correct.
- c) Confirm the routing of the inflator wire harness.

(a) Replacement  
of parts.

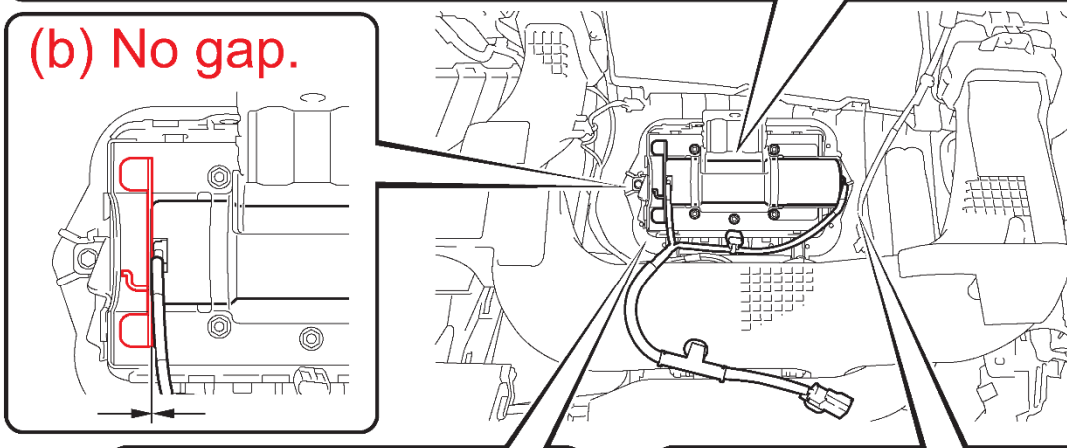
R1701280031H

- If any gaps exist, the flats may move apart and could result in abnormal operation during airbag deployment.

(b) No gap.

(b) Check  
orientation
