# IMPORTANT UPDATE

## TECHNICAL INSTRUCTIONS FOR SAFETY RECALL GLG FRONT PASSENGER AIRBAG MODULE CERTAIN 2010-2013 MY GX 460 **UPDATED 1-9-2018**

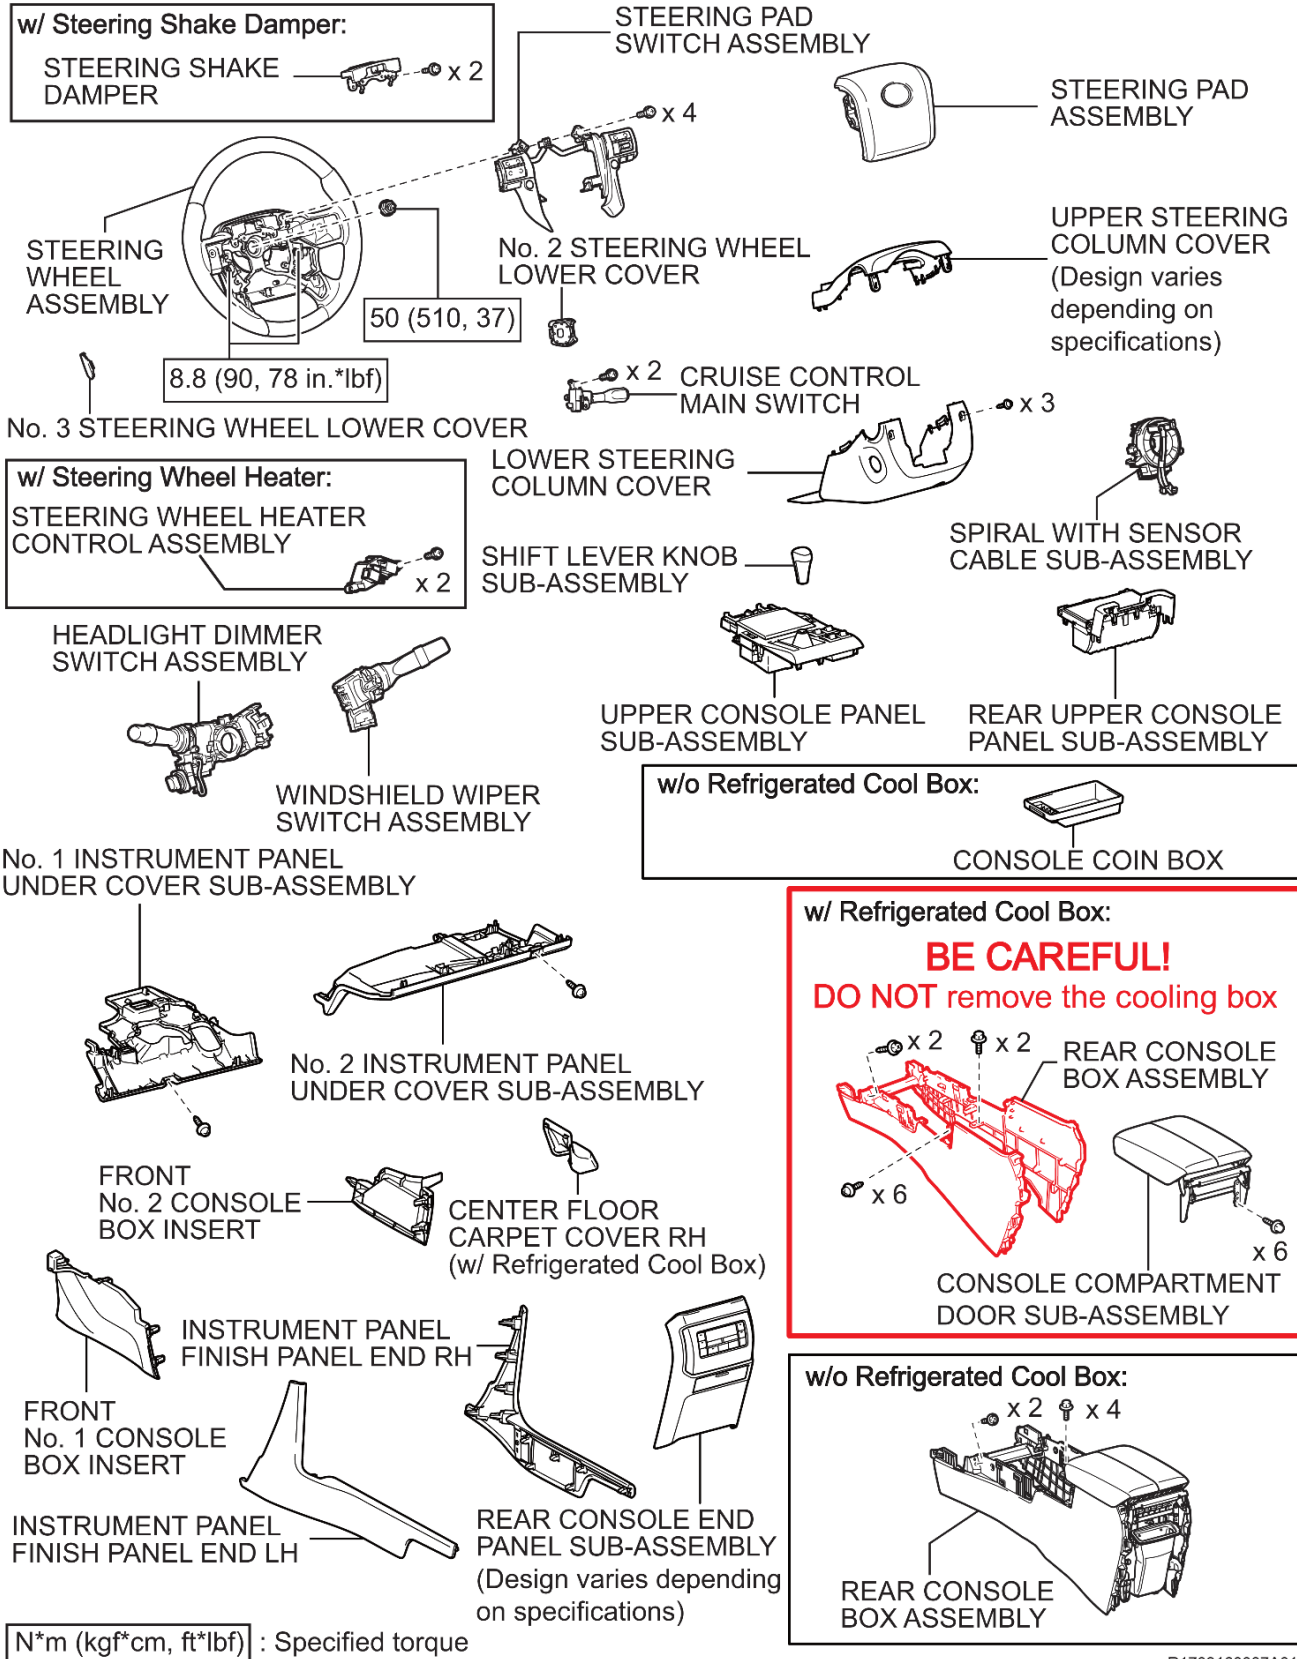
R1703160007A01

## VII. FRONT PASSENGER AIRBAG REMOVAL COMPONENTS

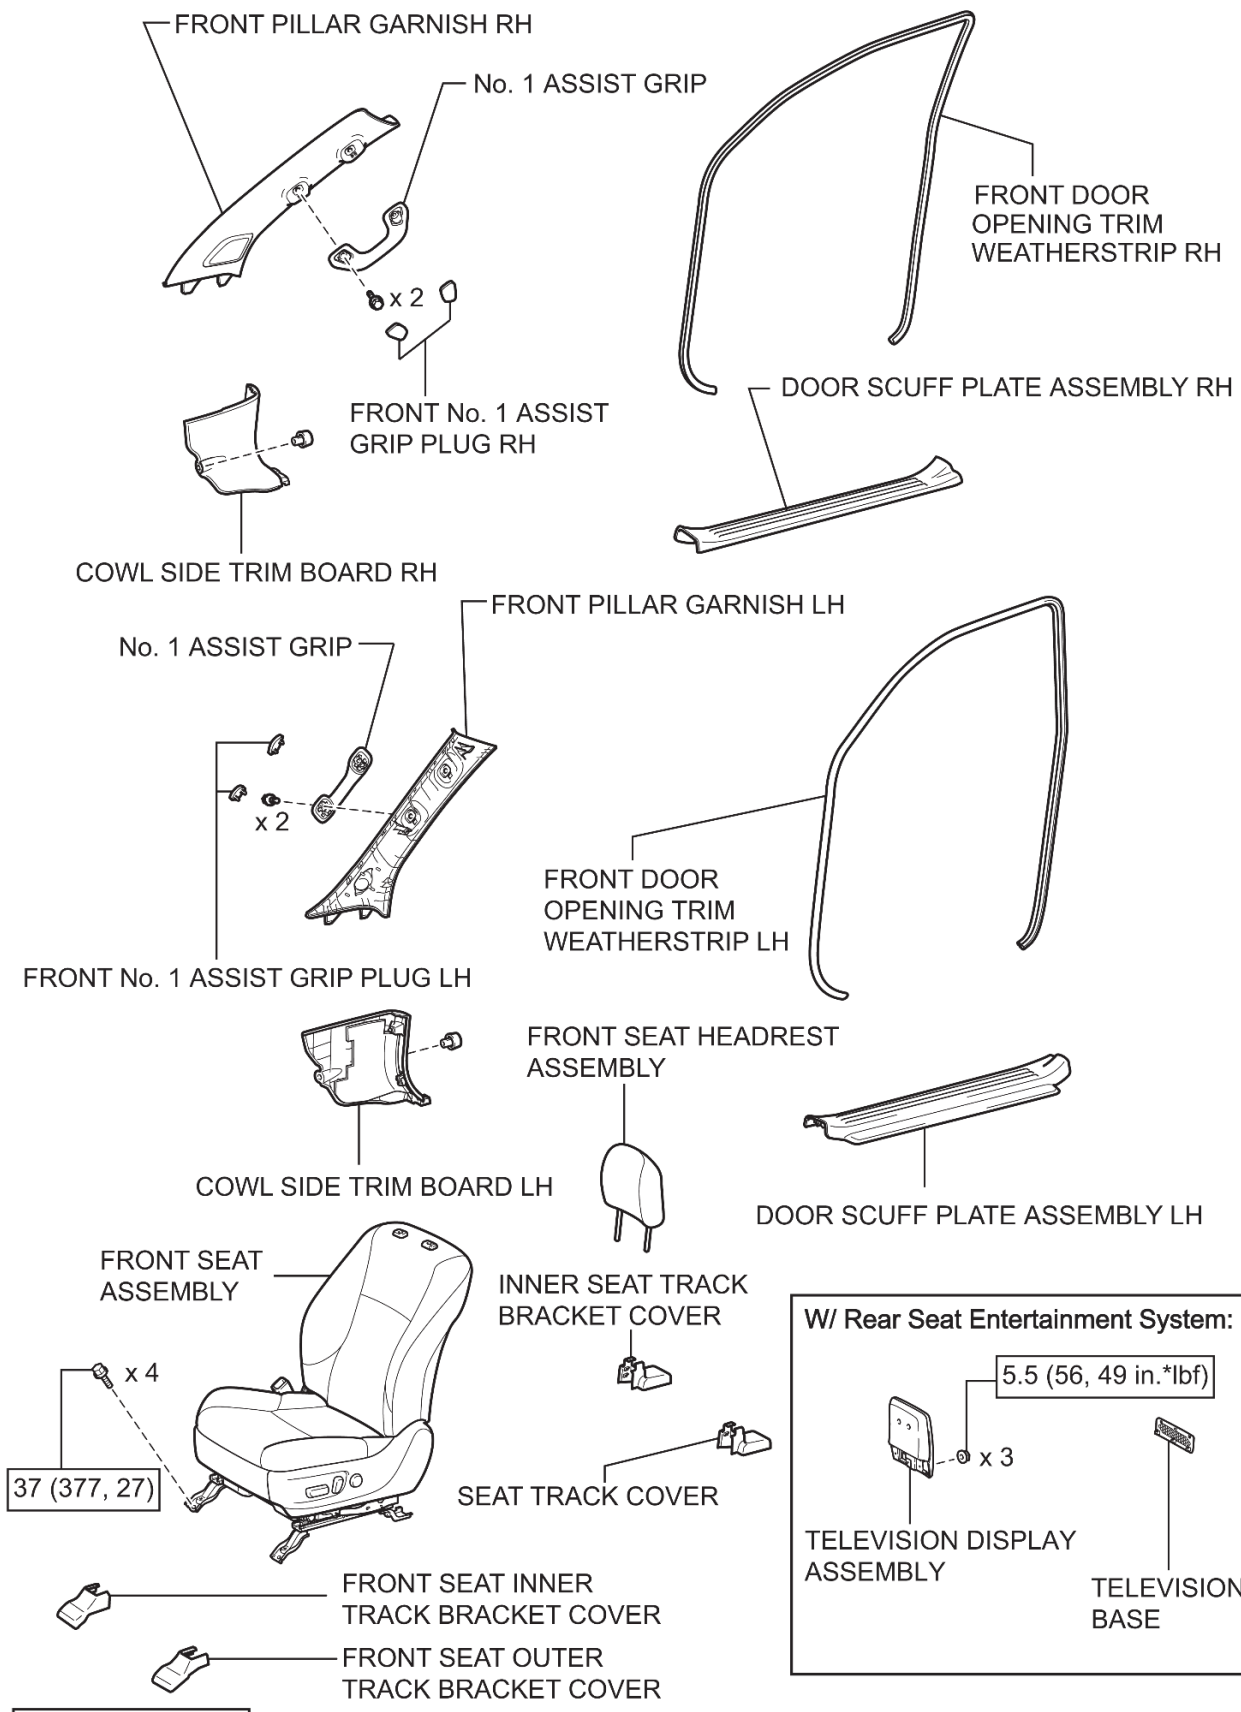
R1703150003

N\*m (kgf\*cm, ft\*lbf) : Specified torque

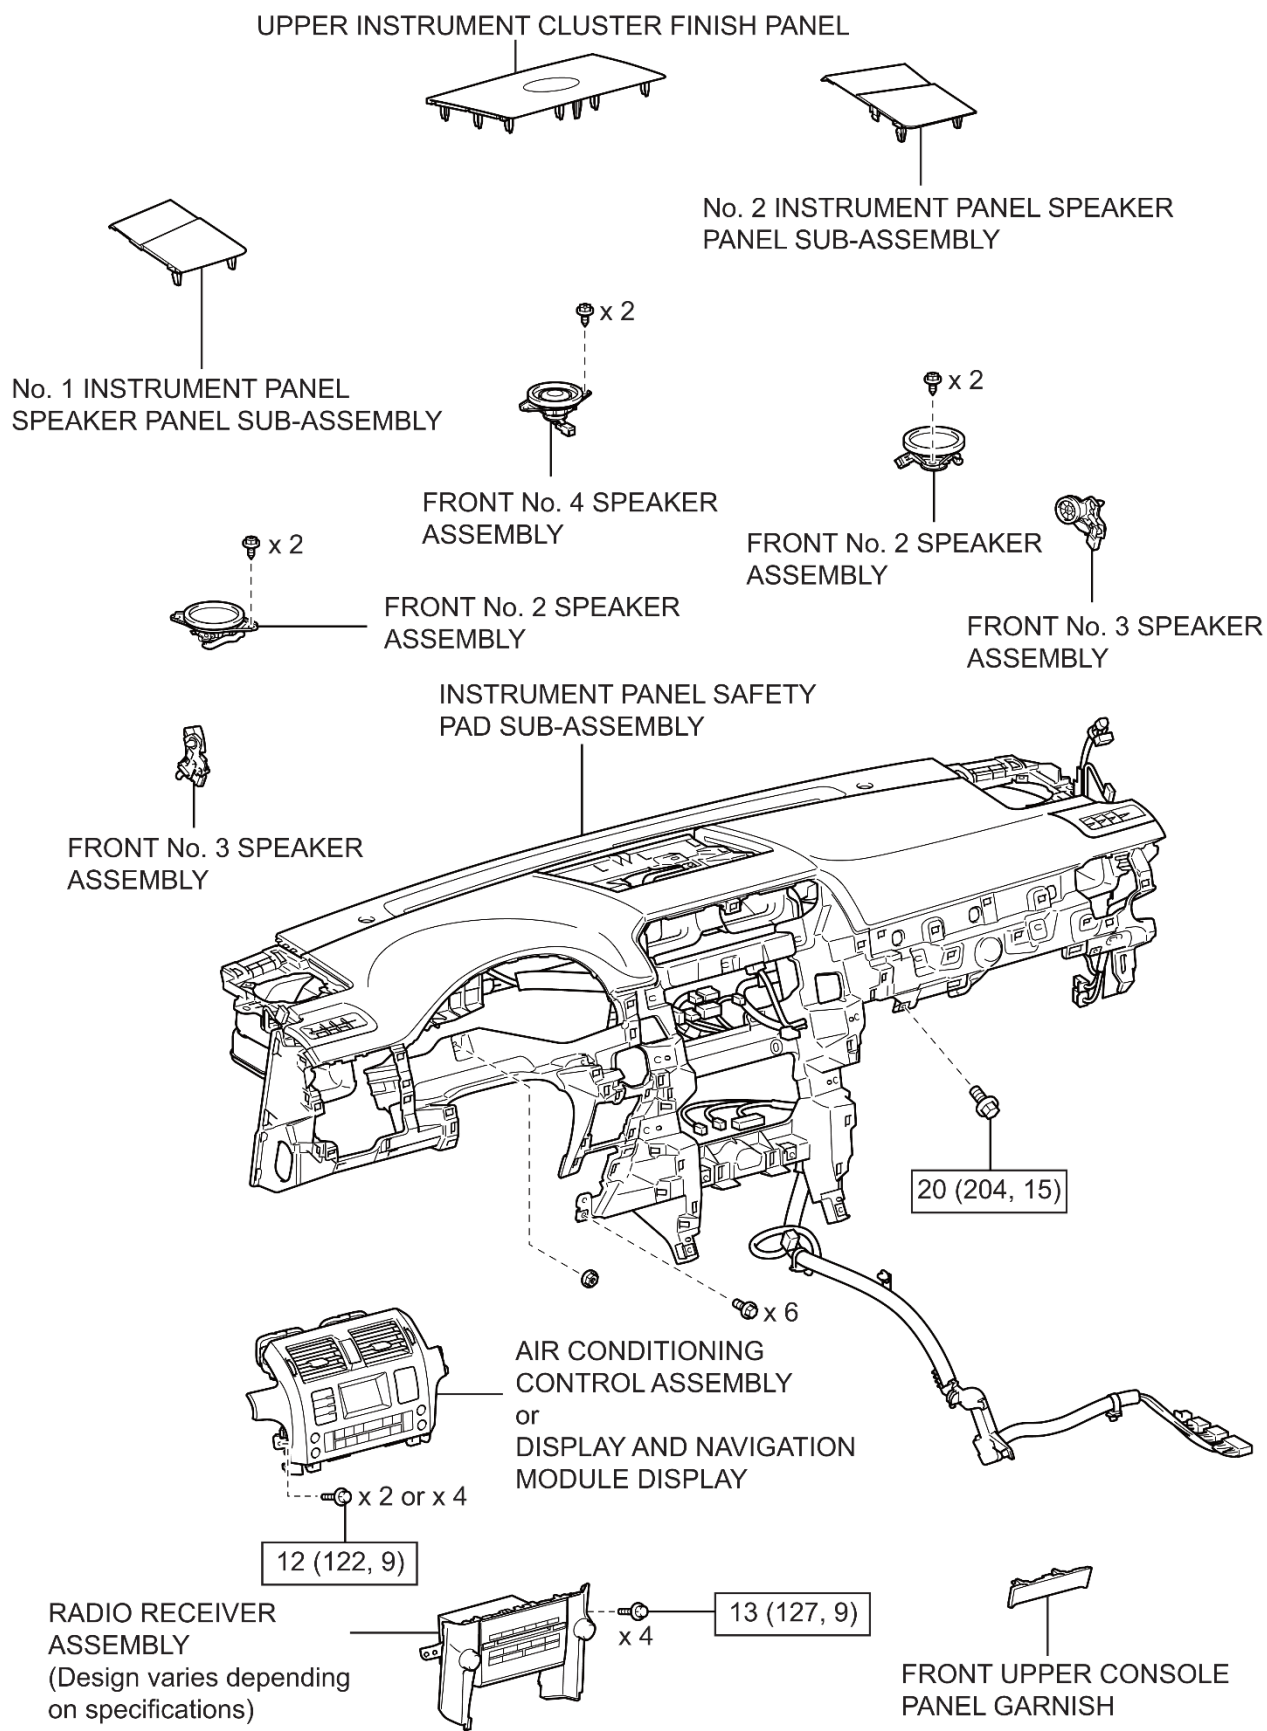
R1703160008

N\*m (kgf\*cm, ft\*lbf) : Specified torque

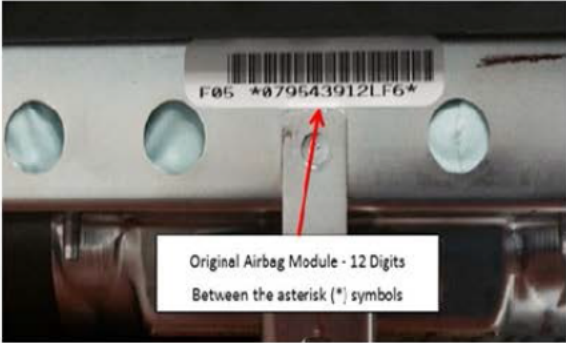
Original Airbag Module - 12 Digits  
Between the asterisk (\*) symbols

The Airbag module Assembly serial number is a **12 digit code**. It can be found along with a bar code on opening the Airbag assembly unit. To manually enter these details into the application, the technician has to identify the 12 digit code between two Asterisks (\*) inside the Airbag assembly unit. The first seven characters of this 12 digit code are numbers and the 10<sup>th</sup> digit is either 'K' or 'L' always.

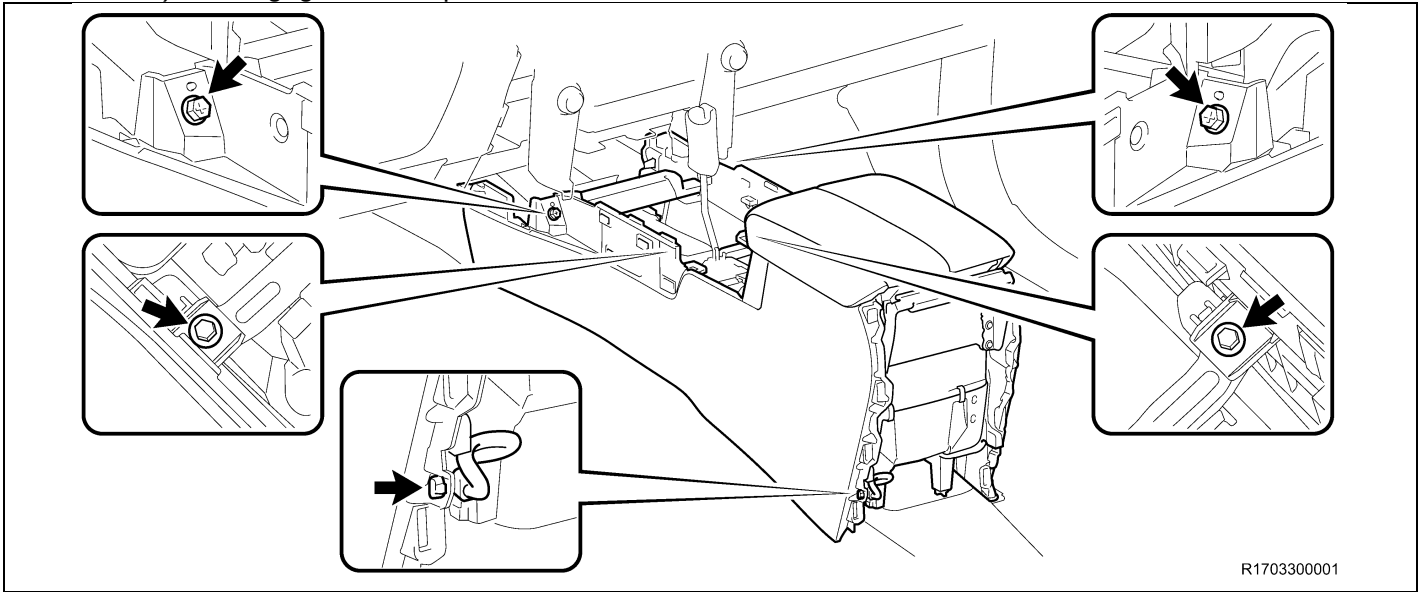
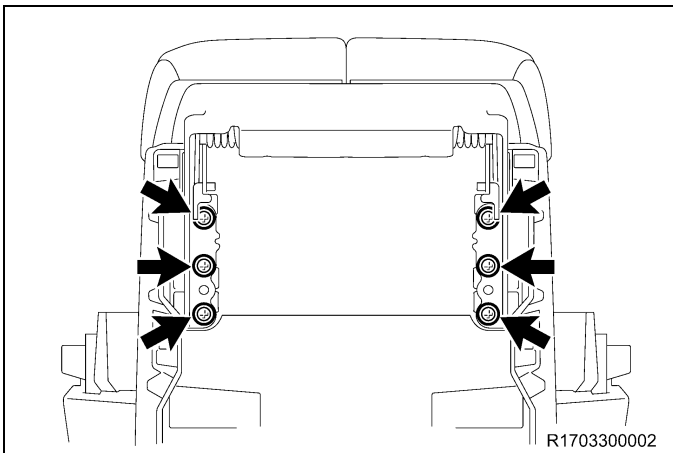
- a) Remove the 2 bolts and 2 screws.
- b) Disengage the clamp.

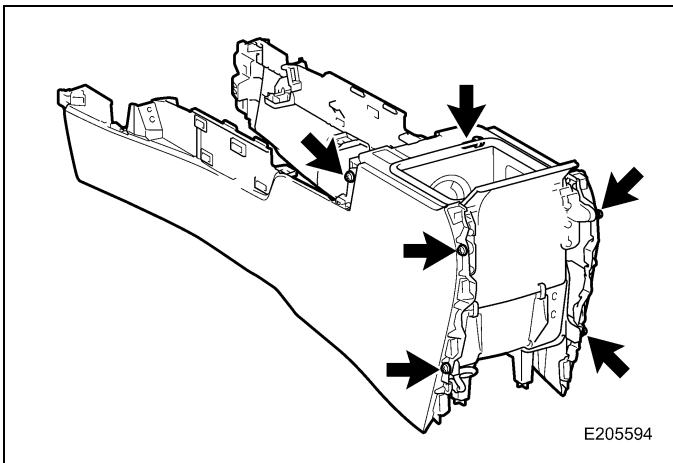
- c) Remove the 6 screws.
- d) Remove the console door.

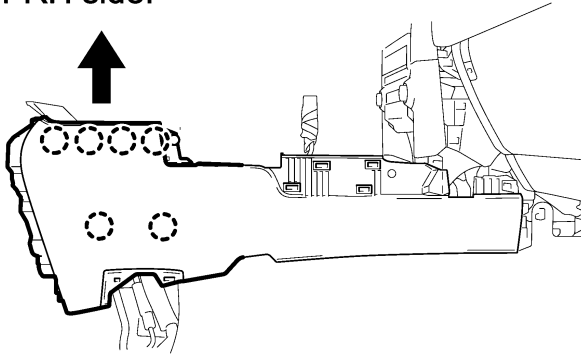
R1703290002

- e) Remove the 6 screws.

for RH side:

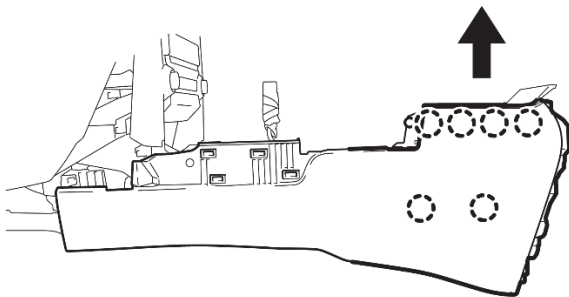
R1703290003

for LH side:

○ : Claw

- f) Disengage the 6 claws on each side of the console as shown.

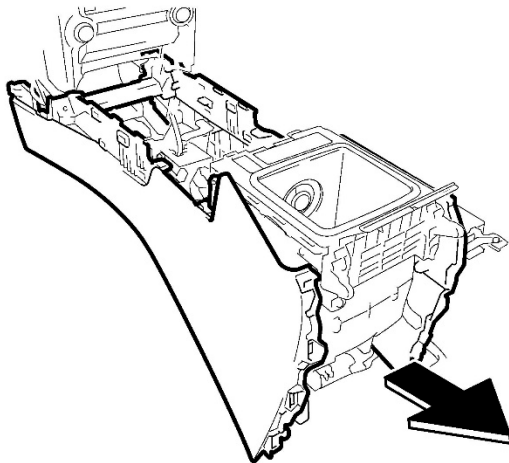
- g) Pull the console box towards the rear of the vehicle, then lift the rear of the box as shown, and remove from vehicle.

**Do not damage  
surrounding components**

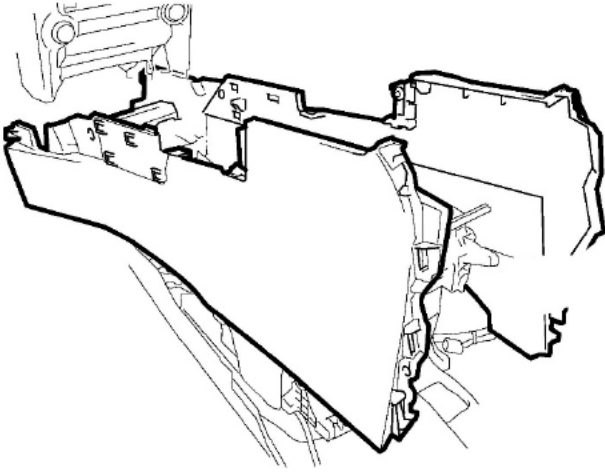
**Do not damage  
surrounding components**

- a) Install the front of the console box with rear section lifted as shown.

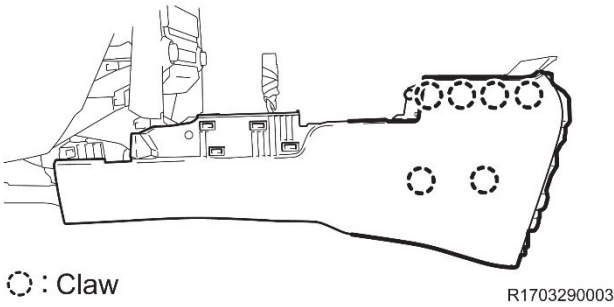
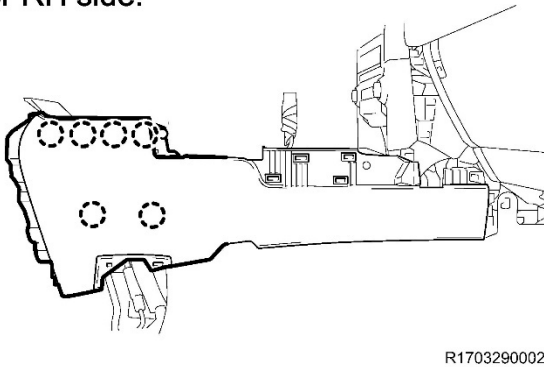
for LH side:

for RH side:

- c) Reengage the 6 claws on each side of the console as shown.

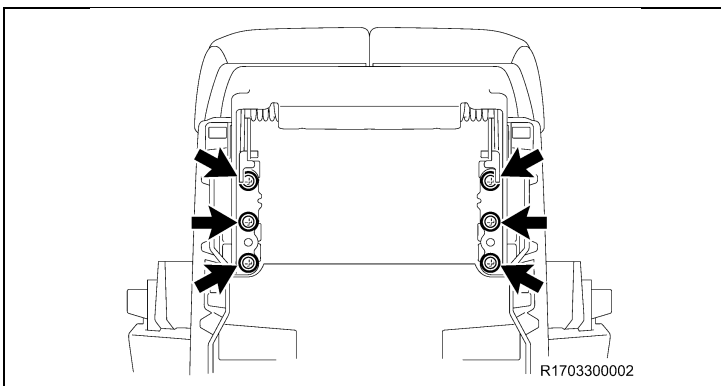
- d) Reinstall the 6 screws.

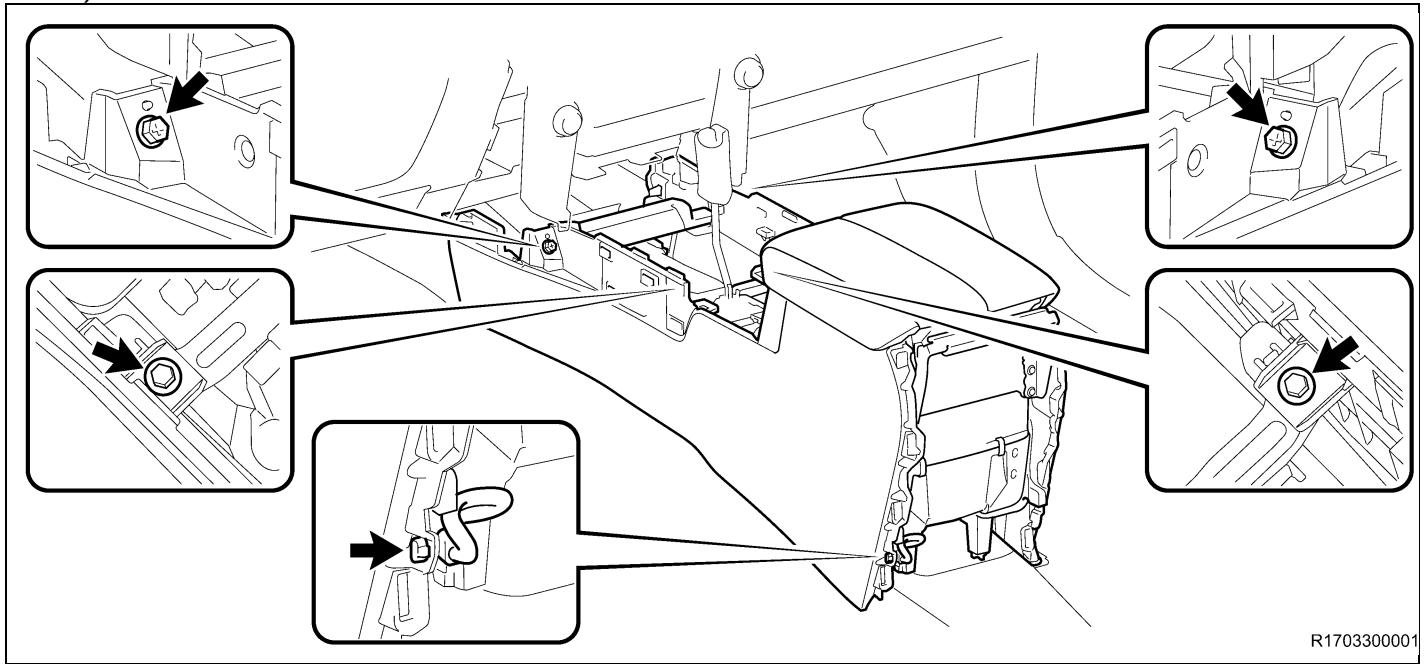
- e) Reinstall the console door.  
f) Reinstall the 6 screws

- g) Reengage the clamp.
- h) Reinstall the 2 bolts and 2 screws.
