### SAFETY RECALL GLG/GLH and HLA

### FRONT PASSENGER AIRBAG MODULE

**CERTAIN 2006 – 2013 MY IS 250/350 and 2008 – 2013 MY IS F**

**Updated 4-18-18**

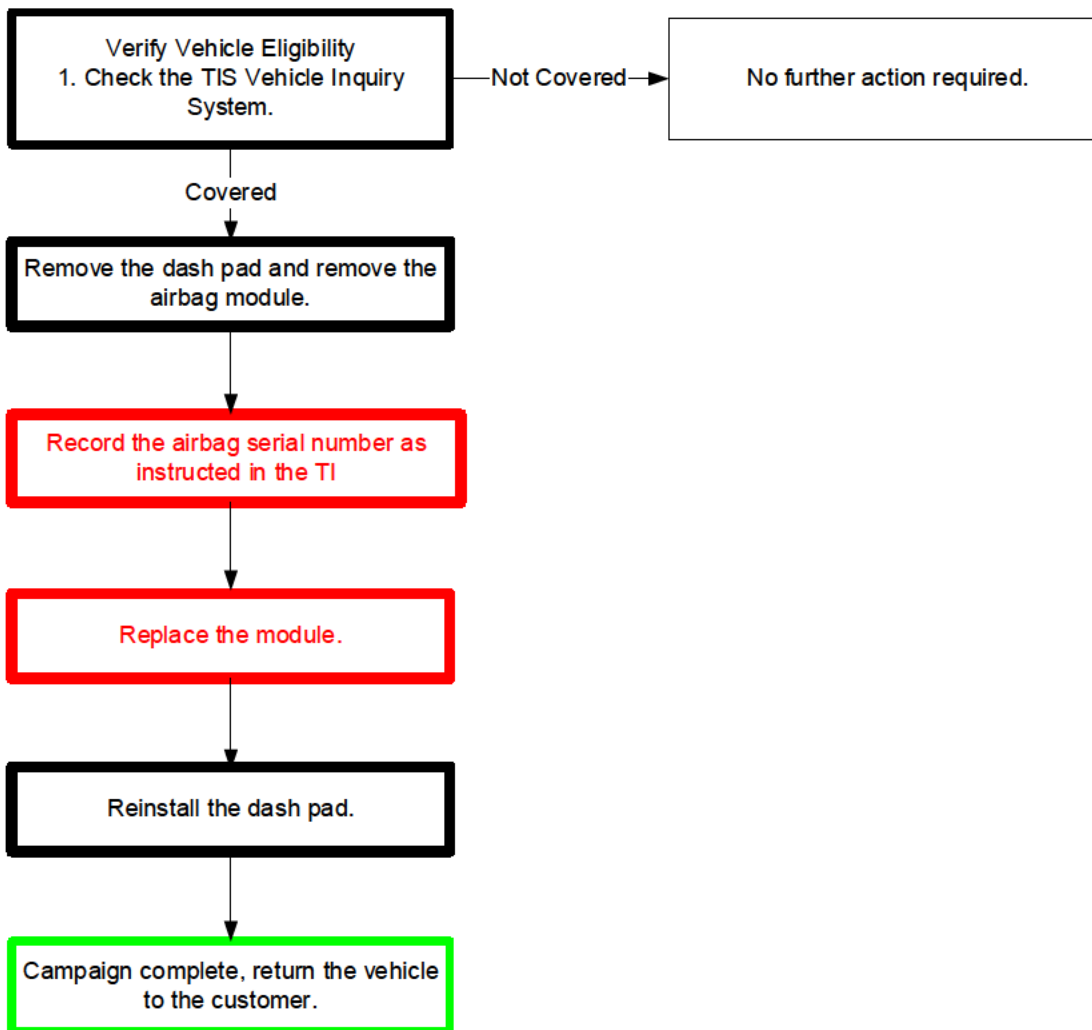
## I. OPERATION FLOW CHART

The flow chart is for reference only. **DO NOT** use it in place of the full technical instructions. Follow **ALL** steps as outlined in the full technical instructions to confirm the campaign is completed correctly.

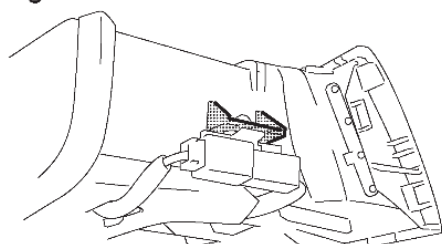
Back side of the part manufactured  
after August 2008:

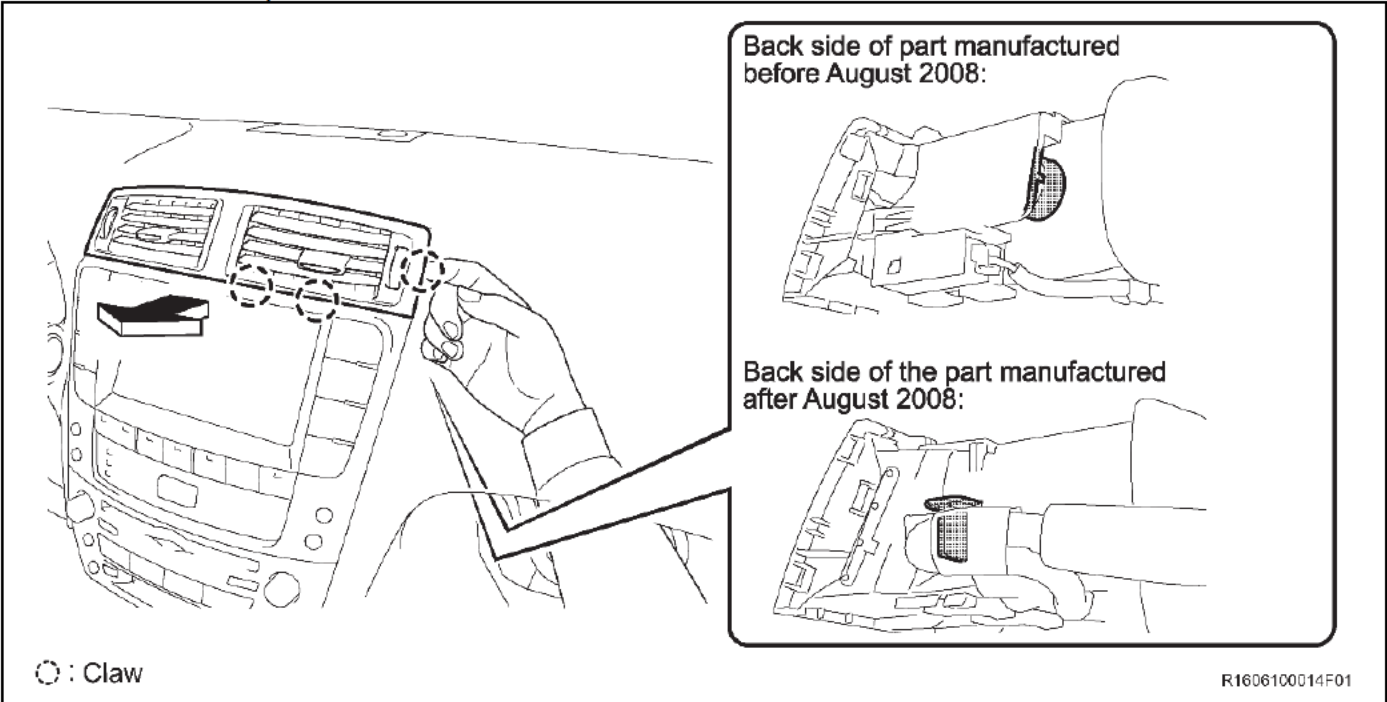
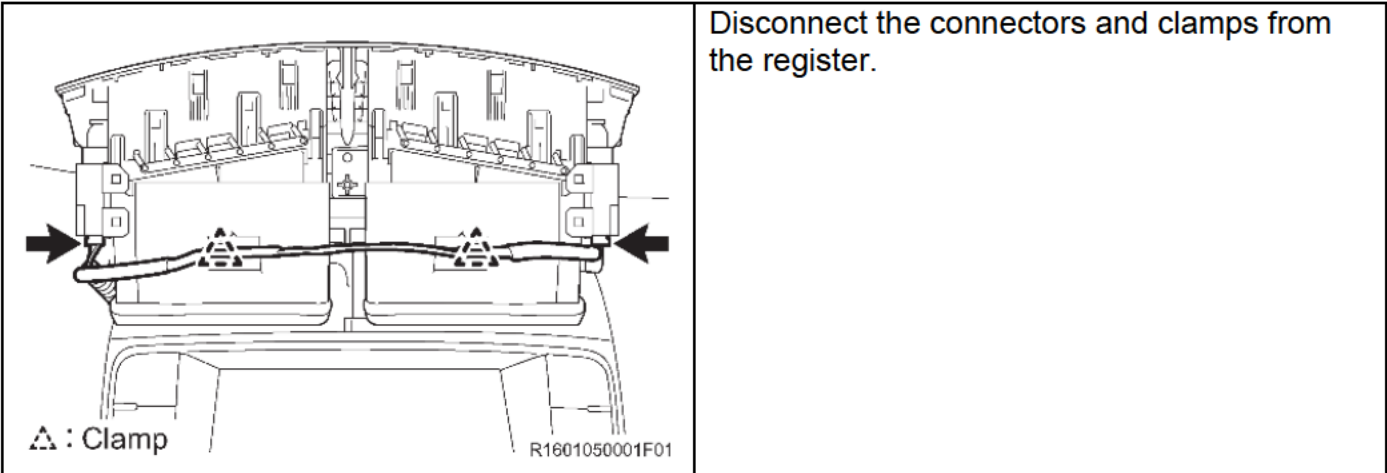
Using your finger on the right side push out at the point shown to disengage the 3 claws and remove the register from the instrument panel.

**NOTE: DO NOT** contact the positioning tabs while removing the instrument panel as the panel could be damaged.

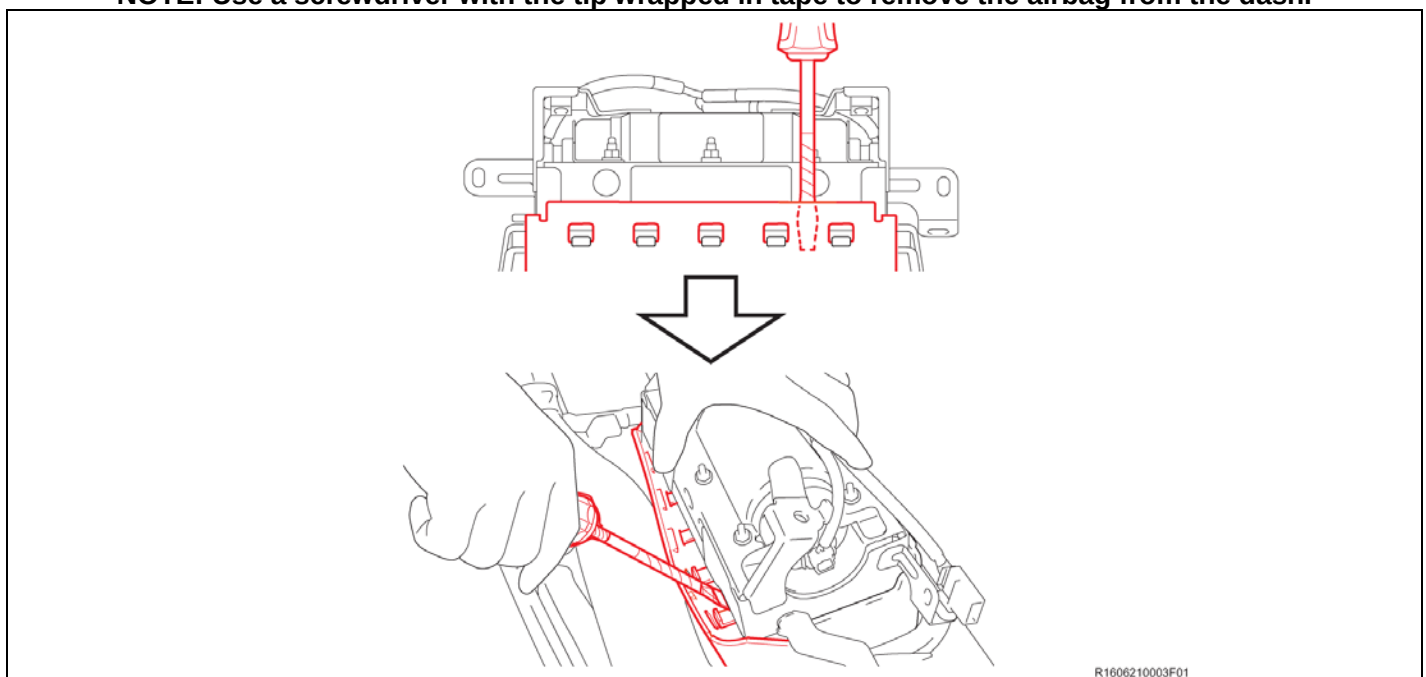
- Remove the 4 bolts, disengage the straps, and then remove the airbag assembly.

**NOTE: Use a screwdriver with the tip wrapped in tape to remove the airbag from the dash.**

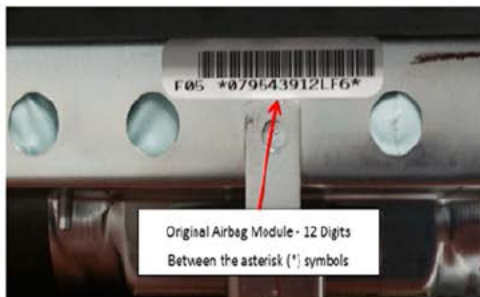
- The airbag serial number is **ALWAYS** the 12 **DIGITS** located between the asterisks.
- The 3 digits before the asterisk **ARE NOT** part of the serial number, and **SHOULD NOT** be entered or an inaccurate response may be returned.

Original Airbag Module - 12 Digits  
Between the asterisk (\*) symbols

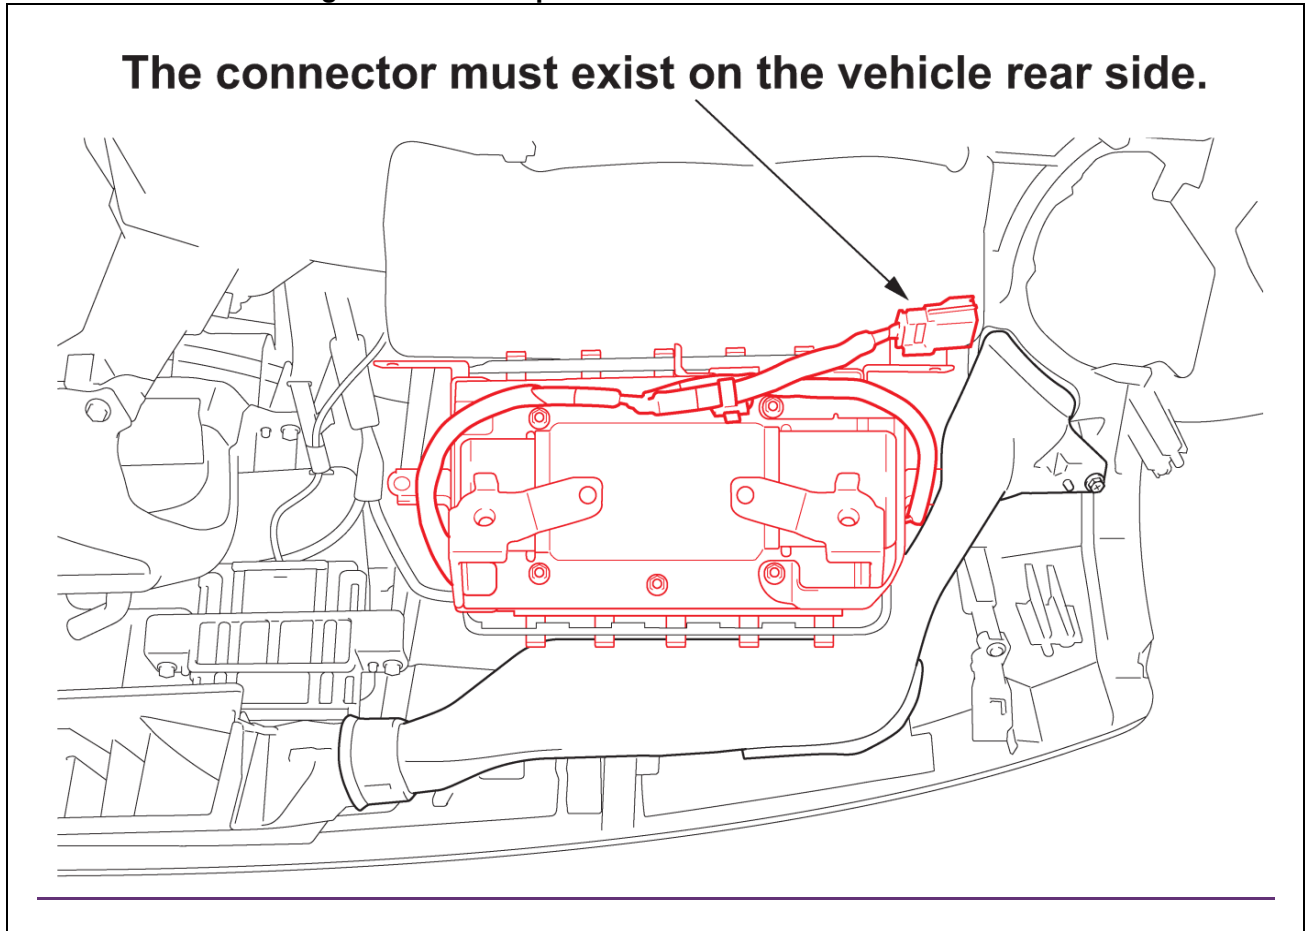
- a) Position the airbag assembly in the instrument panel, engage the straps, and then install the 4 bolts.

**NOTE:** Ensure the airbag connectors is positioned as shown
