## TECHNICAL INSTRUCTIONS FOR SAFETY RECALL G0R FRONT PASSENGER AIRBAG INFLATOR MODULE CERTAIN 2010 MY 4RUNNER

### UPDATE 7-17-18

The subject vehicles are equipped with front passenger airbag inflators produced by Takata. According to Takata, the propellant in these inflators may degrade after prolonged exposure to high absolute humidity and fluctuating high temperatures. Degraded propellant can cause inflator rupture during airbag deployment. In the event of an inflator rupture, metal fragments could pass through the airbag cushion material, striking the vehicle occupants, and result in serious injury or death.

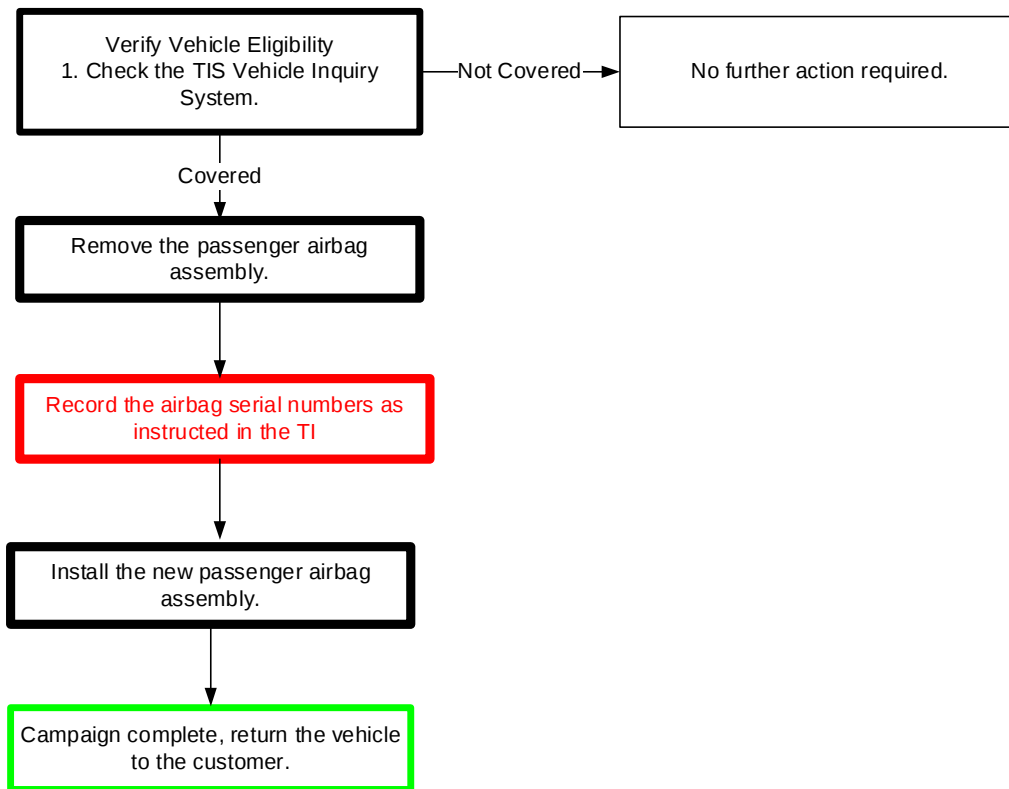
## I. OPERATION FLOW CHART

The flow chart is for reference only. **DO NOT** use it in place of the full technical instructions. Follow **ALL** steps as outlined in the full technical instructions to confirm the campaign is completed correctly.

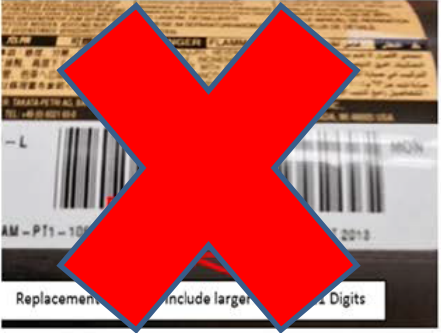
**Replacement Inflator**

The first two characters of the Replacement Inflator Serial code will be either 'LT' or 'LR'.
