### TECHNICAL INSTRUCTIONS FOR SAFETY RECALL G0R FRONT PASSENGER AIRBAG INFLATOR CERTAIN 2008 – 2010 MY SCION xB

**UPDATED 1-9-18**

The subject vehicles are equipped with front passenger airbag inflators produced by Takata. According to Takata, the propellant in these inflators may degrade after prolonged exposure to high absolute humidity and fluctuating high temperatures. Degraded propellant can cause inflator rupture during airbag deployment. In the event of an inflator rupture, metal fragments could pass through the airbag cushion material, striking the vehicle occupants, and result in serious injury or death.

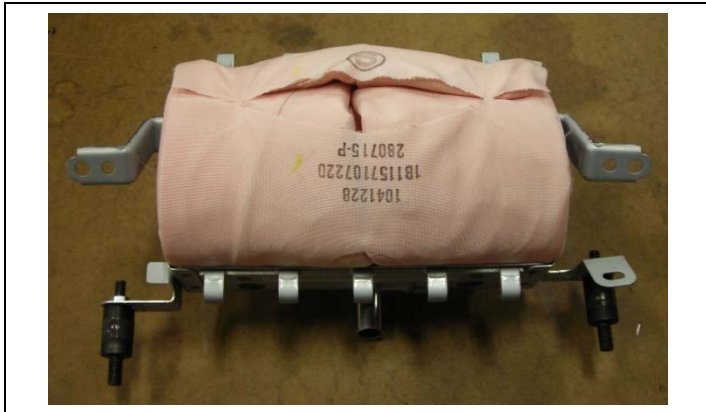
- Mount the adaptors (579943-3R3) to the airbag as shown.

**NOTE: The 6mm stud mounts to the airbag.**
