## TECHNICAL INSTRUCTIONS FOR SAFETY RECALL GLG/GLH and HLA

### FRONT PASSENGER AIRBAG INFLATOR REPLACEMENT CERTAIN 2006 – 2013 MY IS 250/350 and 2008 – 2013 MY IS F

#### UPDATE 4-18-18

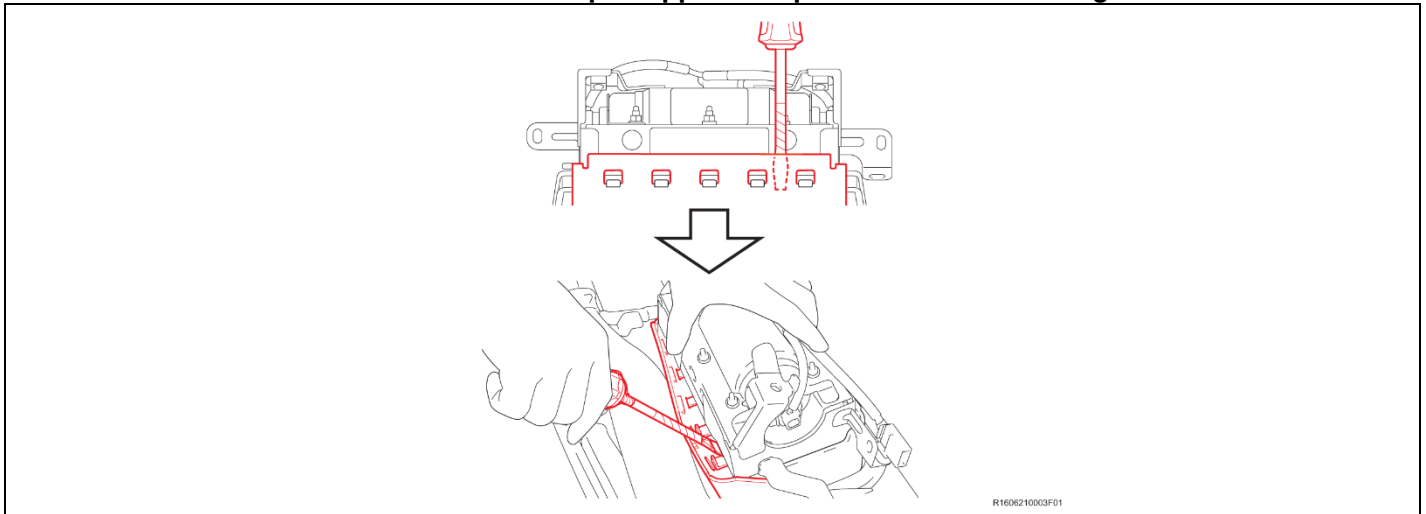
- Remove the 4 bolts, disengage the straps, and then remove the airbag assembly.

**NOTE: Use a screwdriver with the tip wrapped in tape to remove the airbag from the dash.**
