# IMPORTANT UPDATE

## TECHNICAL INSTRUCTIONS FOR SAFETY RECALL H0A FRONT PASSENGER AIRBAG INFLATOR MODULE CERTAIN 2009 MODEL YEAR MATRIX UPDATE 7-17-18

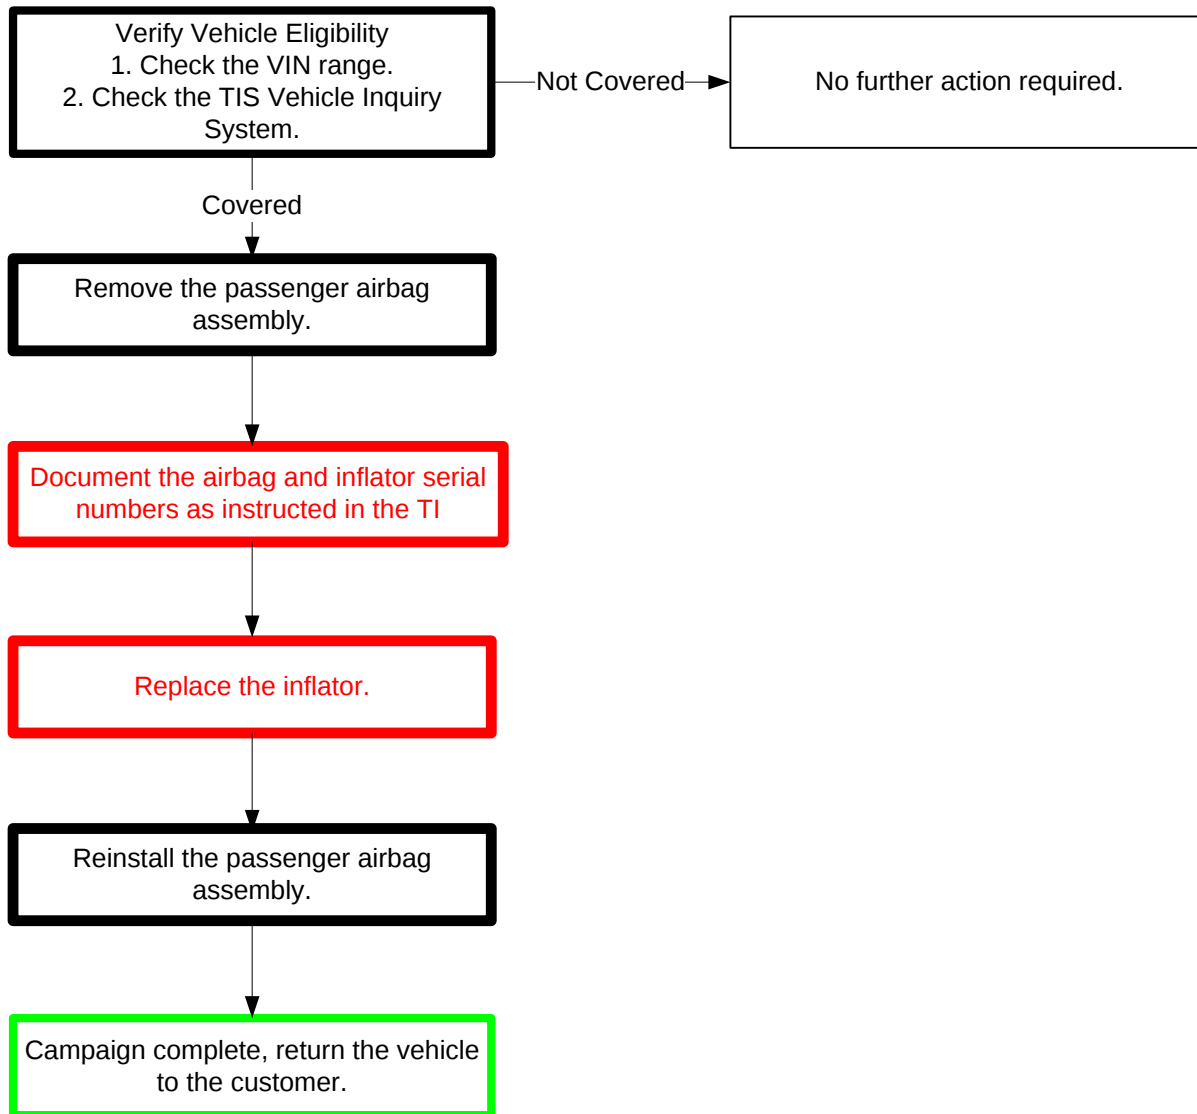
## I. OPERATION FLOW CHART

The flow chart is for reference only. *DO NOT* use it in place of the full technical instructions. Follow *ALL* steps as outlined in the full technical instructions to confirm the campaign is completed correctly.

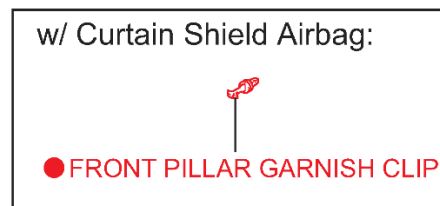
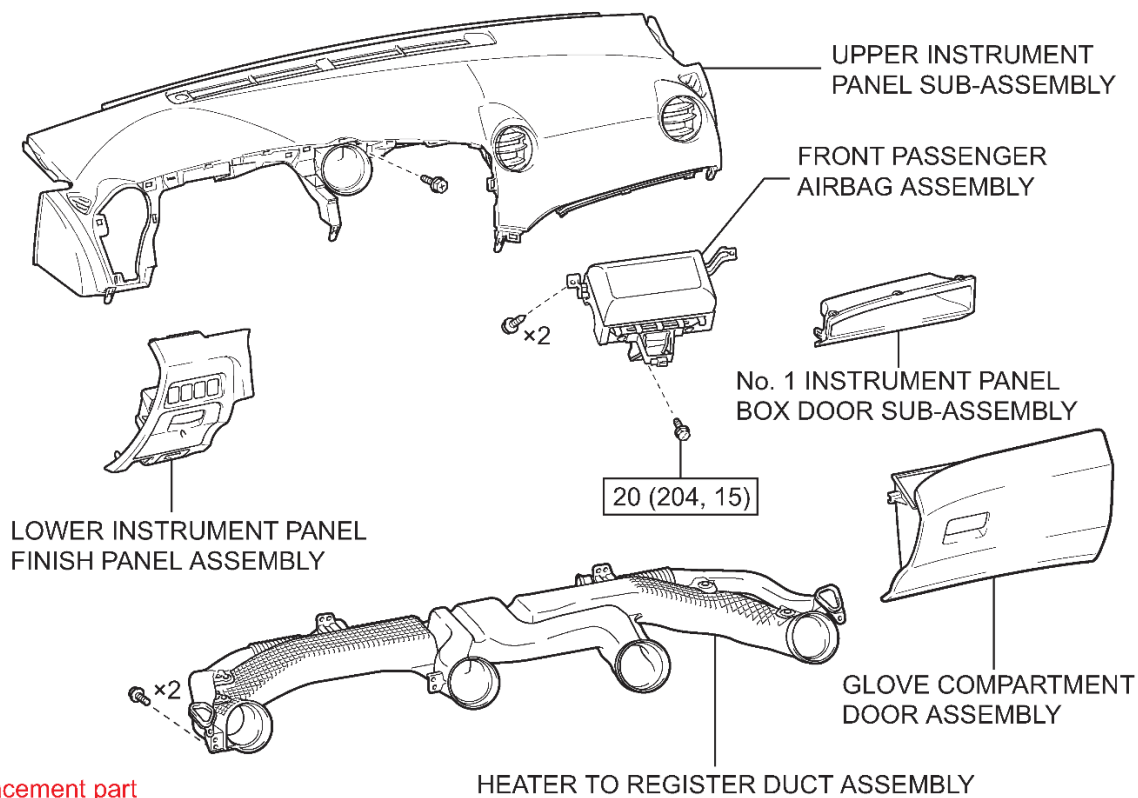
R1703010003

● : Replacement part

N\*m (kgf\*cm, ft.\*lbf) : Specified torque

**3.9 N·m (40, 35 in.\*lbf)**  
**Be careful not to**  
**overtighten.**

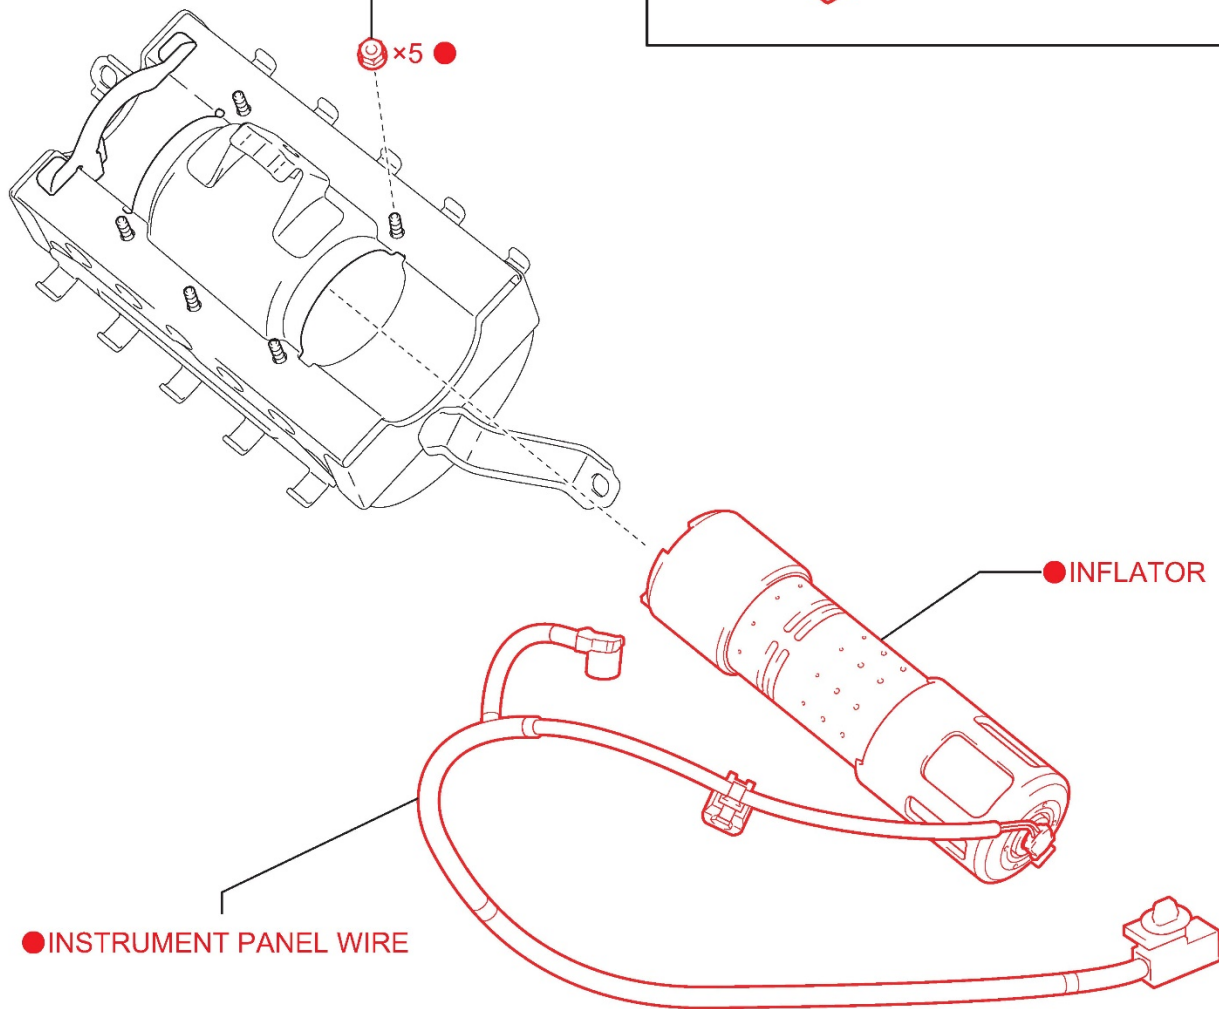
R1702270035

for MATRIX:

● : Replacement part

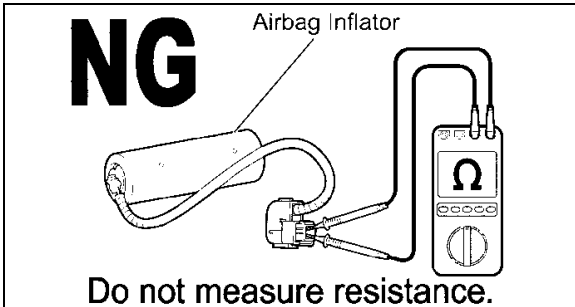
#### 2. DO NOT MEASURE RESISTANCE

- DO NOT** measure resistance of airbag components, this may cause accidental activation.

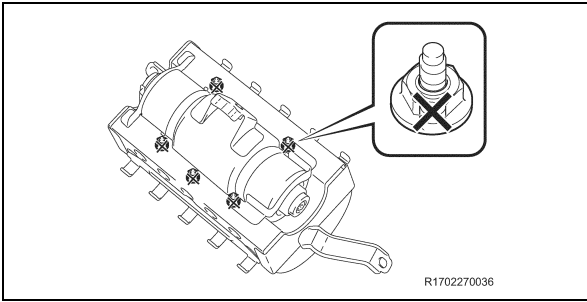
- Use a screwdriver to release the lock button.
- Disconnect the connector.
- Disconnect the wire harness clamps.

**NOTE: Disconnect the connector where the fixed stop plate is located.**

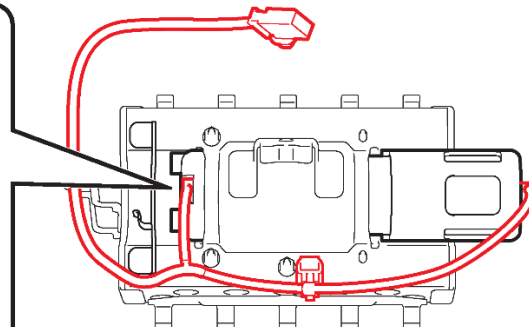
R1702270041

- b) Connect the connector to the inflator and ensure that the connector lock is fully engaged as shown.  
c) Route and secure the wire harness as shown.

**ALIGN CONNECTORS**
