**TECHNICAL INSTRUCTIONS**  
**FOR**  
**SAFETY RECALL GLG**  
**FRONT PASSENGER AIRBAG INFLATOR REPLACEMENT**  
**CERTAIN 2007 – 2012 MY ES 350**

The subject vehicles are equipped with front passenger airbag inflators produced by Takata. The propellant in these inflators may degrade after prolonged exposure to high absolute humidity and fluctuating high temperatures. Degraded propellant can cause inflator rupture during airbag deployment. In the event of an inflator rupture, metal fragments could pass through the airbag cushion material, striking the vehicle occupants, and result in serious injury or death.

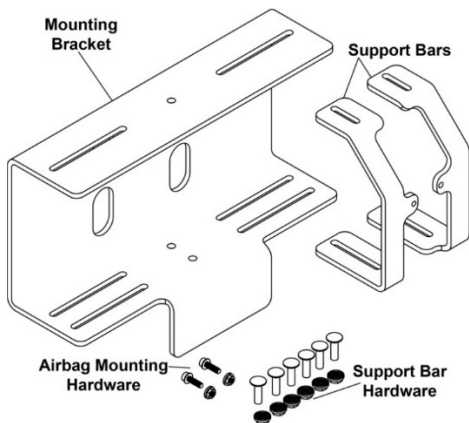
Airbag Mounting Bracket & hardware (Provided to the dealership at the launch of SSC DLC)	1

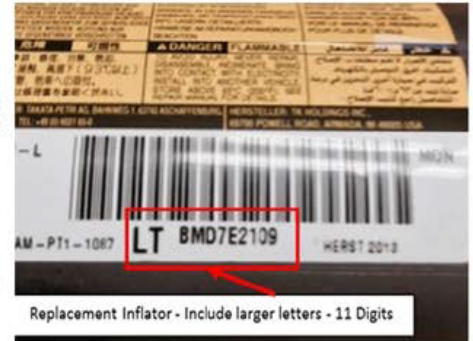
### Replacement Inflator

The first two characters of the Replacement Inflator Serial code will be either 'LT' or 'LR'.

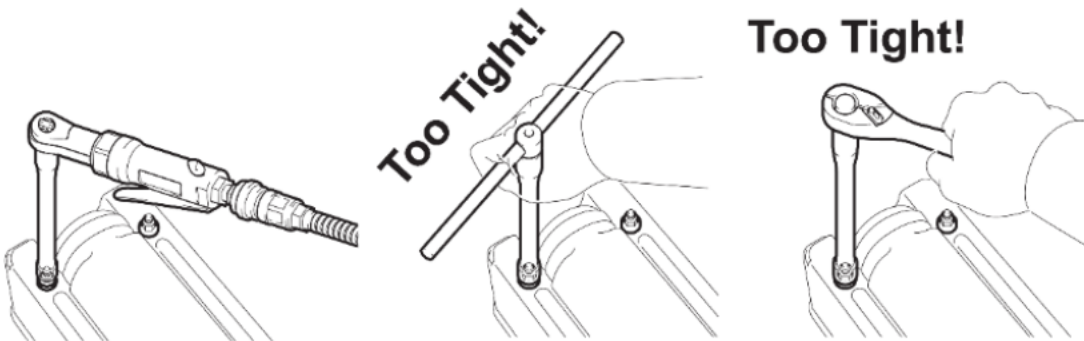
R1701260011Z01

- There will be some resistance when tightening the nuts because they are self-locking, confirm the nuts are tightened correctly.
- **DO NOT** use a power tool, T-handle, or ratchet when tightening the nuts to avoid over torqueing and deforming the studs.
- You may need to slide the airbag to the left or right with in the mounting bracket to access the center nut.

**OK**

**These tools cause overtightening !**
