# TECHNICAL INSTRUCTIONS FOR SAFETY RECALL G0R FRONT PASSENGER AIRBAG INFLATOR MODULE CERTAIN 2008 - 2010 MY SCION xB

**UPDATED 1-9-2018**

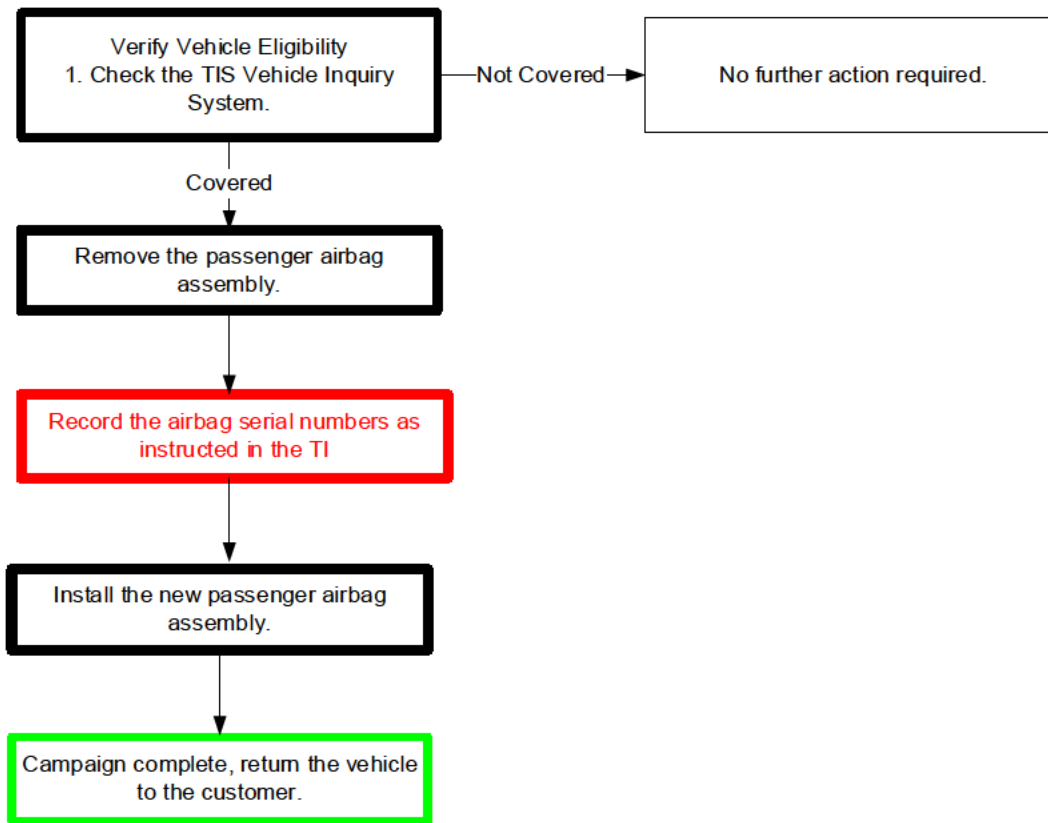
## I. OPERATION FLOW CHART

The flow chart is for reference only. **DO NOT** use it in place of the full technical instructions. Follow **ALL** steps as outlined in the full technical instructions to confirm the campaign is completed correctly.

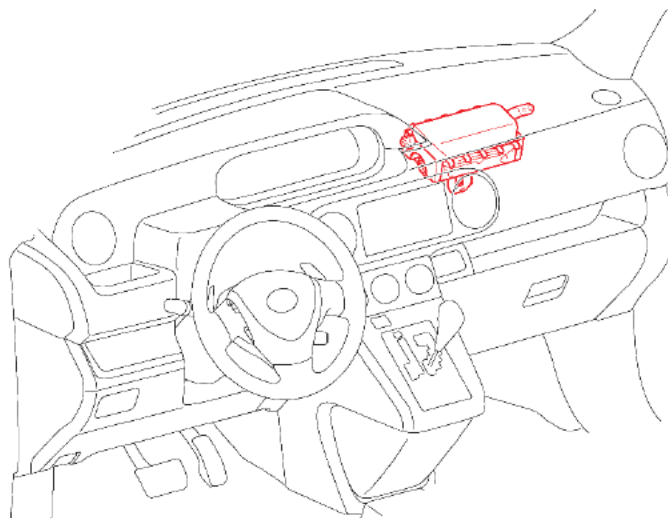
C162294

The subject vehicles are equipped with front passenger airbag inflators produced by Takata. According to Takata, the propellant in these inflators may degrade after prolonged exposure to high absolute humidity and fluctuating high temperatures. Degraded propellant can cause inflator rupture during airbag deployment. In the event of an inflator rupture, metal fragments could pass through the airbag cushion material, striking the vehicle occupants, and result in serious injury or death.

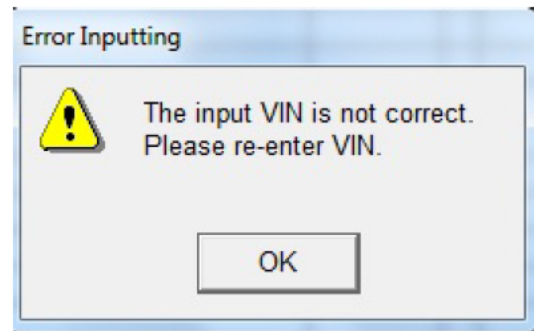
- After the health check has completed, run a diagnostic report by clicking on the link on the health check screen.

**NOTE: If the VIN was not entered in ALL CAPS when Techstream was launched, an error will be displayed and there will be a prompt to reenter the VIN**

- Enter the vehicle mileage and repair order information, then click the 'report' button.

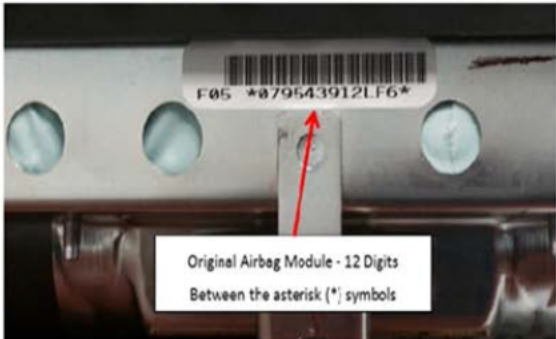
Original Airbag Module - 12 Digits  
Between the asterisk (\*) symbols

a) If the airbag serial number cannot be scanned or is not present check the box as shown below.

Check this box if the label is damaged or missing

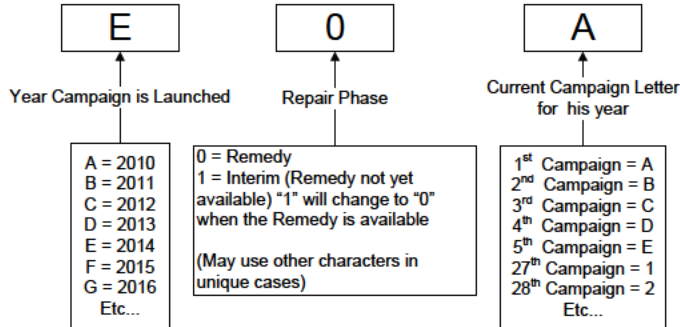
### A. CAMPAIGN DESIGNATION DECODER

Examples:

A0D = Launched in 2010, Remedy Phase, 4<sup>th</sup> Campaign Launched in 2010

B1E = Launched in 2011, Interim Phase, 5<sup>th</sup> Campaign Launched in 2011

C1C = Launched in 2012, Interim Phase, 3<sup>rd</sup> Campaign Launched in 2012
