# IMPORTANT UPDATE

## TECHNICAL INSTRUCTIONS FOR SAFETY RECALL G0P/G0R/H0A FRONT PASSENGER AIRBAG INFLATOR MODULE CERTAIN 2009 – 2013 MODEL YEAR COROLLA

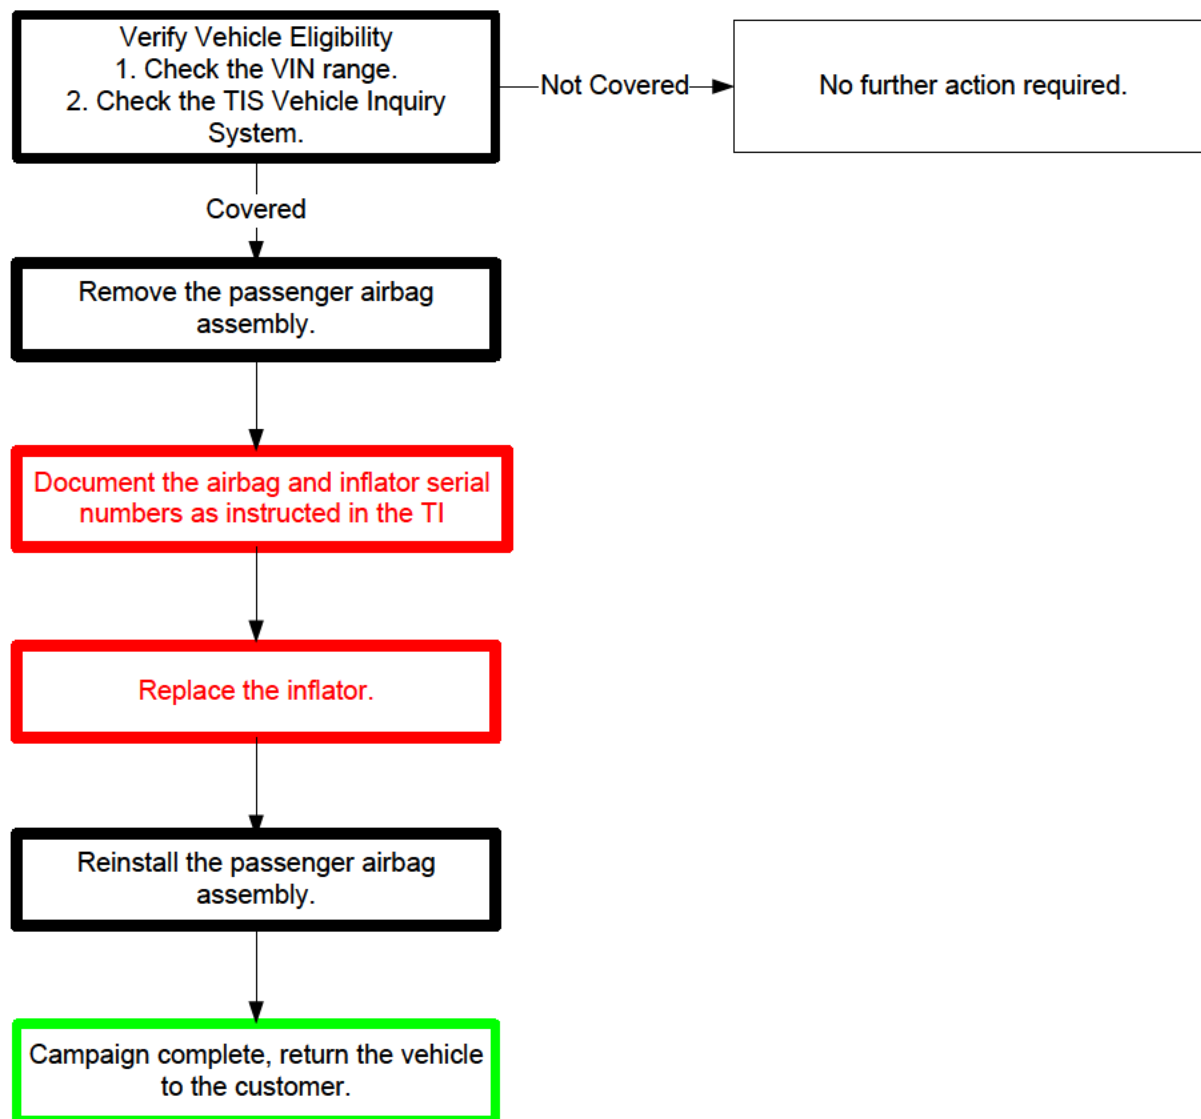
## I. OPERATION FLOW CHART

The flow chart is for reference only. **DO NOT** use it in place of the full technical instructions. Follow **ALL** steps as outlined in the full technical instructions to confirm the campaign is completed correctly.

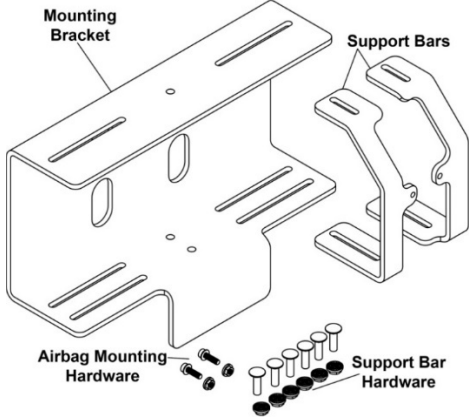
| Image | Name | Quantity |
|---|---|---|
| | Airbag Mounting Bracket & hardware | 1 |

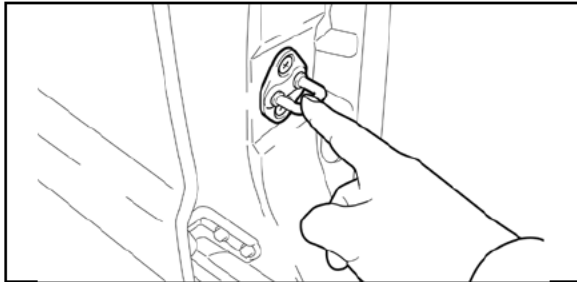
#### 1. ELIMINATE STATIC ELECTRICITY

- Before starting work and periodically while working on the vehicle, touch a metallic part of the vehicle to discharge static electricity in the body.

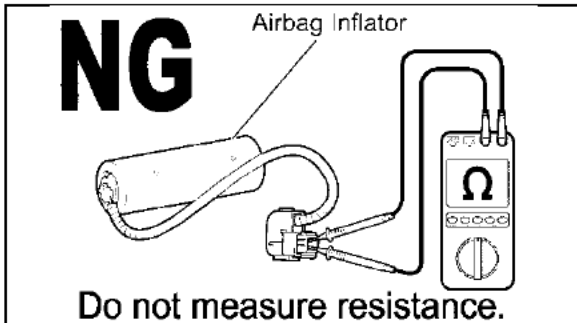
#### 2. DO NOT MEASURE RESISTANCE

- DO NOT** measure resistance of airbag components, this may cause accidental activation.

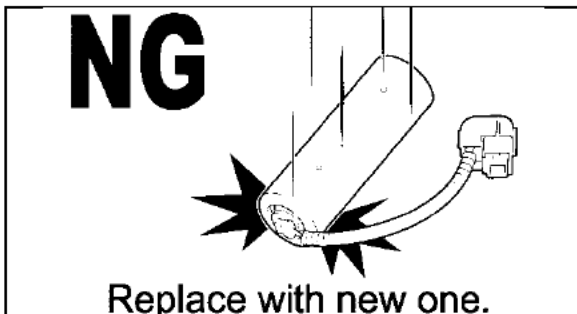
#### 3. HANDLE THE AIRBAG CAREFULLY

- If an inflator is dropped, replace it with a **NEW** inflator.

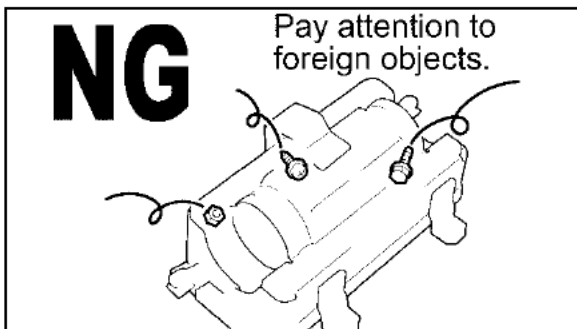
#### 4. DO NOT ALLOW FOREIGN OBJECTS NEAR AIRBAG

- Be sure to collect and account for all removed nuts/bolts to prevent them from landing in the airbag assembly.
- Any foreign objects in the airbag assembly may cause damage or injury if the airbag is activated.

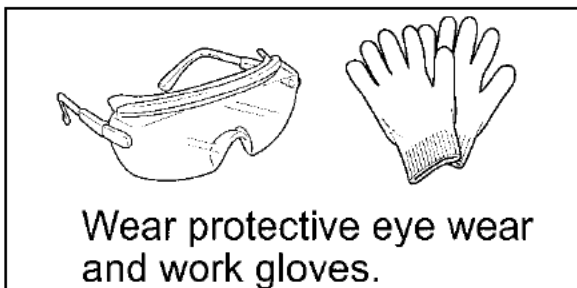
#### 5. WEAR PROTECTIVE EQUIPMENT

- Always wear appropriate protective equipment when working on the SRS.

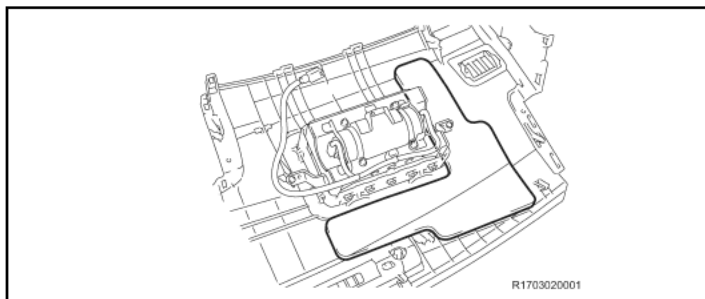
**NOTE:** For TMC made Corolla only (VIN starts with JT). Do not remove the No. 4 instrument panel cushion.

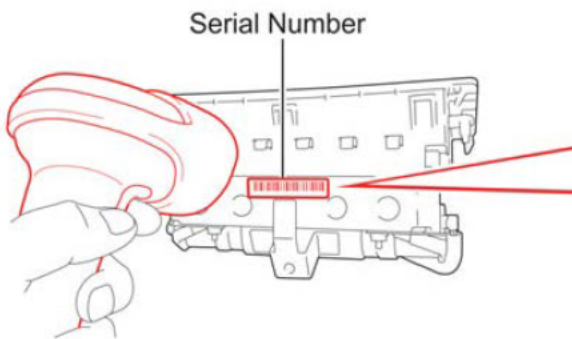
#### Airbag Serial Number Label Example

- The airbag serial number is **ALWAYS** the 12 **DIGITS** located between the asterisks.
- The 3 digits before the asterisk **ARE NOT** part of the serial number, and **SHOULD NOT** be entered or an inaccurate response may be returned.

The **AIRBAG ASSEMBLY** serial number and the **INFLATOR** serial number are **DIFFERENT**. The **AIRBAG ASSEMBLY** serial number **MUST** be recorded prior to replacement.

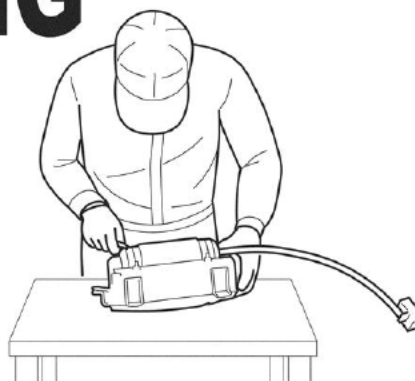
- Carefully place the airbag on the bench inflator side up.

- Avoid standing directly over the inflator.

# OK

# NG

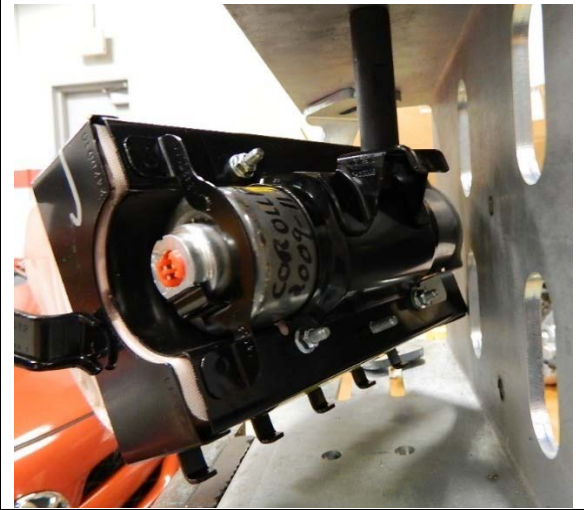
- a) Loosen the 5 nuts until the nuts are at the top of the studs as shown, through the openings in the mounting bracket.

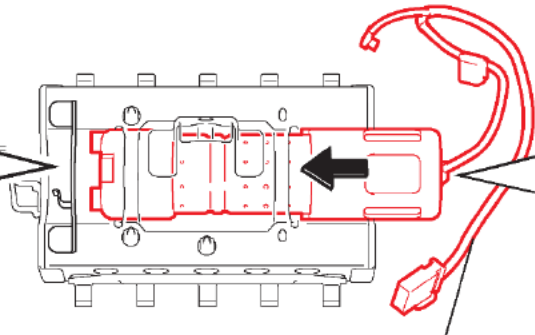
a) Carefully slide the new inflator into the airbag assembly and align as shown.

Bottom

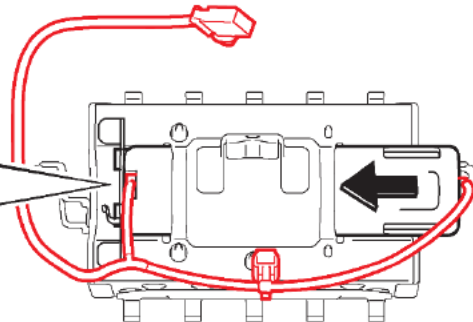
**NG**

**DO NOT**  
pinch the wire

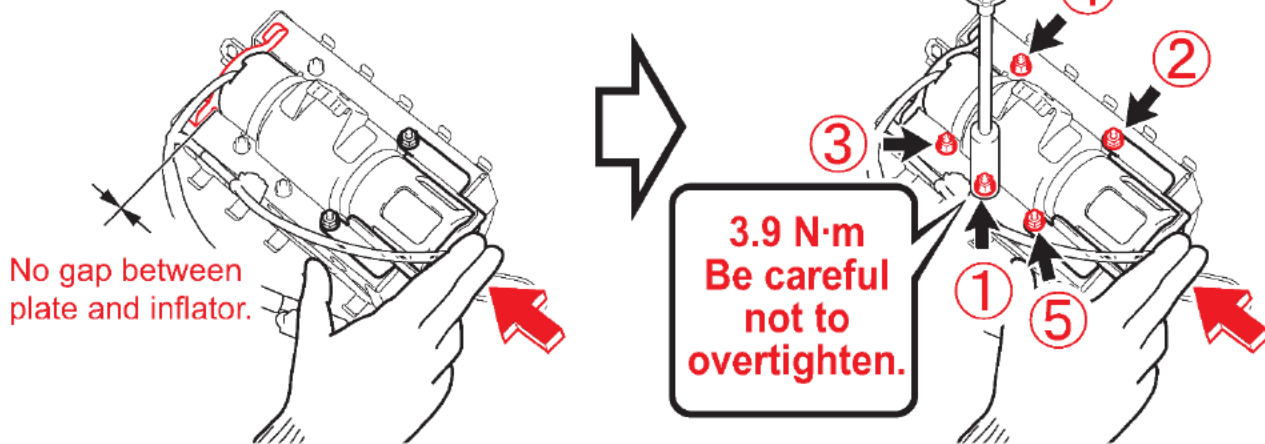
- There will be some resistance when tightening the nuts because they are self-locking, confirm the nuts are tightened correctly.
- **DO NOT** use a power tool, T-handle, or ratchet when tightening the nuts to avoid over torquing and deforming the studs.
- You may need to turn the airbag to the left or right with in the mounting bracket to access the center nut.

# OK

# NG

## These tools cause overtightening !
