# IMPORTANT UPDATE

## TECHNICAL INSTRUCTIONS FOR SAFETY RECALL G0P/G0R/H0A FRONT PASSENGER AIRBAG INFLATOR MODULE CERTAIN 2009 –2013 MODEL YEAR MATRIX

**Updated 1-9-2019**

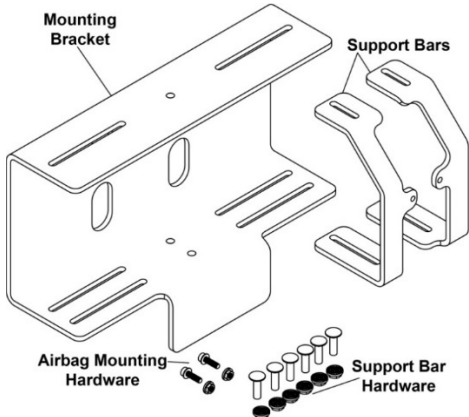
| Image | Name | Quantity |
|---|---|---|
| | Airbag Mounting Bracket & hardware | 1 |

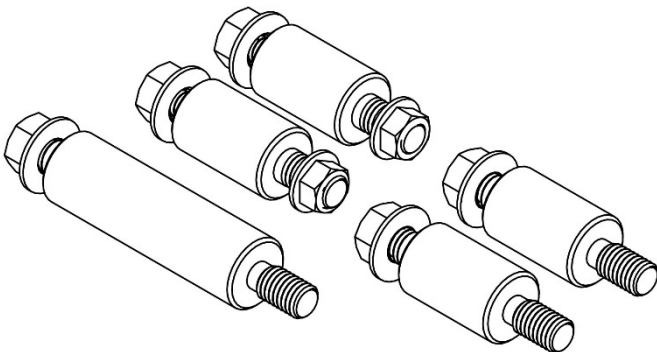
| Image | Name | Quantity |
|---|---|---|
| | Adaptor set* | 1 |

\*The adaptor set was sent to dealers at the start of this campaign.

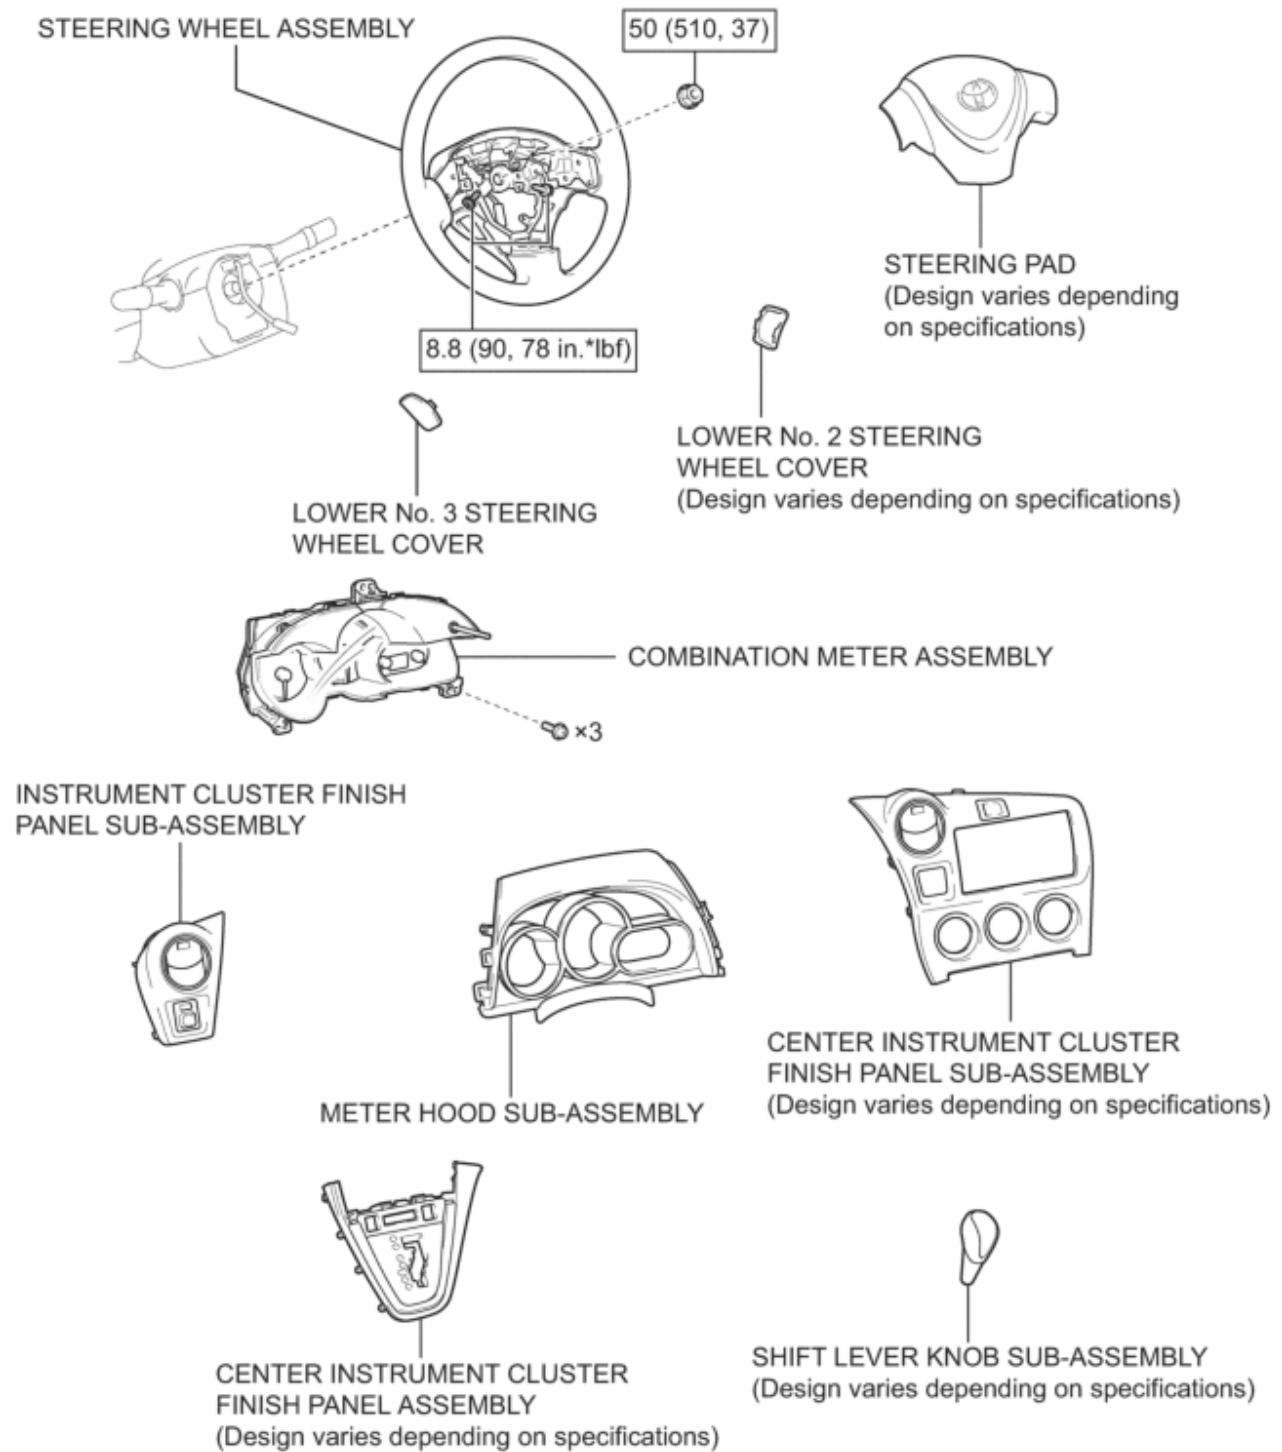
R1703010002

**N\*m (kgf\*cm, ft\*lbf)** : Specified torque

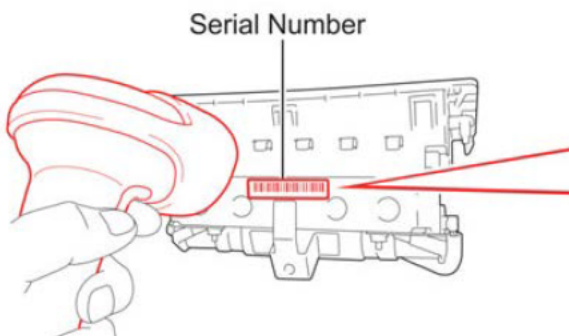
**Airbag Serial Number Label Example**

**AIRBAG SERIAL NUMBER IDENTIFICATION**

- The airbag serial number is **ALWAYS** the 12 **DIGITS** located between the asterisks.
- The 3 digits before the asterisk **ARE NOT** part of the serial number, and **SHOULD NOT** be entered or an inaccurate response may be returned.

The **AIRBAG ASSEMBLY** serial number and the **INFLATOR** serial number are **DIFFERENT**. The **AIRBAG ASSEMBLY** serial number **MUST** be recorded prior to replacement.

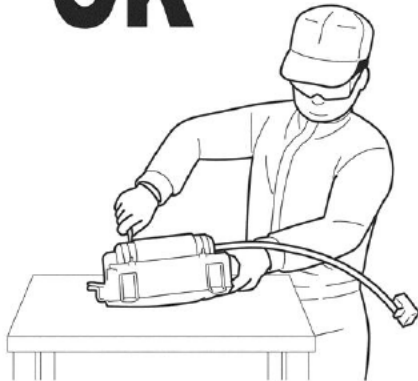
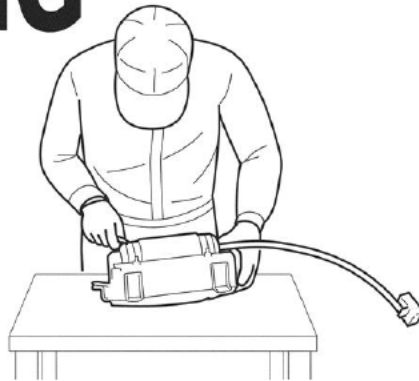
R1301230008E

- Carefully place the airbag on the bench inflator side up.

**NOTE:** Place clean sheet(s) of paper on the bench to protect the airbag.

- Avoid standing directly over the inflator.

# OK

# NG

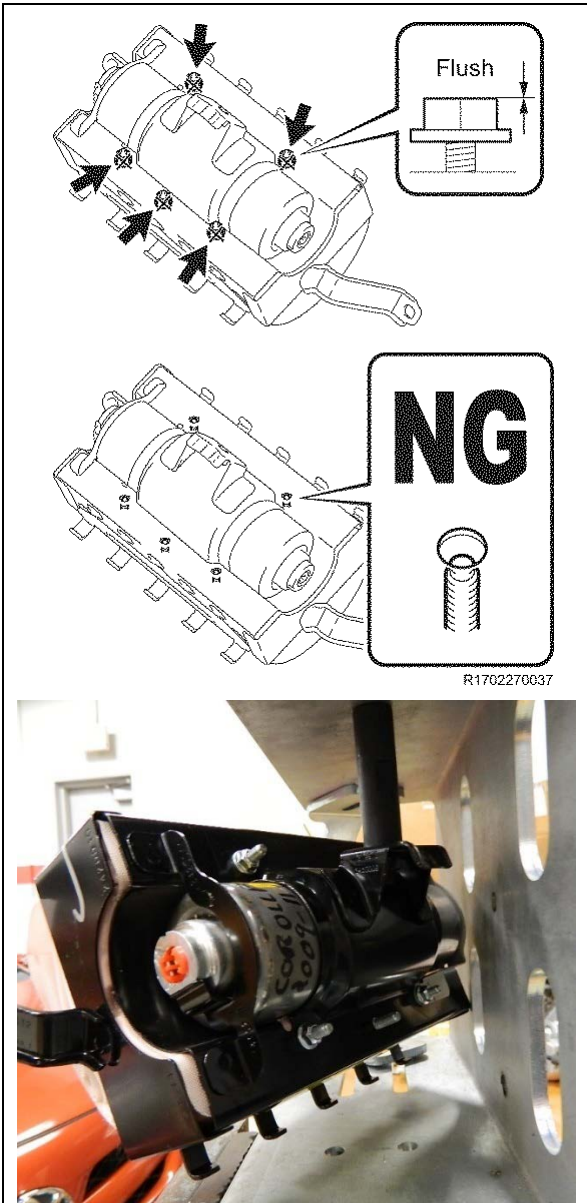
g) Mount the airbag into the mounting bracket as shown. Pass the stud on the adaptor through the hole in the middle of the bracket with the nut.

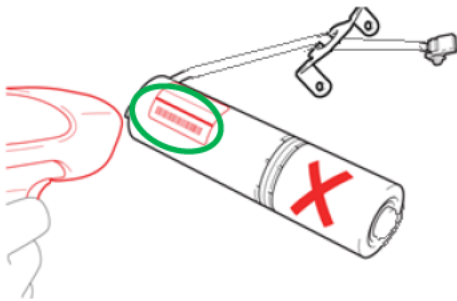
Step a) Old Inflator (bar code)

- Scan the **OLD** inflator bar code.
- Scan the **NEW** inflator QR code.

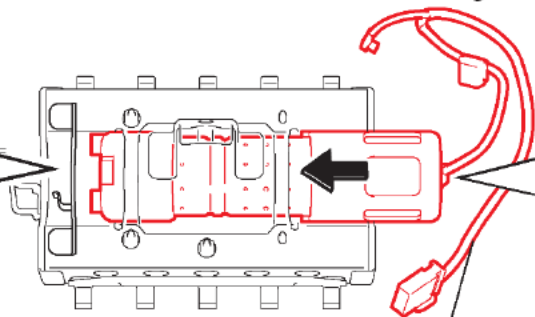
R1702270040

a) Carefully slide the new inflator into the airbag assembly and align as shown.

- DO NOT** connect the inflator harness at this time. It is **CRITICAL** to first confirm that the inflator is installed in the correct position before connecting the harness.

**DO NOT** insert fully.

Check orientation

Upper side

Bottom

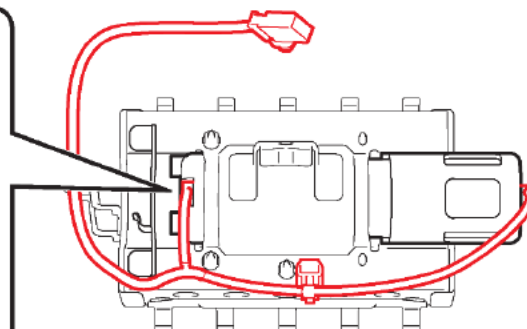
R1702270041

b) Connect the connector to the inflator and ensure that the connector lock is fully engaged as shown.

c) Route and secure the wire harness as shown.

**ALIGN CONNECTORS**

Wire Harness Side:

Inflator Side:

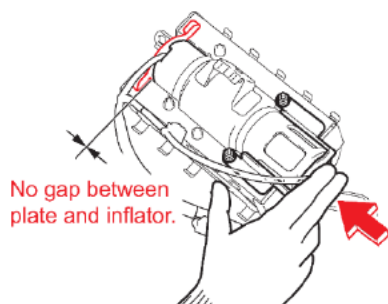
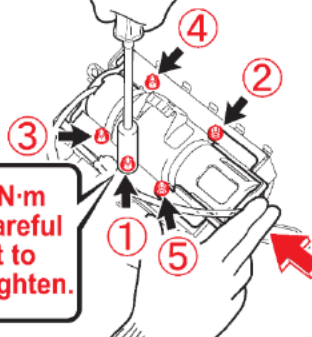
R1702270046

- a) Tighten the 5 nuts evenly in several increments in the sequence shown. Use a socket driver or torque wrench to tighten the nuts.

Torque: 35in. lbf (3.9N·m)

- There will be some resistance when tightening the nuts because they are self-locking, confirm the nuts are tightened correctly.
- **DO NOT** use a power tool, T-handle, or ratchet when tightening the nuts to avoid over torqueing and deforming the studs.
- You may need to turn the airbag to the left or right with in the mounting bracket to access the center nut.

**OK**

Socket Driver

**These tools cause overtightening !**
