## IMPORTANT UPDATE

### TECHNICAL INSTRUCTIONS FOR SAFETY RECALL G0P FRONT PASSENGER AIRBAG INFLATOR MODULE CERTAIN 2008 – 2013 MY SCION xB

**Updated 7-17-2018**

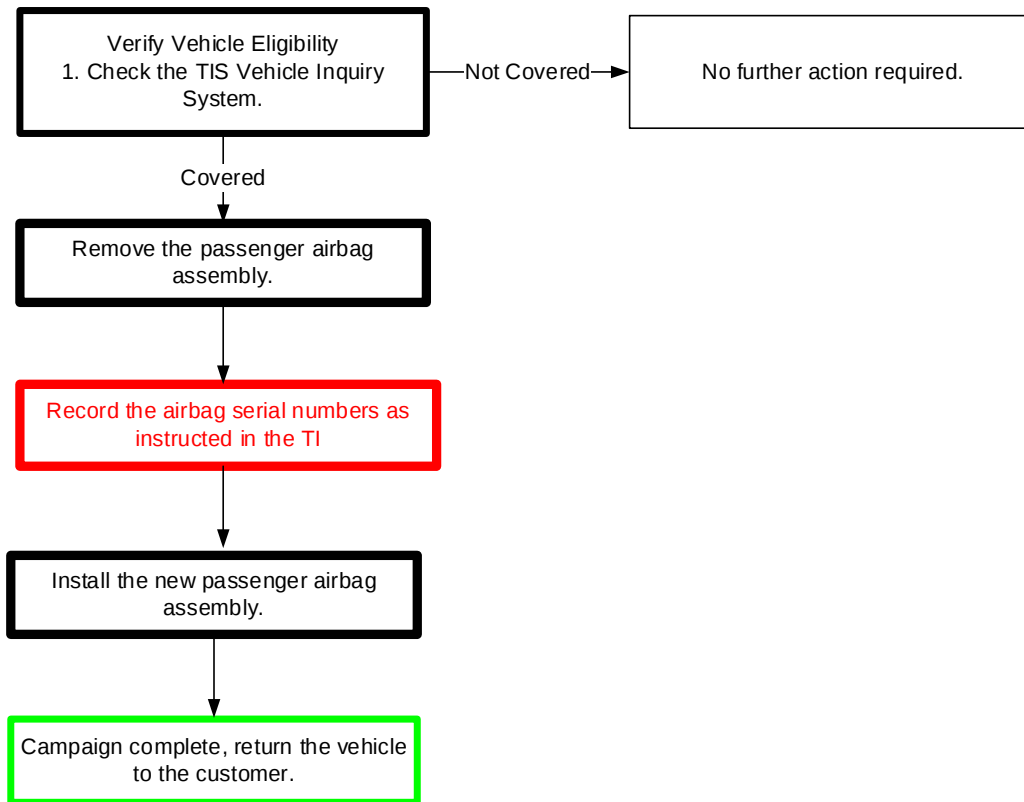
## I. OPERATION FLOW CHART

The flow chart is for reference only. **DO NOT** use it in place of the full technical instructions. Follow **ALL** steps as outlined in the full technical instructions to confirm the campaign is completed correctly.

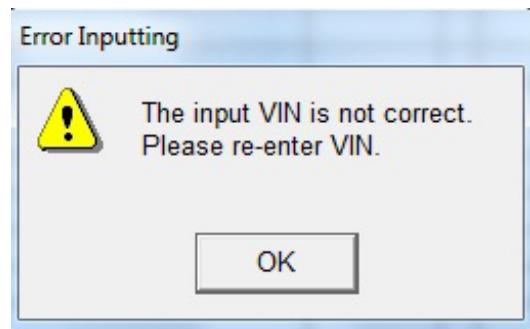
- After the health check has completed, run a diagnostic report by clicking on the link on the health check screen.

**NOTE: If the VIN was not entered in ALL CAPS when Techstream was launched, an error will be displayed and there will be a prompt to reenter the VIN**

- Enter the vehicle mileage and repair order information, then click the 'report' button.

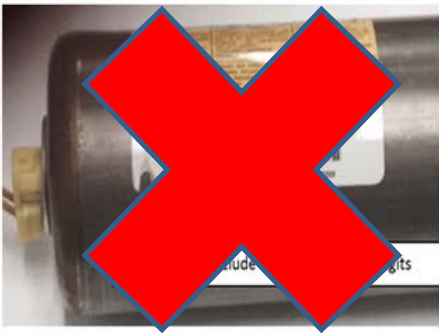
**Original Inflator**

How to Identify the Inflator serial code on the Original and Replacement Inflator can?

The Inflator serial code is an 11 digit code on the Inflator can. It can be found with a bar code on removing the Inflator can from the Airbag Assembly unit.

The first two characters of the Original Inflator Serial code will be from [AA, AB, AJ, FD or JD].

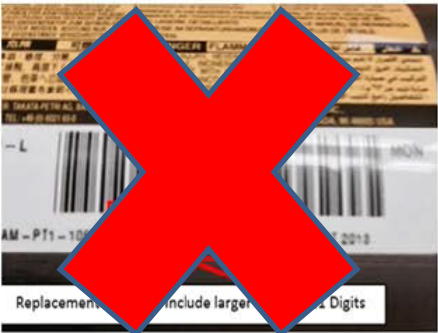
**Replacement Inflator**

The first two characters of the Replacement Inflator Serial code will be either 'LT' or 'LR'.

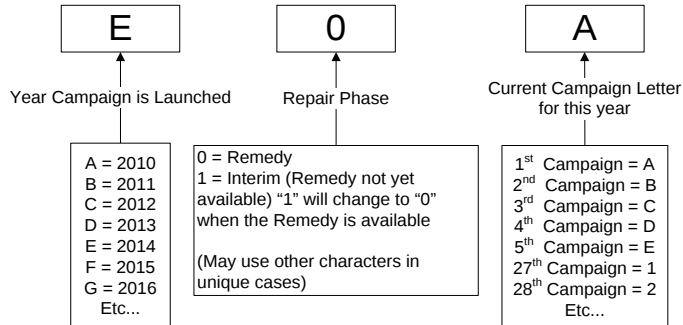
### A. CAMPAIGN DESIGNATION DECODER

Examples:

A0D = Launched in 2010, Remedy Phase, 4<sup>th</sup> Campaign Launched in 2010

B1E = Launched in 2011, Interim Phase, 5<sup>th</sup> Campaign Launched in 2011

C1C = Launched in 2012, Interim Phase, 3<sup>rd</sup> Campaign Launched in 2012
