## TECHNICAL INSTRUCTIONS FOR SAFETY RECALL GLG/GLH and HLA

### FRONT PASSENGER AIRBAG INFLATOR REPLACEMENT CERTAIN 2006 – 2013 MY IS 250/350 and 2008 – 2013 MY IS F

#### UPDATE 6-14-18

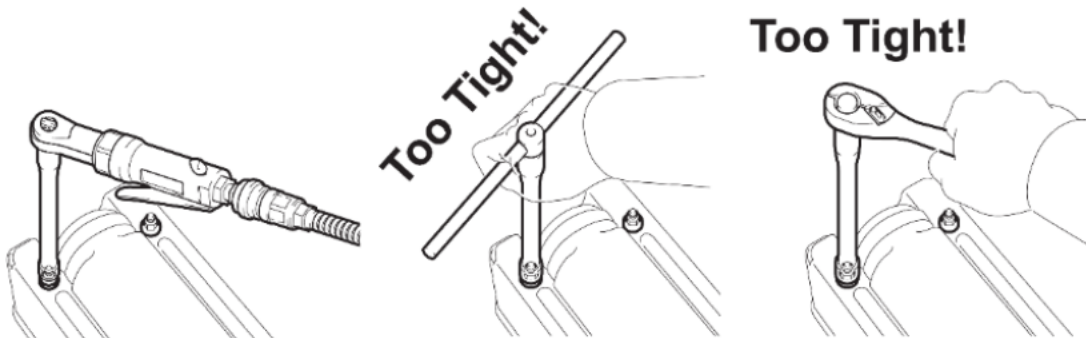
R1701260011Z01

- j) Tighten the 5 nuts evenly in several increments in the sequence shown. Use a socket driver or torque wrench to tighten the nuts.

- There will be some resistance when tightening the nuts because they are self-locking, confirm the nuts are tightened correctly.
- **DO NOT** use a power tool, T-handle, or ratchet when tightening the nuts to avoid over torqueing and deforming the studs.
- You may need to slide the airbag to the left or right with in the mounting bracket to access the center nut.

**OK**

**These tools cause overtightening !**
