## TECHNICAL INSTRUCTIONS FOR SAFETY RECALL GLG/GLH/HLA

### FRONT PASSENGER AIRBAG INFLATOR REPLACEMENT CERTAIN 2006 – 2013 MY IS 250/350 and 2008 – 2014 MY IS F

#### UPDATE 1-15-2019

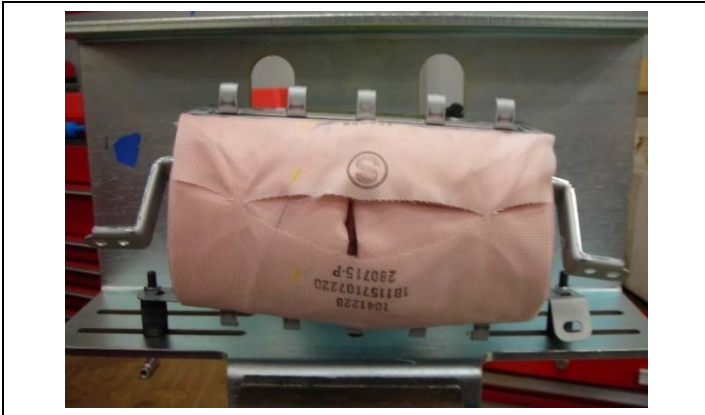
- b) Mount the adaptors (579943-3R3) to the airbag as shown.

**NOTE: The 6mm stud mounts to the airbag.**

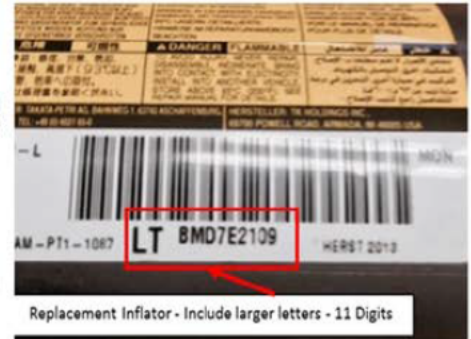
### Replacement Inflator

The first two characters of the Replacement Inflator Serial code will be either 'LT' or 'LR'.

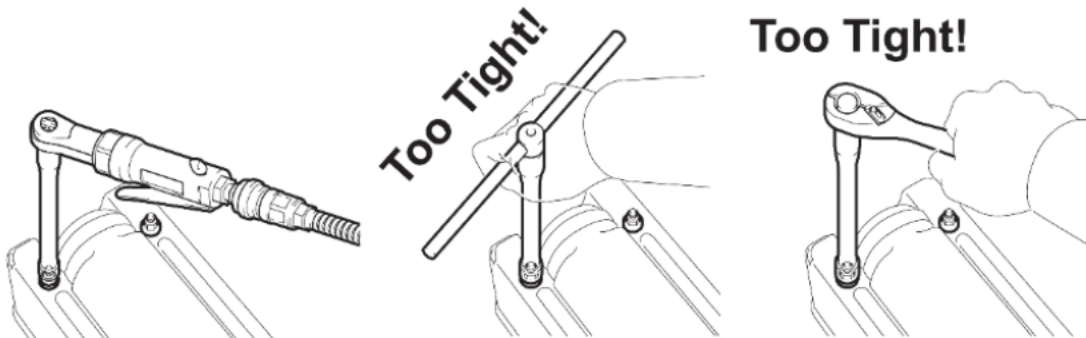
R1701260011Z01

- j) Tighten the 5 nuts evenly in several increments in the sequence shown. Use a socket driver or torque wrench to tighten the nuts.

- There will be some resistance when tightening the nuts because they are self-locking, confirm the nuts are tightened correctly.
- **DO NOT** use a power tool, T-handle, or ratchet when tightening the nuts to avoid over torqueing and deforming the studs.
- You may need to slide the airbag to the left or right with in the mounting bracket to access the center nut.

**OK**

**These tools cause overtightening !**
