# IMPORTANT UPDATE

## TECHNICAL INSTRUCTIONS FOR SAFETY RECALL G0P FRONT PASSENGER AIRBAG INFLATOR MODULE CERTAIN 2009 – 2013 MODEL YEAR COROLLA

**Updated 7-17-18**

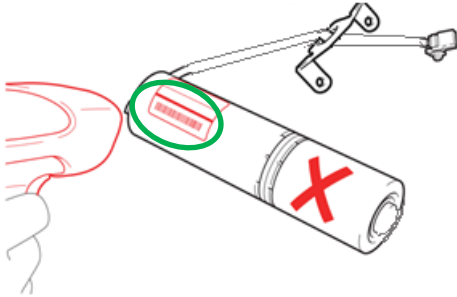
**Step a) Old Inflator (bar code)**

- Scan the **OLD** inflator bar code.
- Scan the **NEW** inflator QR code.

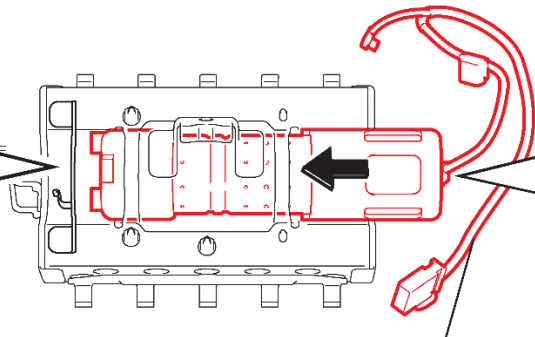
R1702270040

- a) Carefully slide the new inflator into the airbag assembly and align as shown.

- DO NOT** connect the inflator harness at this time. It is **CRITICAL** to first confirm that the inflator is installed in the correct position before connecting the harness.

**DO NOT** insert fully.

Check orientation

Upper side

Bottom

Instrument panel wire

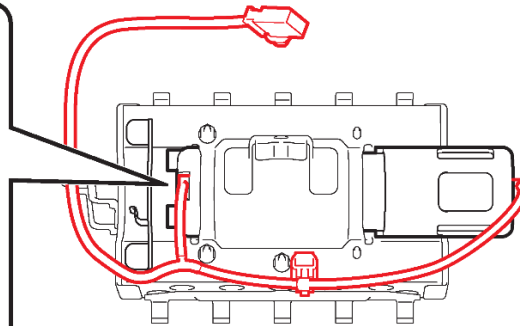
R1702270041

- b) Connect the connector to the inflator and ensure that the connector lock is fully engaged as shown.  
c) Route and secure the wire harness as shown.

**ALIGN CONNECTORS**

Wire Harness Side:

Inflator Side:

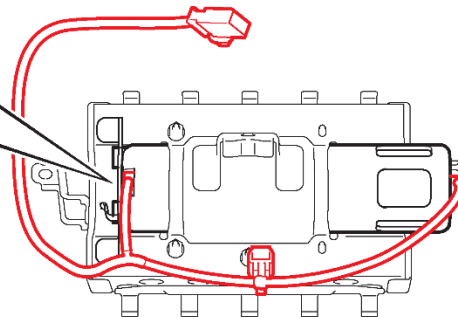
R1702270043

Check orientation
