# IMPORTANT UPDATE

## TECHNICAL INSTRUCTIONS FOR SAFETY RECALL H0A FRONT PASSENGER AIRBAG INFLATOR MODULE CERTAIN 2008 - 2009 MY SCION xB

**UPDATED 4-18-2018**

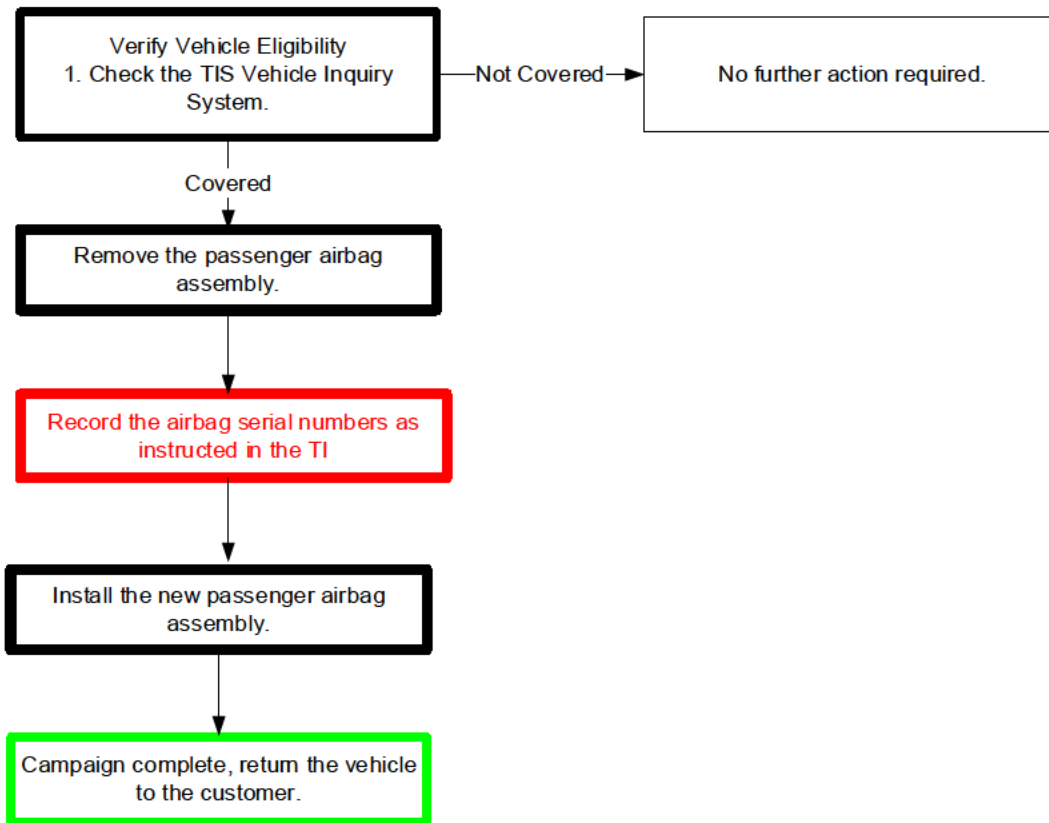
## I. OPERATION FLOW CHART

The flow chart is for reference only. **DO NOT** use it in place of the full technical instructions. Follow **ALL** steps as outlined in the full technical instructions to confirm the campaign is completed correctly.

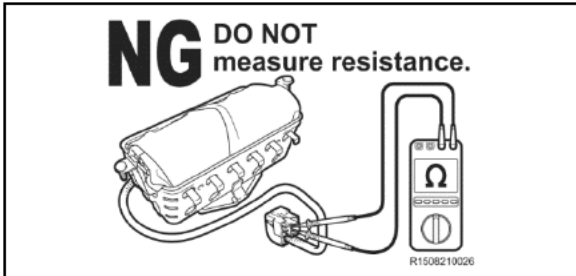
#### 2. DO NOT MEASURE RESISTANCE

- DO NOT** measure resistance of airbag components, this may cause accidental activation.

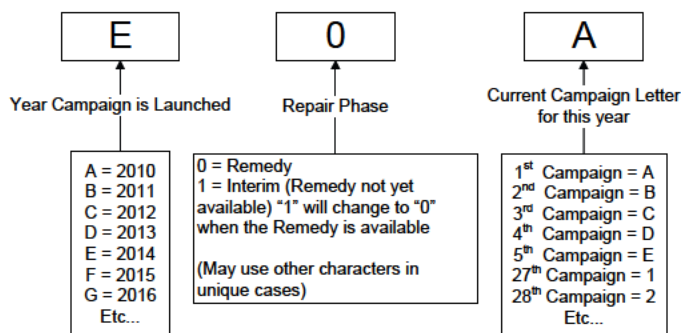
### A. CAMPAIGN DESIGNATION DECODER

Examples:

A0D = Launched in 2010, Remedy Phase, 4<sup>th</sup> Campaign Launched in 2010

B1E = Launched in 2011, Interim Phase, 5<sup>th</sup> Campaign Launched in 2011

C1C = Launched in 2012, Interim Phase, 3<sup>rd</sup> Campaign Launched in 2012
