# TECHNICAL INSTRUCTIONS FOR SAFETY RECALL G0P/G0R/H0A FRONT PASSENGER AIRBAG INFLATOR MODULE CERTAIN 2011-2014 MODEL YEAR SIENNA

**Updated 1-9-2019**

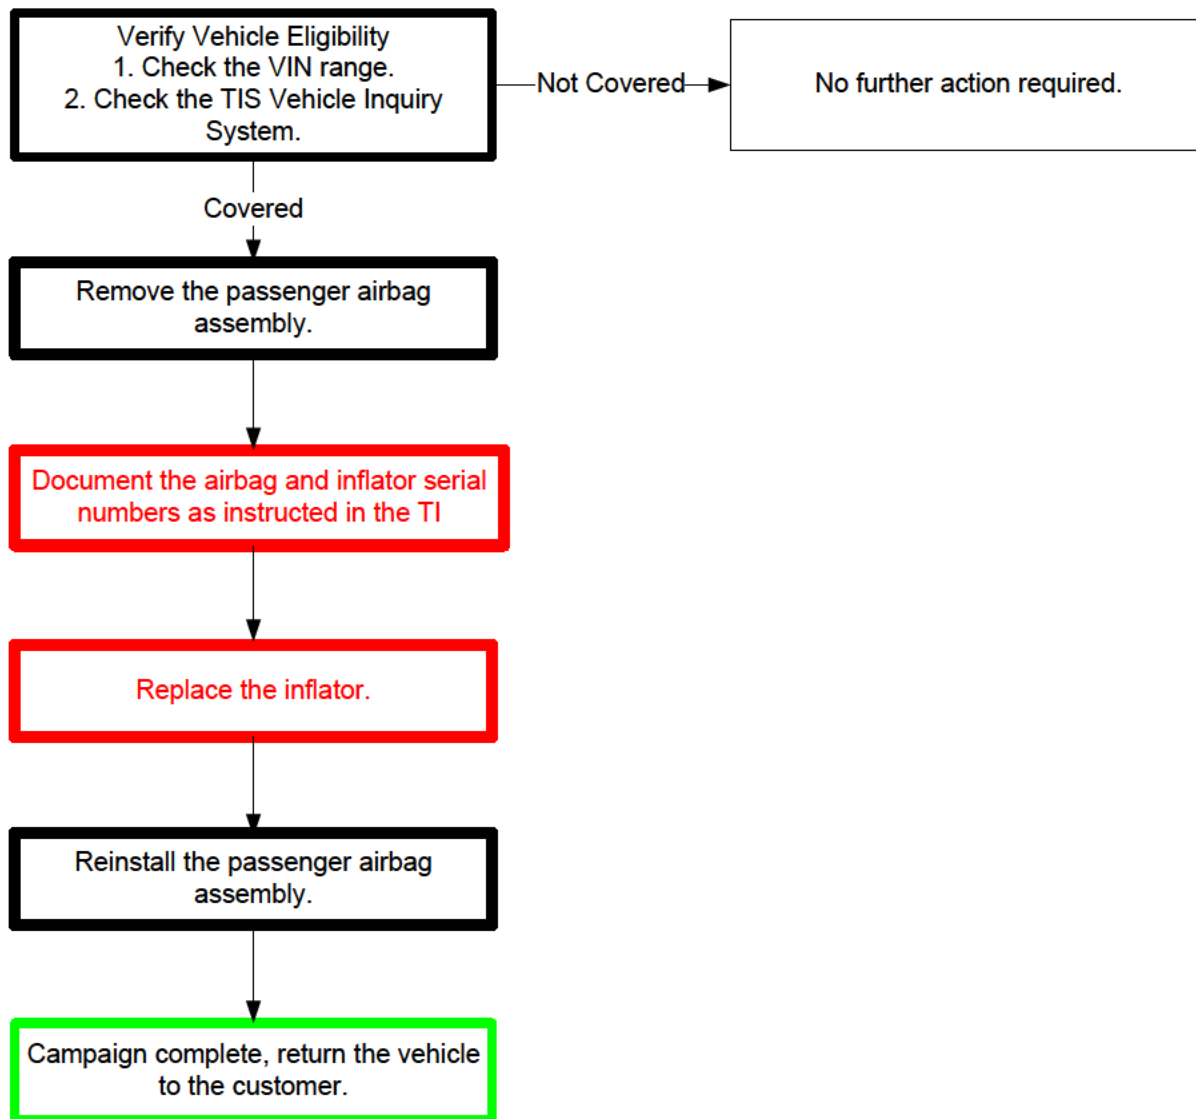
## I. OPERATION FLOW CHART

The flow chart is for reference only. **DO NOT** use it in place of the full technical instructions. Follow **ALL** steps as outlined in the full technical instructions to confirm the campaign is completed correctly.

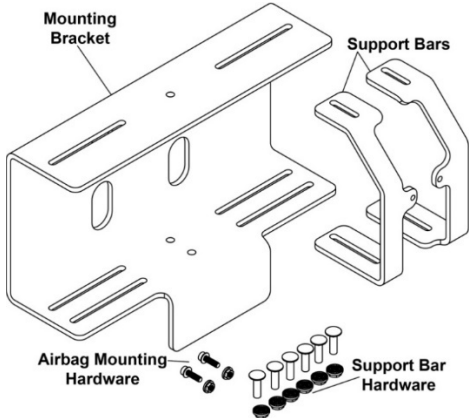
| Image | Name | Quantity |
|---|---|---|
| | Airbag Mounting Bracket & hardware | 1 |

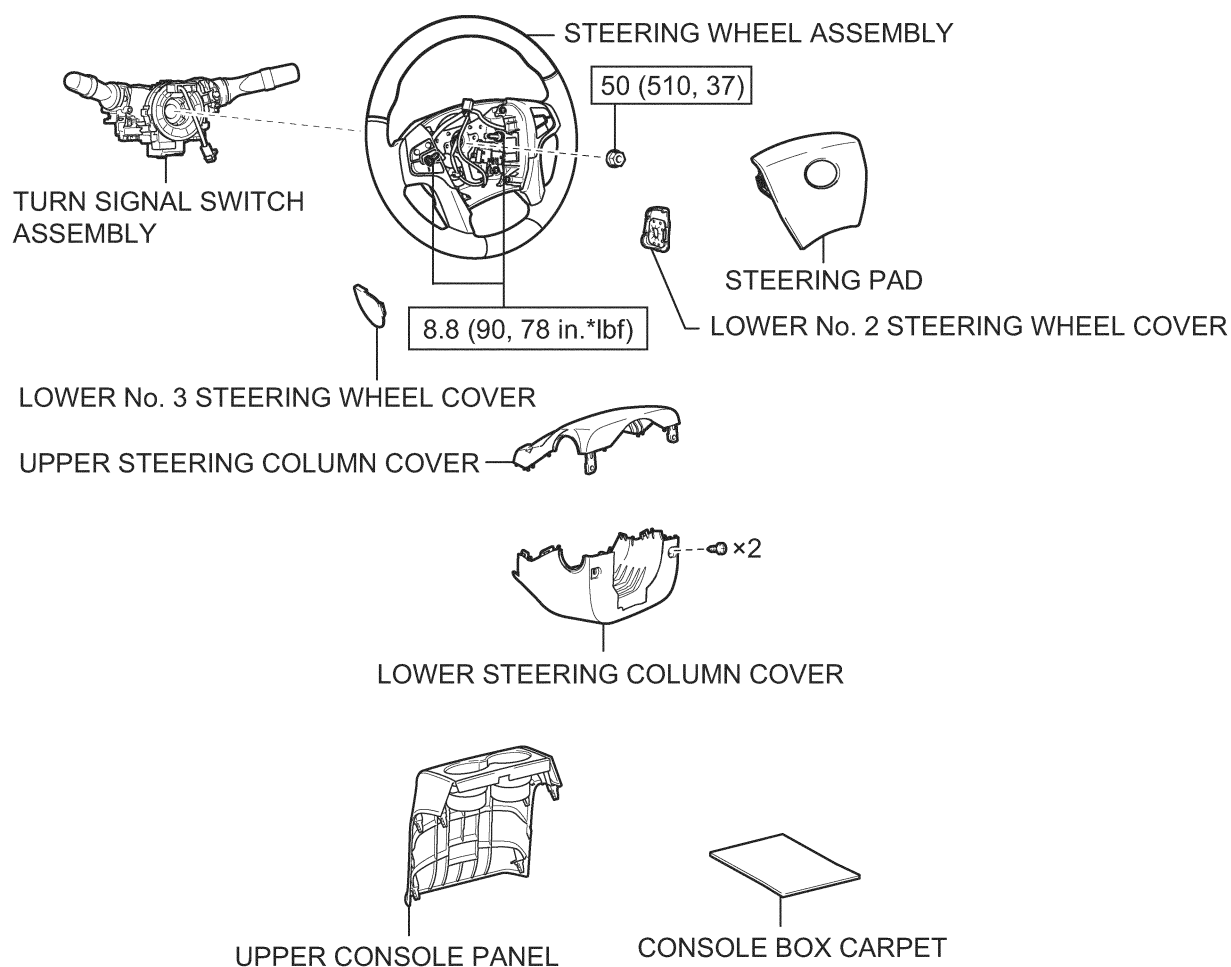
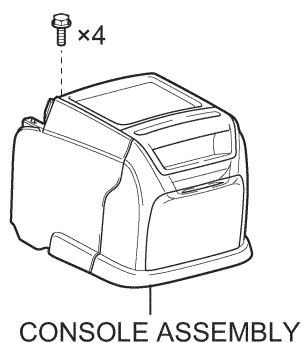
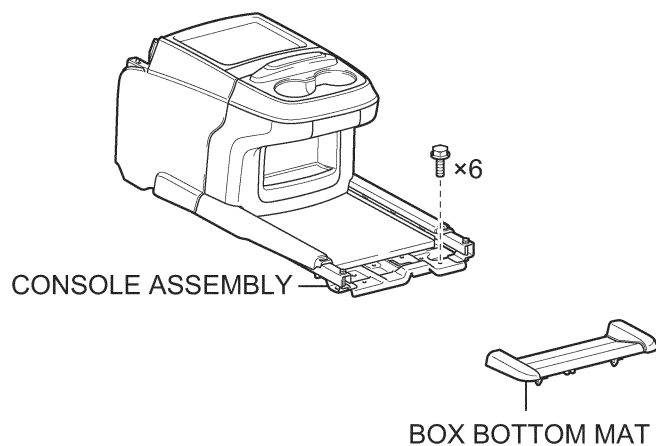
R1701060003

【for Fixed Type】

【for Slide Type】

N\*m (kgf\*cm, ft.\*lbf) : Specified torque

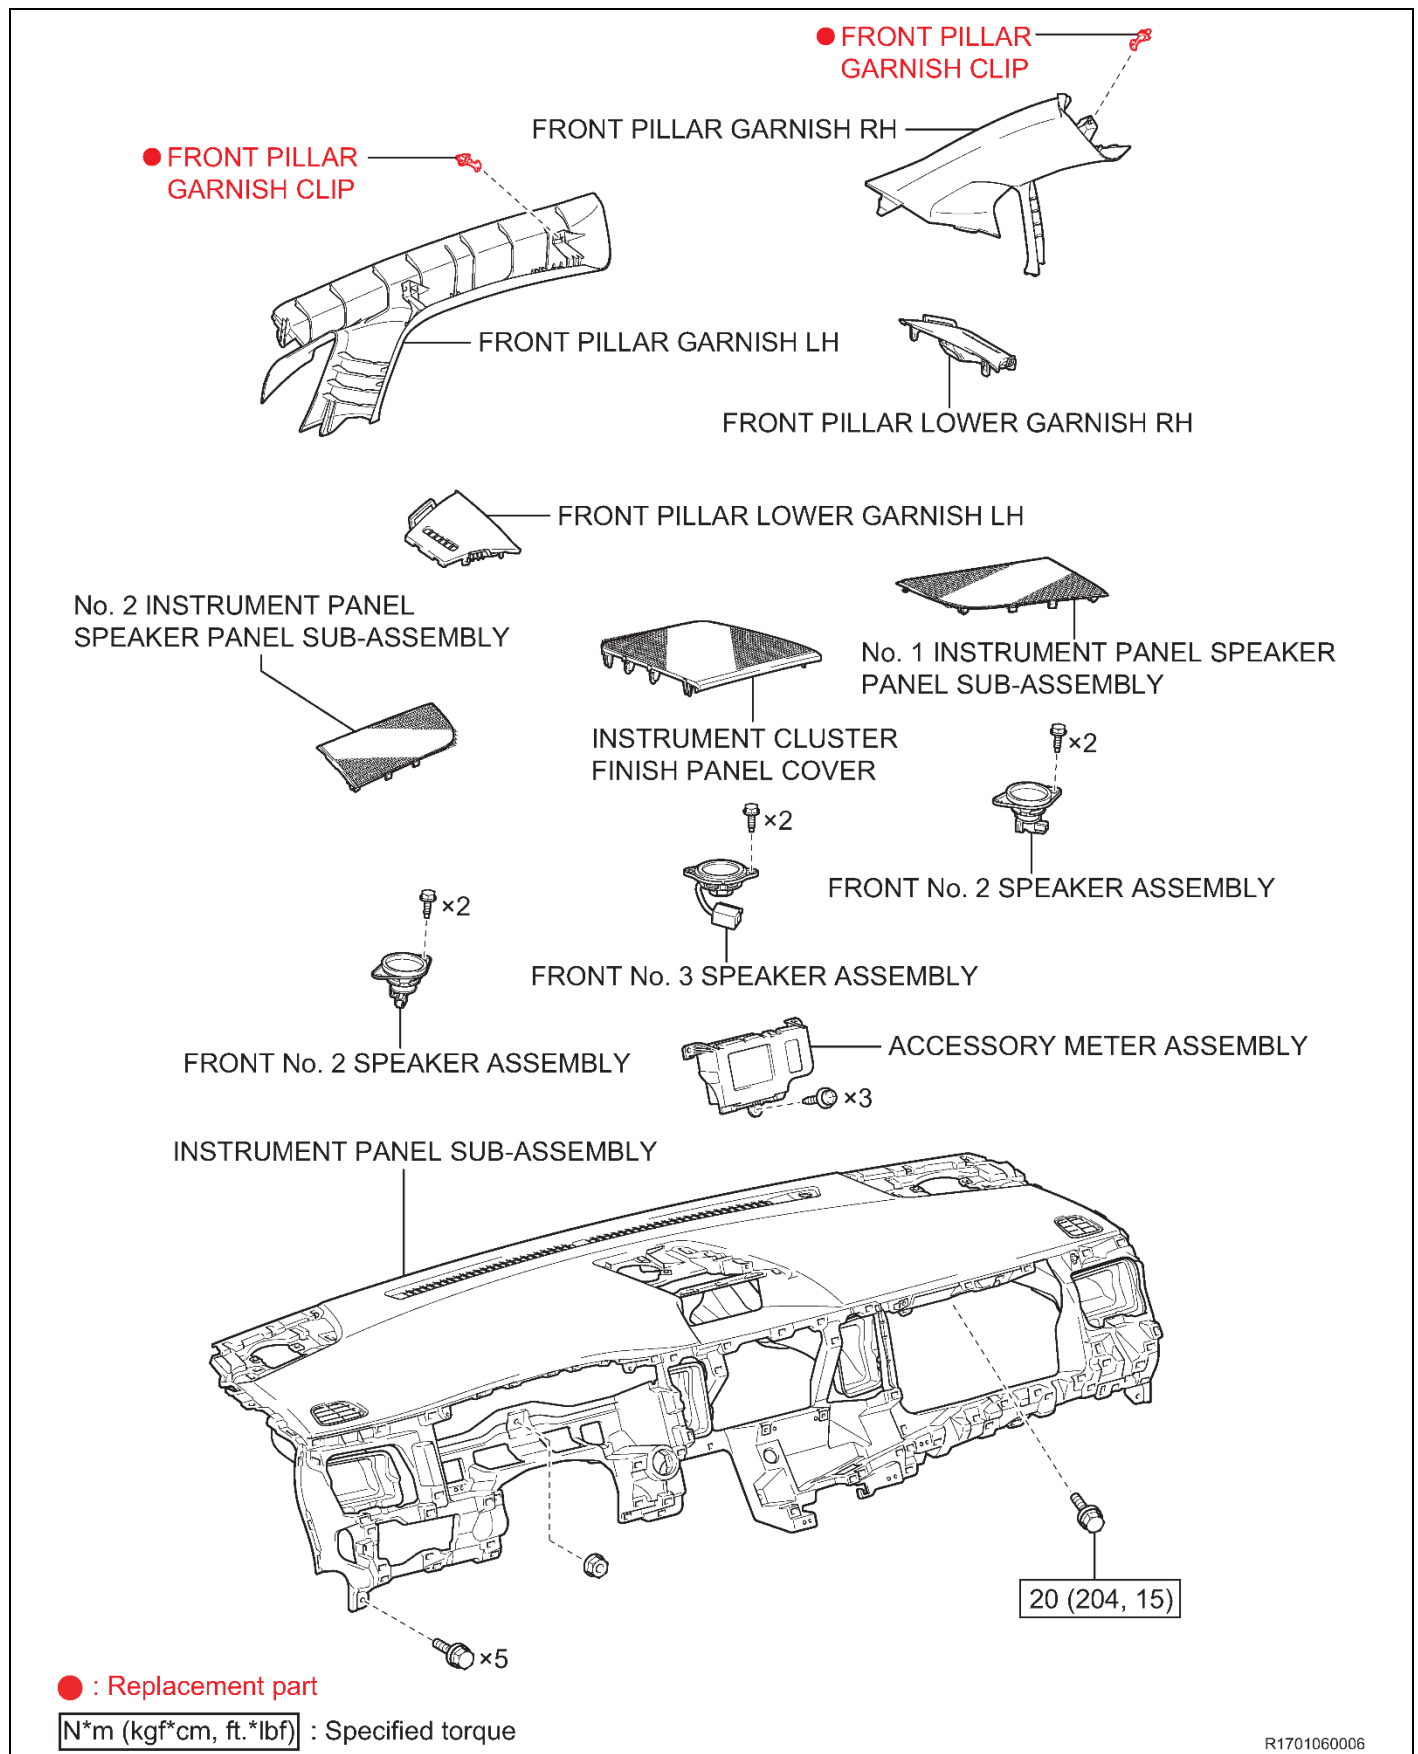
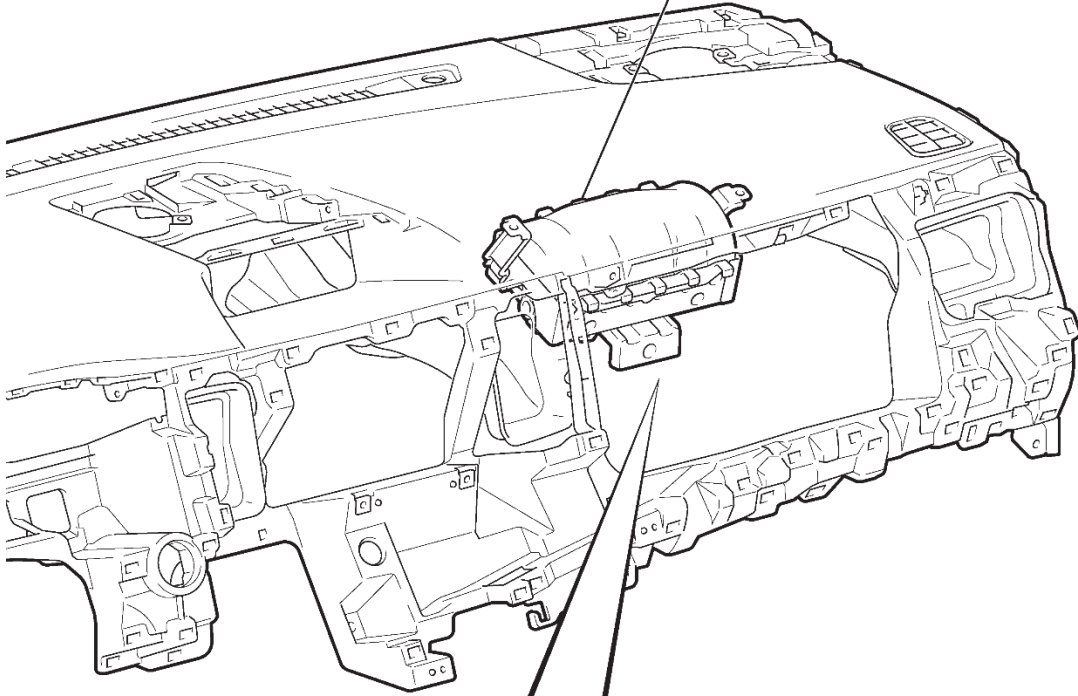
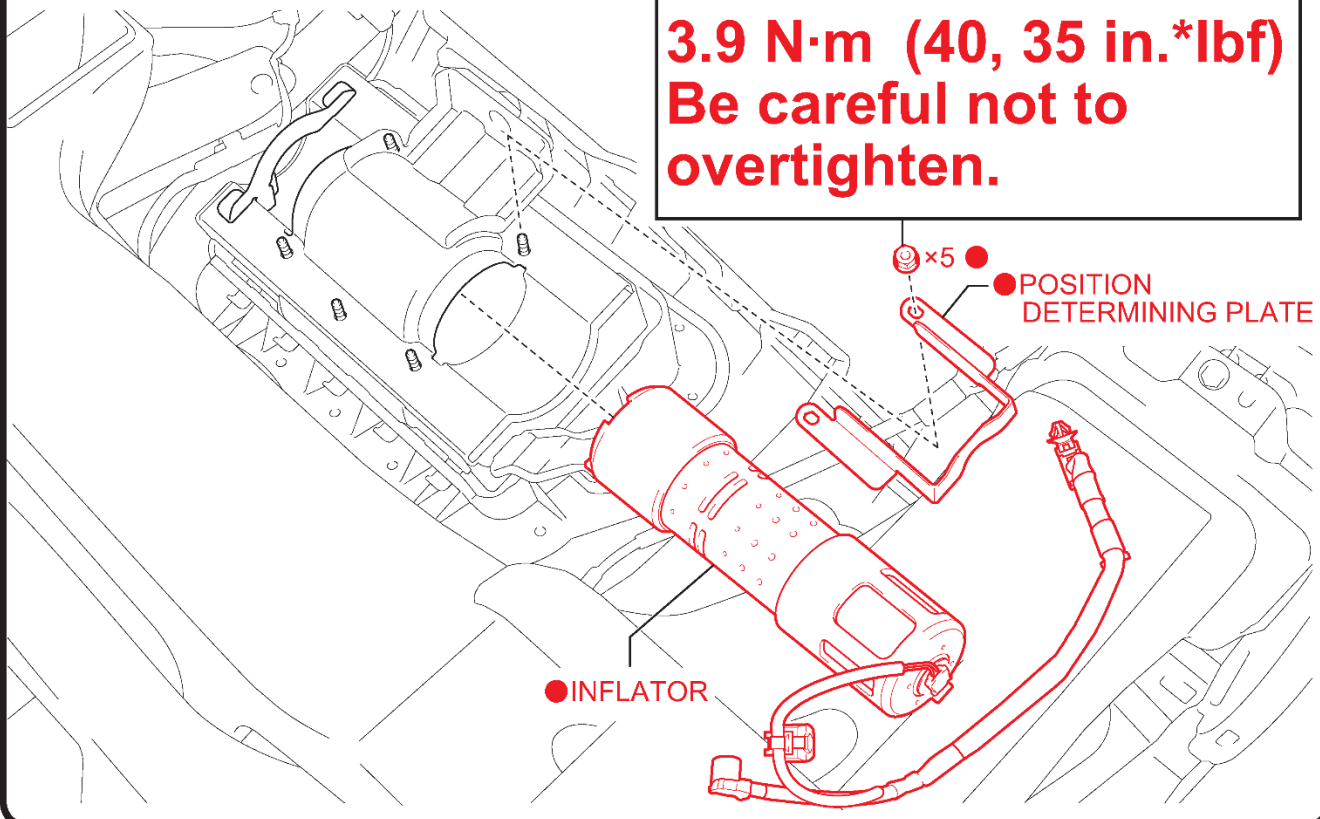
R1701280028H

INSTRUMENT PANEL PASSENGER  
AIRBAG ASSEMBLY

**3.9 N·m (40, 35 in.\*lbf)**  
**Be careful not to**  
**overtighten.**

● : Replacement part

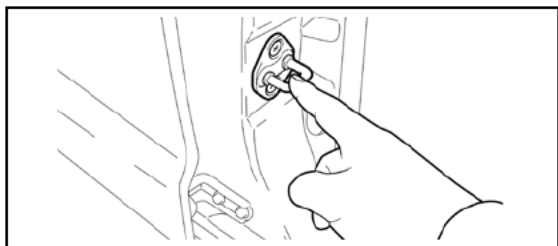
The anti-static mat set that is an essential SST may be available at your dealership and is optional to use during inflator replacement. If the anti-static kit is not available, before starting work and periodically while working on the vehicle, touch a metallic part of the vehicle to discharge static electricity in the body.

If the anti-static kit is not available, before starting work and periodically while working on the vehicle, touch a metallic part of the vehicle to discharge static electricity in the body.

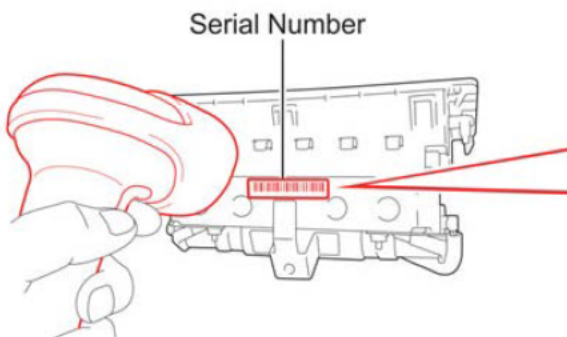
- The airbag serial number is **ALWAYS** the 12 **DIGITS** located between the asterisks.
- The 3 digits before the asterisk **ARE NOT** part of the serial number, and **SHOULD NOT** be entered or an inaccurate response may be returned.

The **AIRBAG ASSEMBLY** serial number and the **INFLATOR** serial number are **DIFFERENT**. The **AIRBAG ASSEMBLY** serial number **MUST** be recorded prior to replacement.

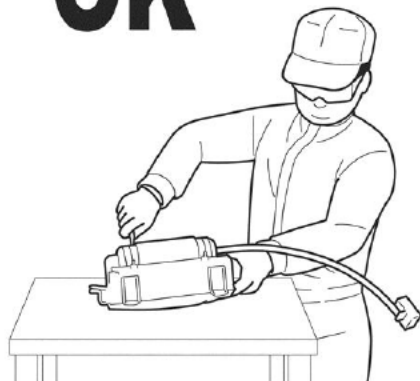
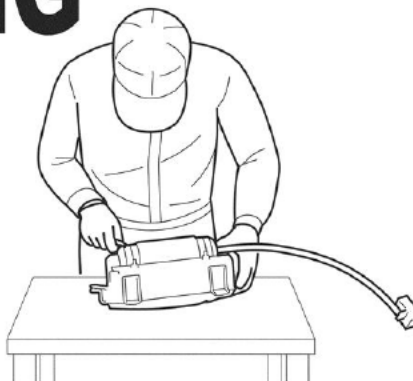
R1301230008E

- Carefully place the airbag on the bench inflator side up.

- Avoid standing directly over the inflator.

\* Images of parts shown above may differ from the actual ones.

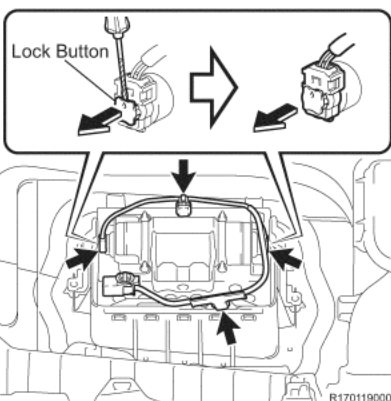
### 2. AIRBAG PREPARATION

- Use a screwdriver to release the lock button on each end of the inflator.
- Disconnect both connectors.
- Disconnect the 2 wire harness clamps.
- Remove and discard the harness.

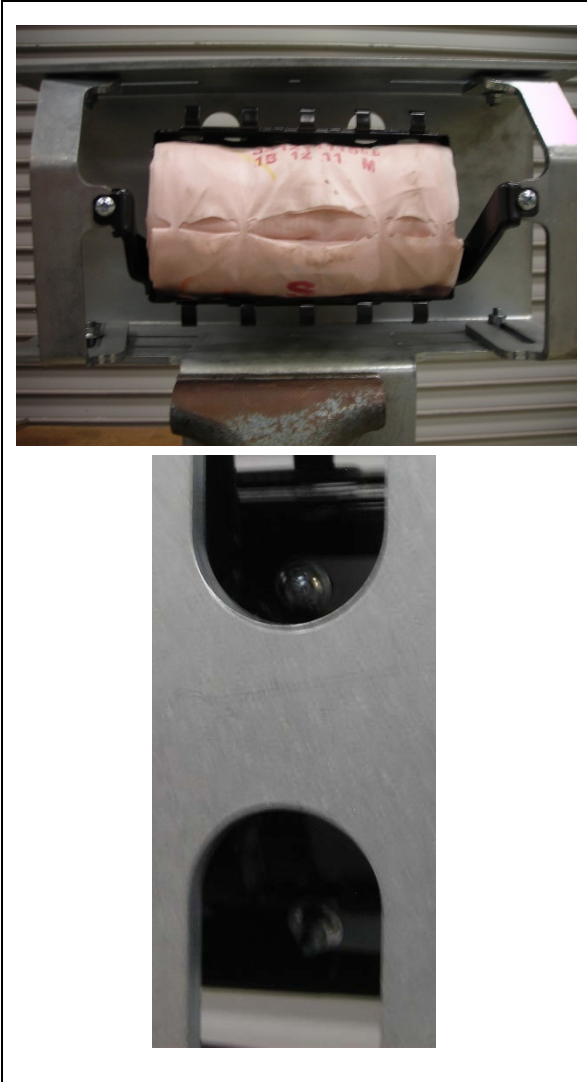
e) Mark all 5 nuts so they will not be reused.

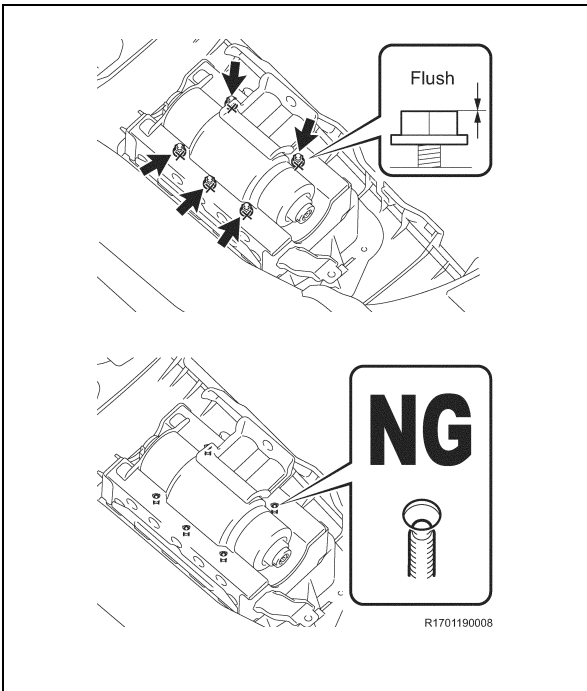
f) Mount the airbag into the mounting bracket as shown.

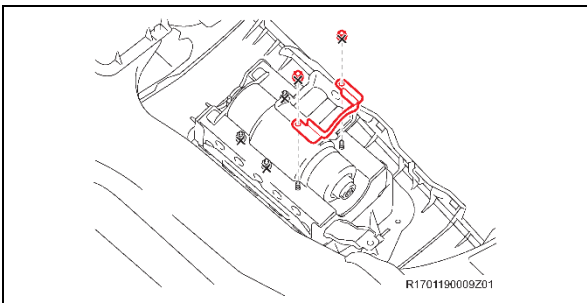
- Loosen the 5 nuts until the nuts are at the top of the studs as shown, through the openings in the mounting bracket.

**NOTE:** Do not use power tools. It may be necessary to slide the airbag to the left or right to access the middle nut.

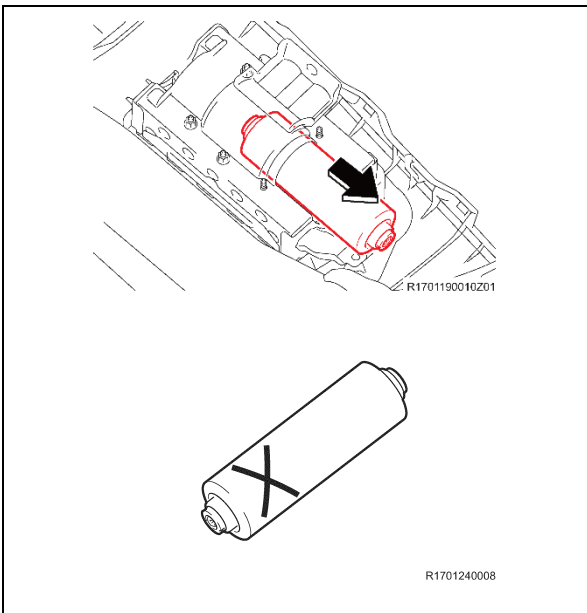
- Gently push the inflator in the direction shown.

- Remove the inflator from the airbag assembly and place it on a safe work surface.
- Mark the old inflator so it is not reused.

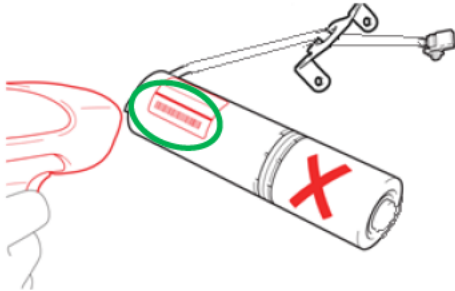
**Step a) Old Inflator (bar code)**

- Scan the **OLD** inflator bar code.
- Scan the **NEW** inflator QR code.

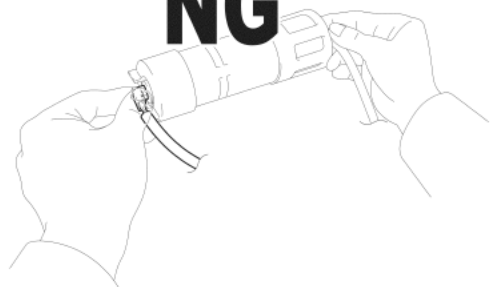
R17020000

- DO NOT** connect the inflator harness at this time. It is **CRITICAL** to first confirm that the inflator is installed in the correct position before connecting the harness.

DO NOT CONNECT PREMATURELY  
CANNOT DISCONNECTED

**NOTE:** Once connected the inflator harness cannot be disconnected without damaging the connector, and would require that the inflator and harness be replaced.

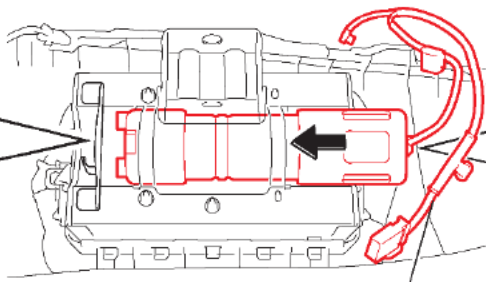
R1702010005H

- a) Carefully slide the new inflator half way into the airbag assembly and align as shown.

**DO NOT insert fully.**

Instrument panel wire

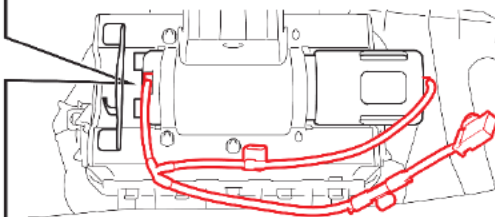
R1702010008H

- b) Connect the connector to the inflator and ensure that the connector lock is fully engaged as shown.

### ALIGN CONNECTORS

Wire Harness Side:

Inflator Side:

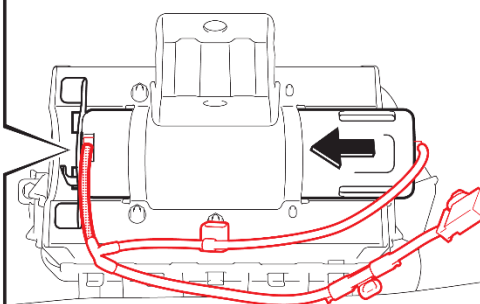
R1702010007H

- a) Fully insert the inflator and ensure that the inflator is correctly oriented as shown.

**NOTE: DO NOT pinch the wiring between the bracket and the inflator.**

**DO NOT  
pinch the wire**

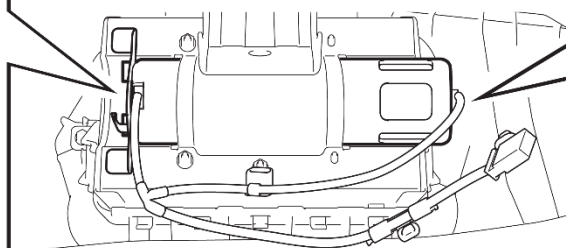
R1701280029H

**NOTE: Ensure the inflator is correctly oriented.**

**Check orientation**

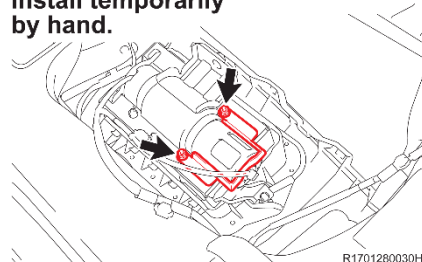
R1701280030H

**Install temporarily  
by hand.**

- b) Install the **NEW** stopper plate.  
c) Install 2 **NEW** nuts by hand.

**NOTE: Ensure that the stopper plate is the one from the kit and installed in the correct orientation.**

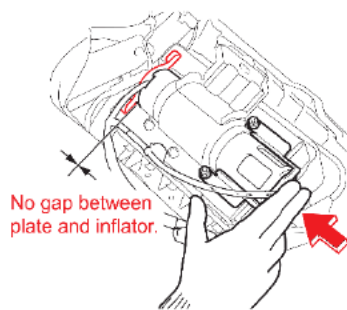
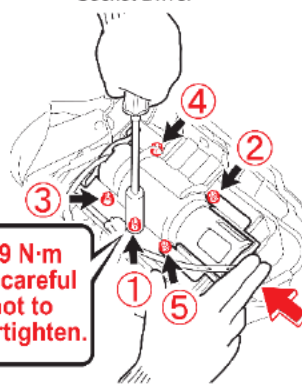
R1702010002H

- a) Tighten the 5 nuts evenly in several increments in the sequence shown. Use a socket driver or torque wrench to tighten the nuts.

Torque: 35in. lbf (40 kgf.cm, 3.9N·m)

- There will be some resistance when tightening the nuts because they are self-locking, confirm the nuts are tightened correctly.
- **DO NOT** use a power tool, T-handle, or ratchet when tightening the nuts to avoid overtorqueing and deforming the studs.
- You may need to turn the airbag to the left or right with in the mounting bracket to access the center nut.

Socket Driver

**These tools cause overtightening !**

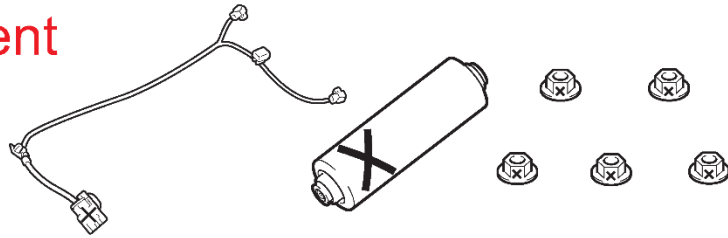
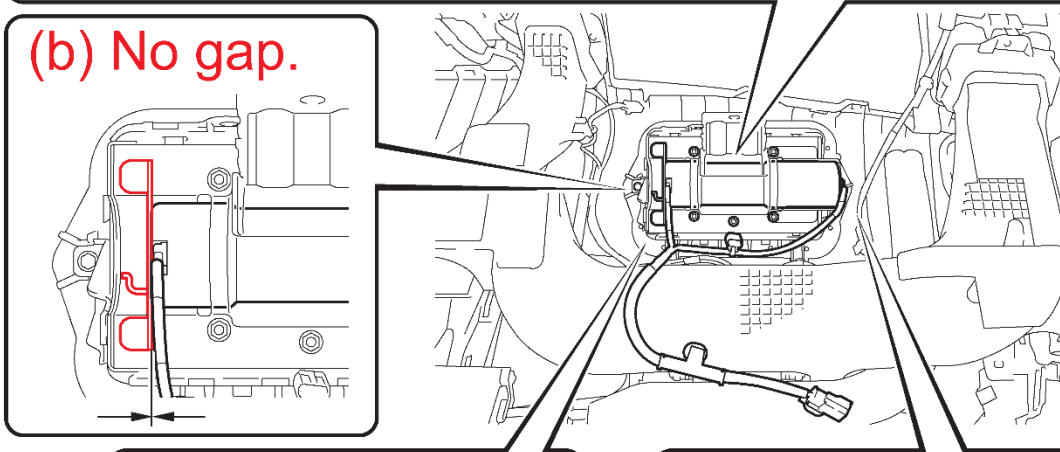
R1701280031H

- a) Confirm the **NEW** inflator and 5 **NEW** nuts have been installed.
- b) Confirm the position of the inflator and position determining plates are correct.
- c) Confirm the routing of the inflator wire harness.

(a) Replacement  
of parts.

(b) No gap.

(b) Check  
orientation
