# IMPORTANT UPDATE

## TECHNICAL INSTRUCTIONS FOR SAFETY RECALL H0A FRONT PASSENGER AIRBAG INFLATOR MODULE CERTAIN 2008 - 2009 MY SCION xB

**UPDATED 7-17-2018**

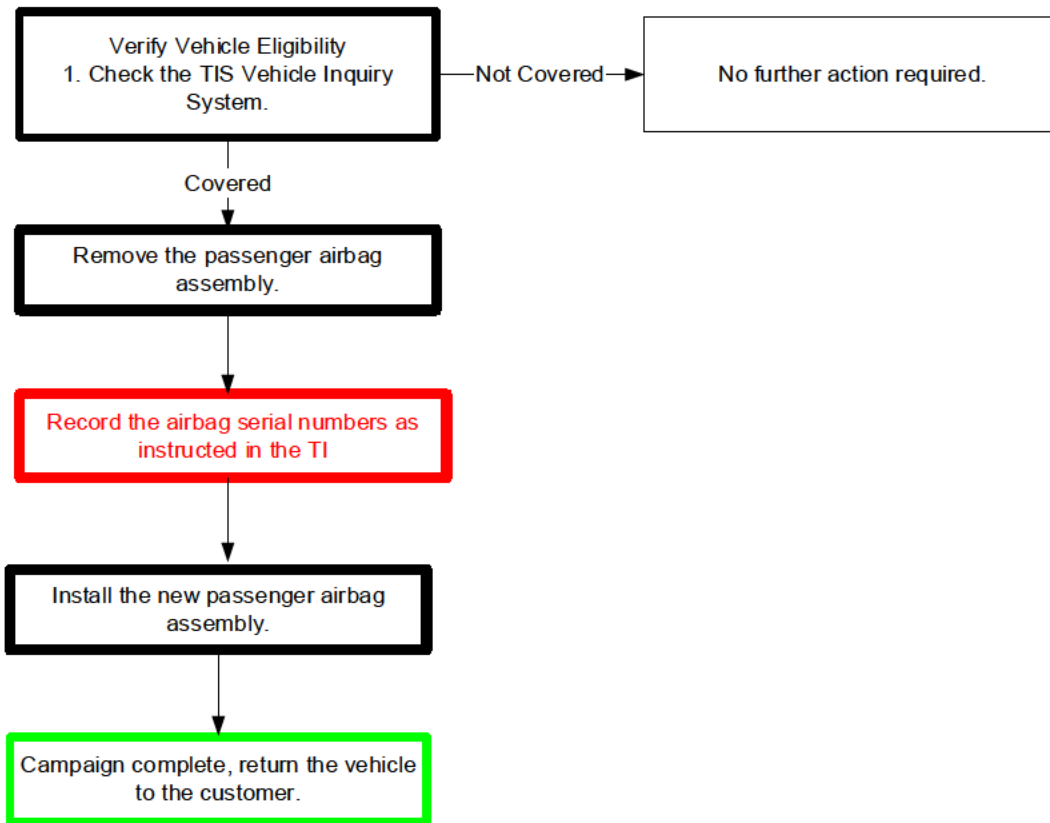
## I. OPERATION FLOW CHART

The flow chart is for reference only. **DO NOT** use it in place of the full technical instructions. Follow **ALL** steps as outlined in the full technical instructions to confirm the campaign is completed correctly.

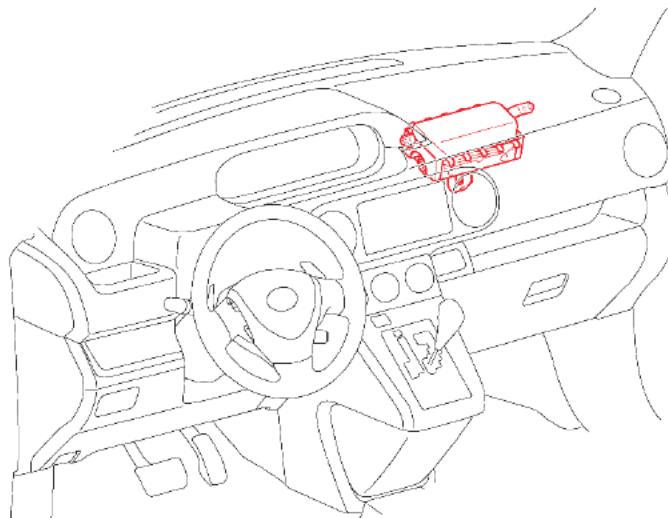
C162294

The subject vehicles are equipped with front passenger airbag inflators produced by Takata. According to Takata, the propellant in these inflators may degrade after prolonged exposure to high absolute humidity and fluctuating high temperatures. Degraded propellant can cause inflator rupture during airbag deployment. In the event of an inflator rupture, metal fragments could pass through the airbag cushion material, striking the vehicle occupants, and result in serious injury or death.

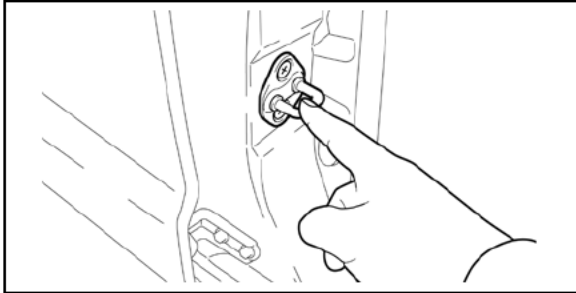
#### 1. ELIMINATE STATIC ELECTRICITY

- a) Before starting work and periodically while working on the vehicle, touch a metallic part of the vehicle to discharge static electricity in the body.

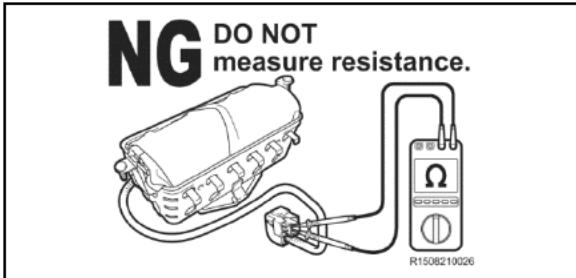
#### 2. DO NOT MEASURE RESISTANCE

- a) **DO NOT** measure resistance of airbag components, this may cause accidental activation.

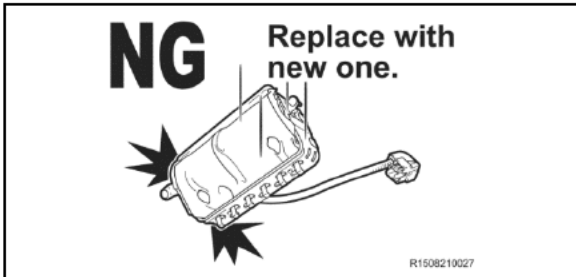
#### 3. HANDLE THE AIRBAG CAREFULLY

- a) If an airbag is dropped, replace it with a **NEW** one.

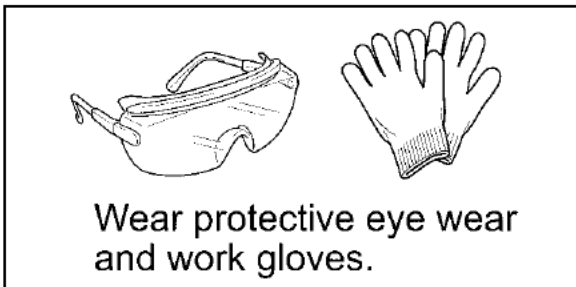
#### 4. WEAR PROTECTIVE EQUIPMENT

- a) Always wear appropriate protective equipment when working on the SRS.

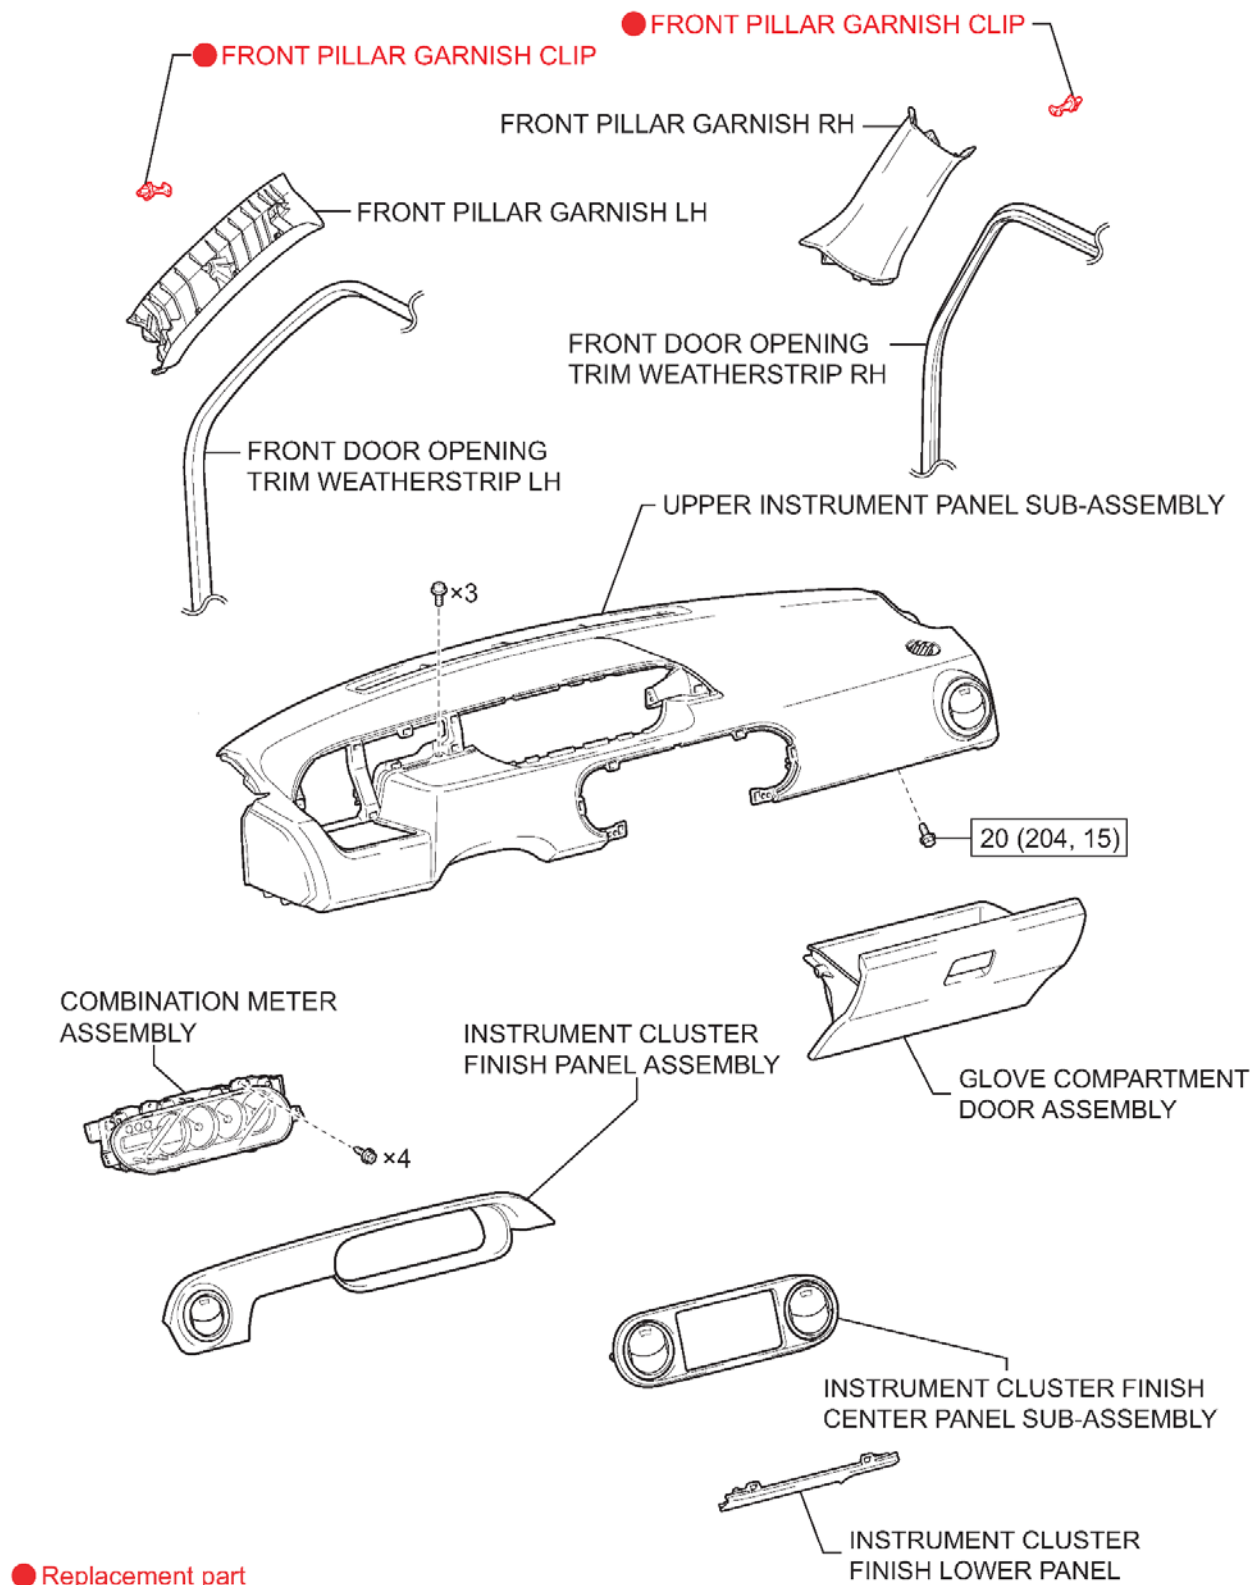
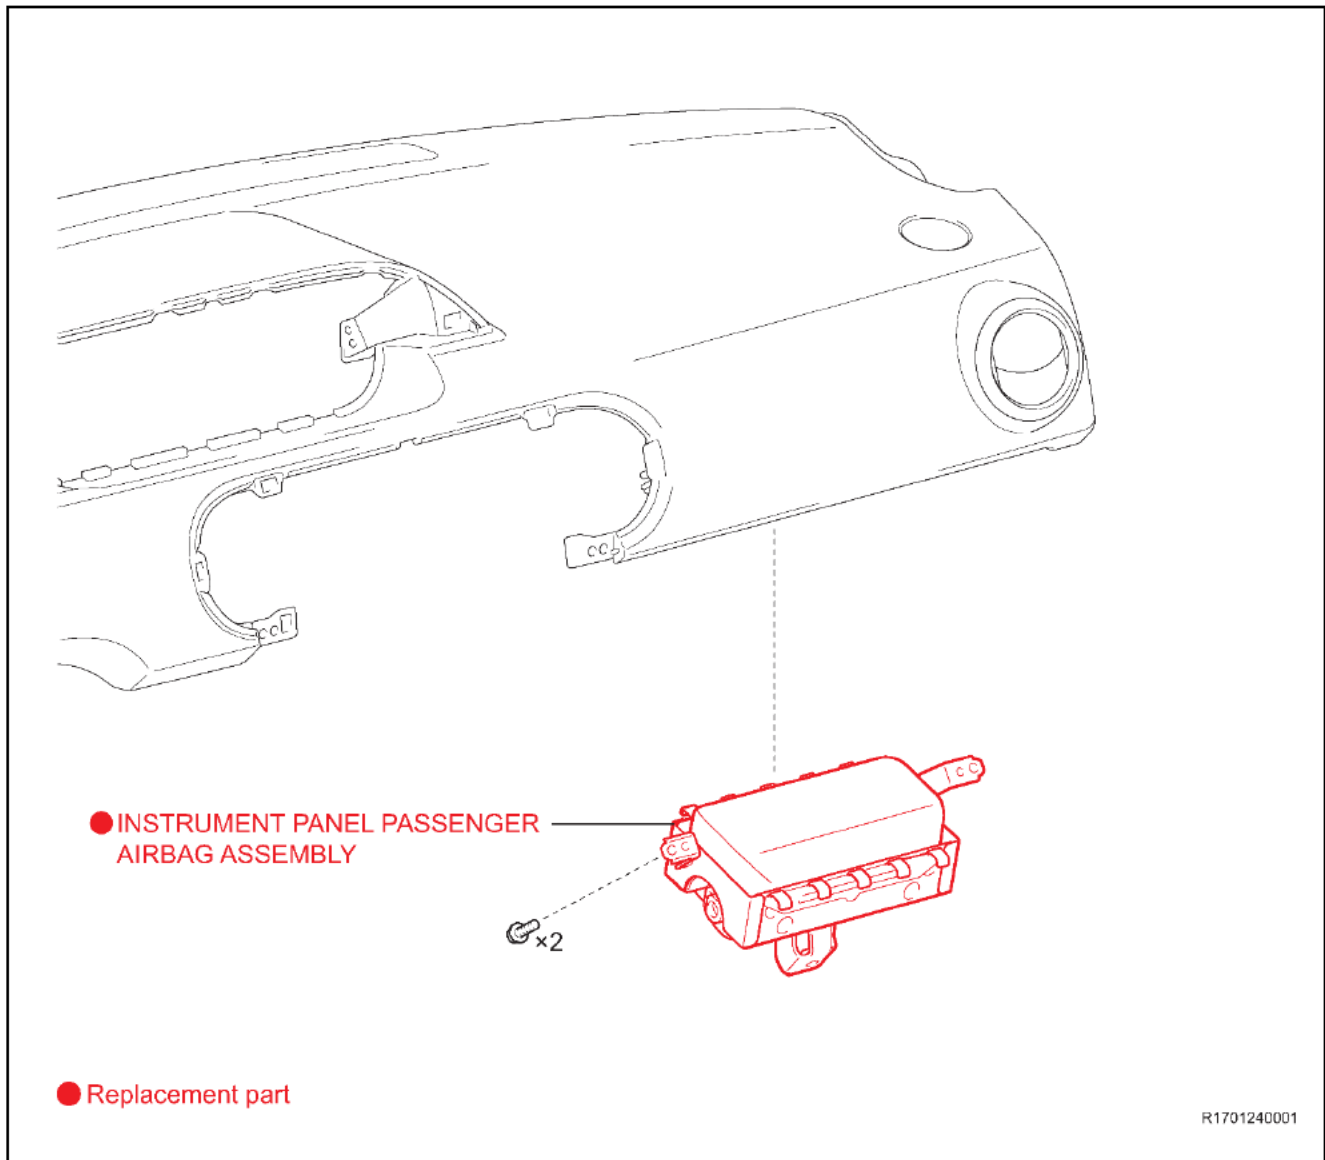
### COMPONENTS

**N\*m (kgf\*cm, ft.\*lbf) : Specified torque**

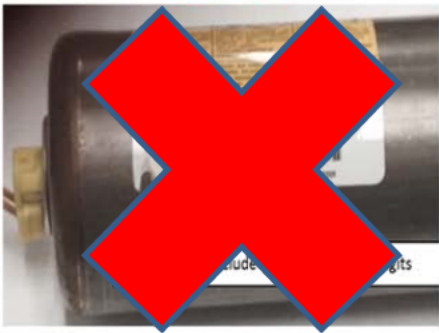
**Original Inflator**

The Inflator serial code is an 11 digit code on the Inflator can. It can be found with a bar code on removing the Inflator can from the Airbag Assembly unit.

The first two characters of the Original Inflator Serial code will be from [AA, AB, AJ, FD or JD].

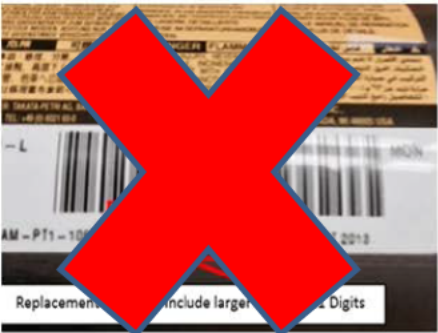
**Replacement Inflator**

The first two characters of the Replacement Inflator Serial code will be either 'LT' or 'LR'.

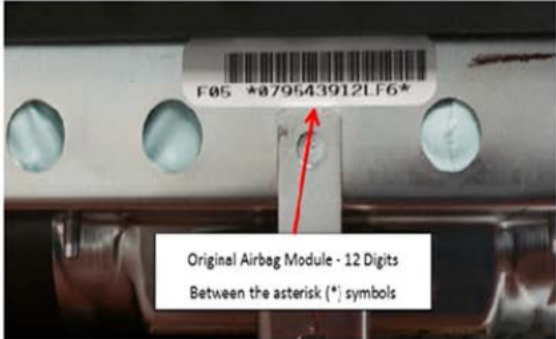
a) If the airbag serial number cannot be scanned or is not present check the box as shown below.

Check this box if the label is damaged or missing

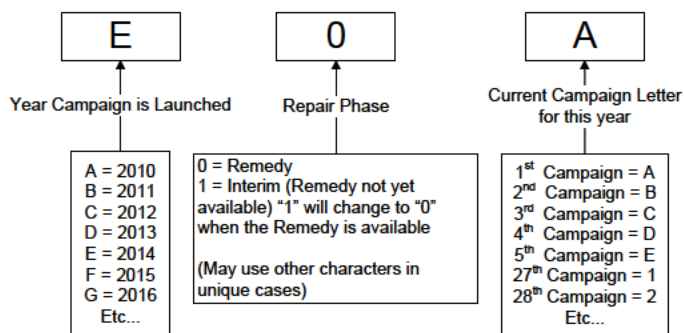
### A. CAMPAIGN DESIGNATION DECODER

A0D = Launched in 2010, Remedy Phase, 4<sup>th</sup> Campaign Launched in 2010

B1E = Launched in 2011, Interim Phase, 5<sup>th</sup> Campaign Launched in 2011

C1C = Launched in 2012, Interim Phase, 3<sup>rd</sup> Campaign Launched in 2012
