# IMPORTANT UPDATE

## TECHNICAL INSTRUCTIONS FOR SAFETY RECALL G0R FRONT PASSENGER AIRBAG INFLATOR MODULE CERTAIN 2009-2010 MODEL YEAR MATRIX

**Updated 1-9-18**

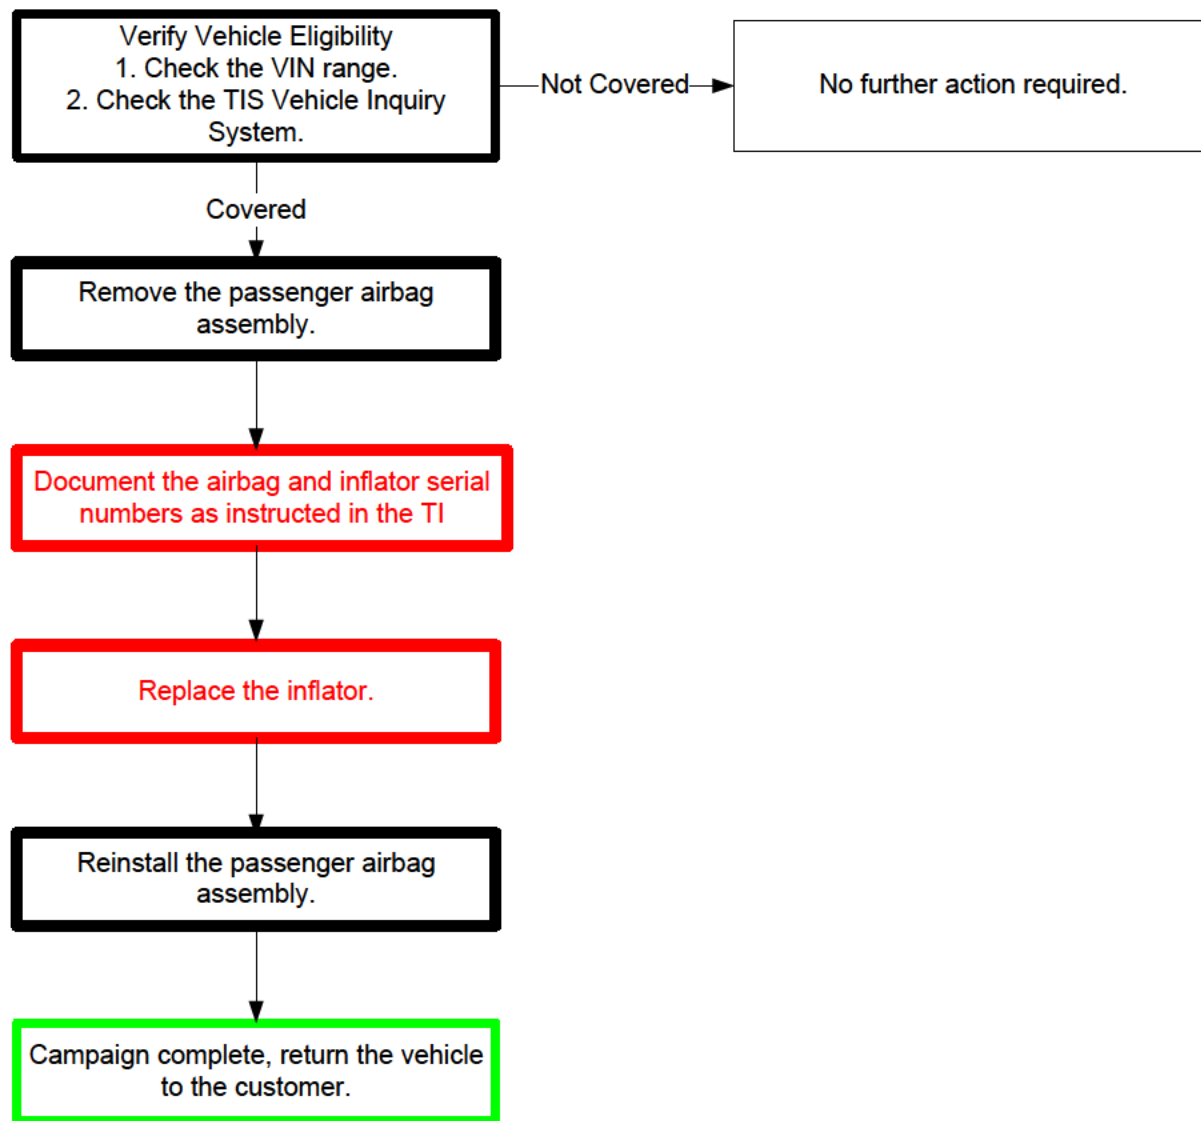
## I. OPERATION FLOW CHART

The flow chart is for reference only. **DO NOT** use it in place of the full technical instructions. Follow **ALL** steps as outlined in the full technical instructions to confirm the campaign is completed correctly.

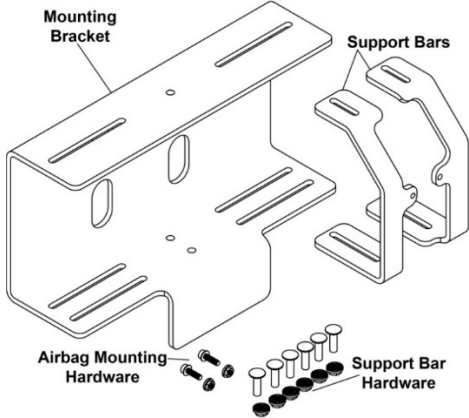
| Image | Name | Quantity |
|---|---|---|
| | Airbag Mounting Bracket & hardware | 1 |

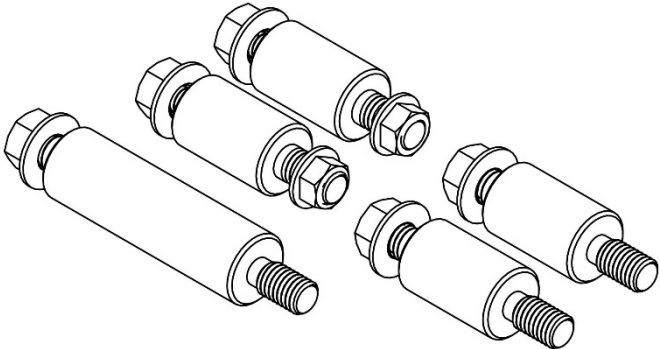
| Image | Name | Quantity |
|---|---|---|
| | Adaptor set* | 1 |

\*The adapter set was sent to dealers at the start of this campaign.

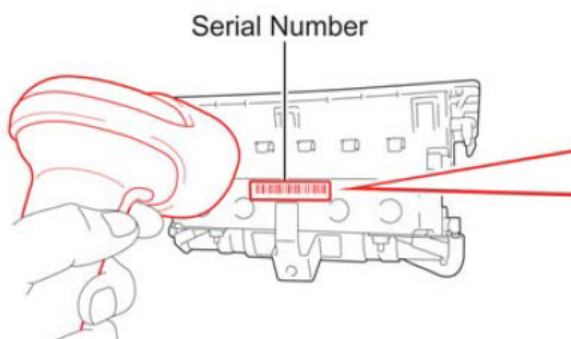
**Airbag Serial Number Label Example**

- The airbag serial number is **ALWAYS** the 12 **DIGITS** located between the asterisks.
- The 3 digits before the asterisk **ARE NOT** part of the serial number, and **SHOULD NOT** be entered or an inaccurate response may be returned.

The **AIRBAG ASSEMBLY** serial number and the **INFLATOR** serial number are **DIFFERENT**. The **AIRBAG ASSEMBLY** serial number **MUST** be recorded prior to replacement.

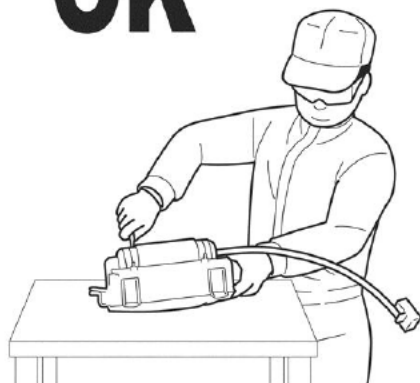
# OK

- Carefully place the airbag on the bench inflator side up.

**NOTE:** Place clean sheet(s) of paper on the bench to protect the airbag.

- Avoid standing directly over the inflator.

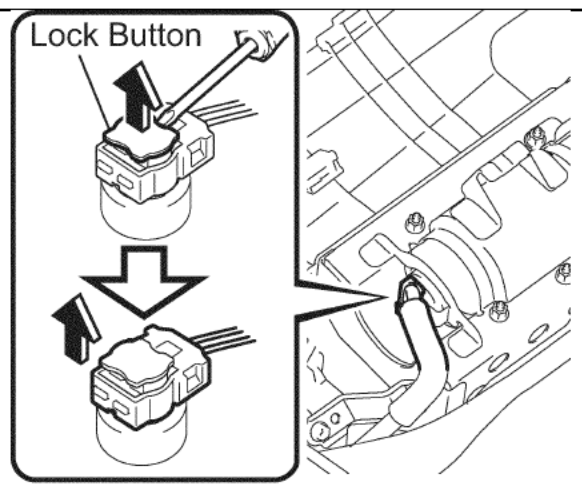
Lock Button

- Use a screwdriver to release the lock button.
- Disconnect the connector.
- Disconnect the wire harness clamps.

**NOTE:** Disconnect the connector where the fixed stop plate is located.

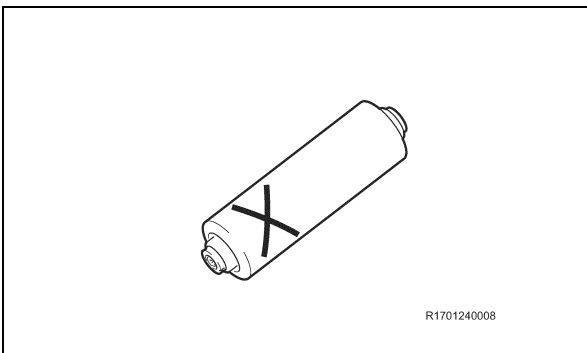
- a) Gently push in the studs until the nuts make contact with the housing to loosen the inflator for removal.

- b) Remove the inflator from the airbag assembly and place it on a safe work surface.
- c) Mark the old inflator so it is not reused.

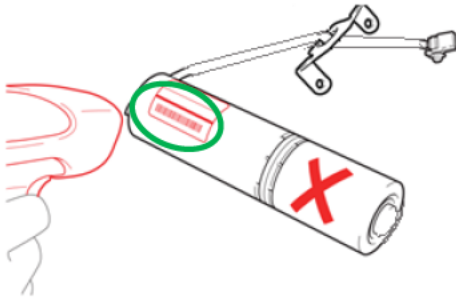
Step a) Old Inflator (bar code)

- Scan the **OLD** inflator bar code.
- Scan the **NEW** inflator QR code.

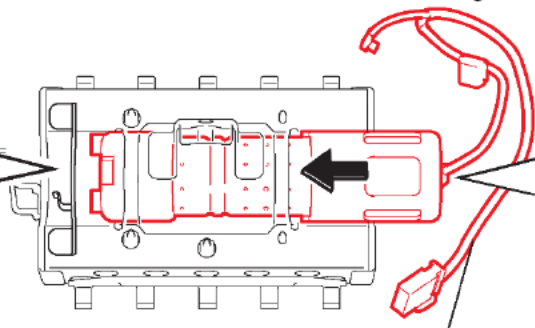
R1702270040

- a) Carefully slide the new inflator into the airbag assembly and align as shown.

- DO NOT** connect the inflator harness at this time. It is **CRITICAL** to first confirm that the inflator is installed in the correct position before connecting the harness.

**DO NOT** insert fully.

Check orientation

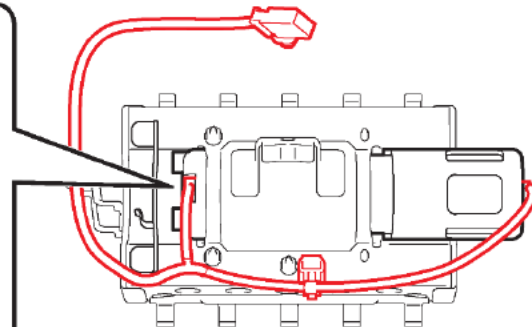
R1702270041

- b) Connect the connector to the inflator and ensure that the connector lock is fully engaged as shown.  
c) Route and secure the wire harness as shown.

**ALIGN CONNECTORS**

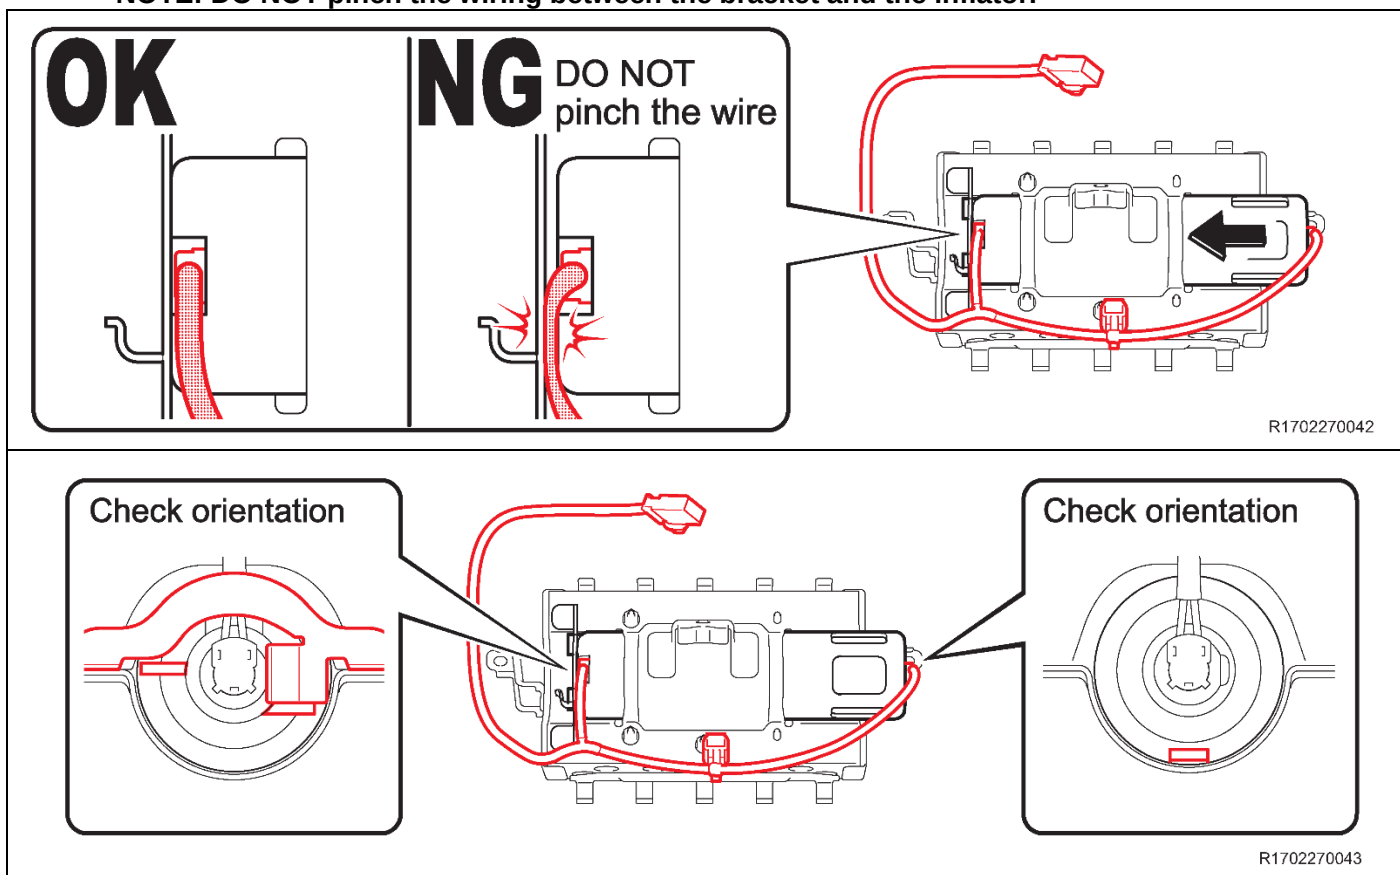
d) Fully insert the inflator and ensure that the inflator is correctly oriented as shown.

**NOTE: DO NOT pinch the wiring between the bracket and the inflator.**

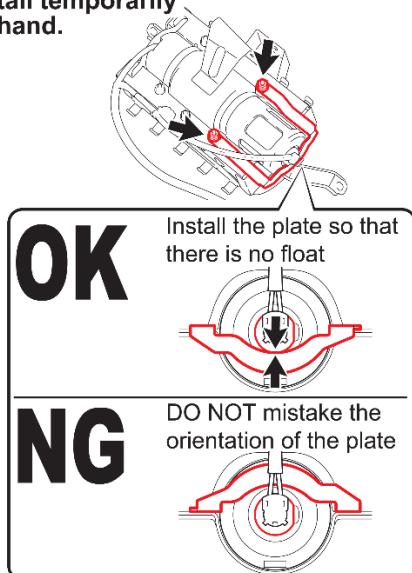
Install temporarily by hand.

e) Install the **NEW** stopper plate.

f) Install 2 **NEW** nuts by hand.

**NOTE: Ensure that the stopper plate is the one from the bracket kit and installed in the correct orientation.**

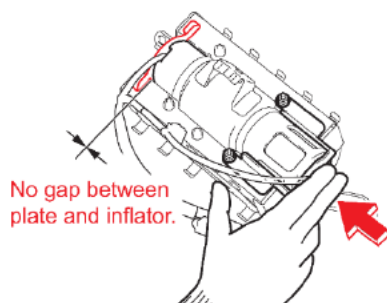
**OK**

- a) Tighten the 5 nuts evenly in several increments in the sequence shown. Use a socket driver or torque wrench to tighten the nuts.

Torque: 35in. lbf (3.9N·m)

- There will be some resistance when tightening the nuts because they are self-locking, confirm the nuts are tightened correctly.
- **DO NOT** use a power tool, T-handle, or ratchet when tightening the nuts to avoid over torqueing and deforming the studs.
- You may need to turn the airbag to the left or right with in the mounting bracket to access the center nut.

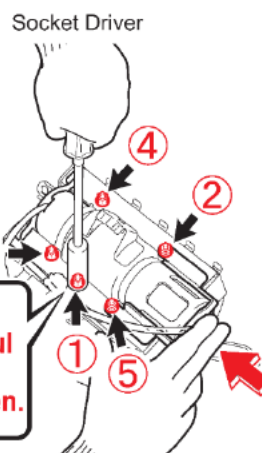
3.9 N·m  
Be careful  
not to  
overtighten.

**These tools cause overtightening !**

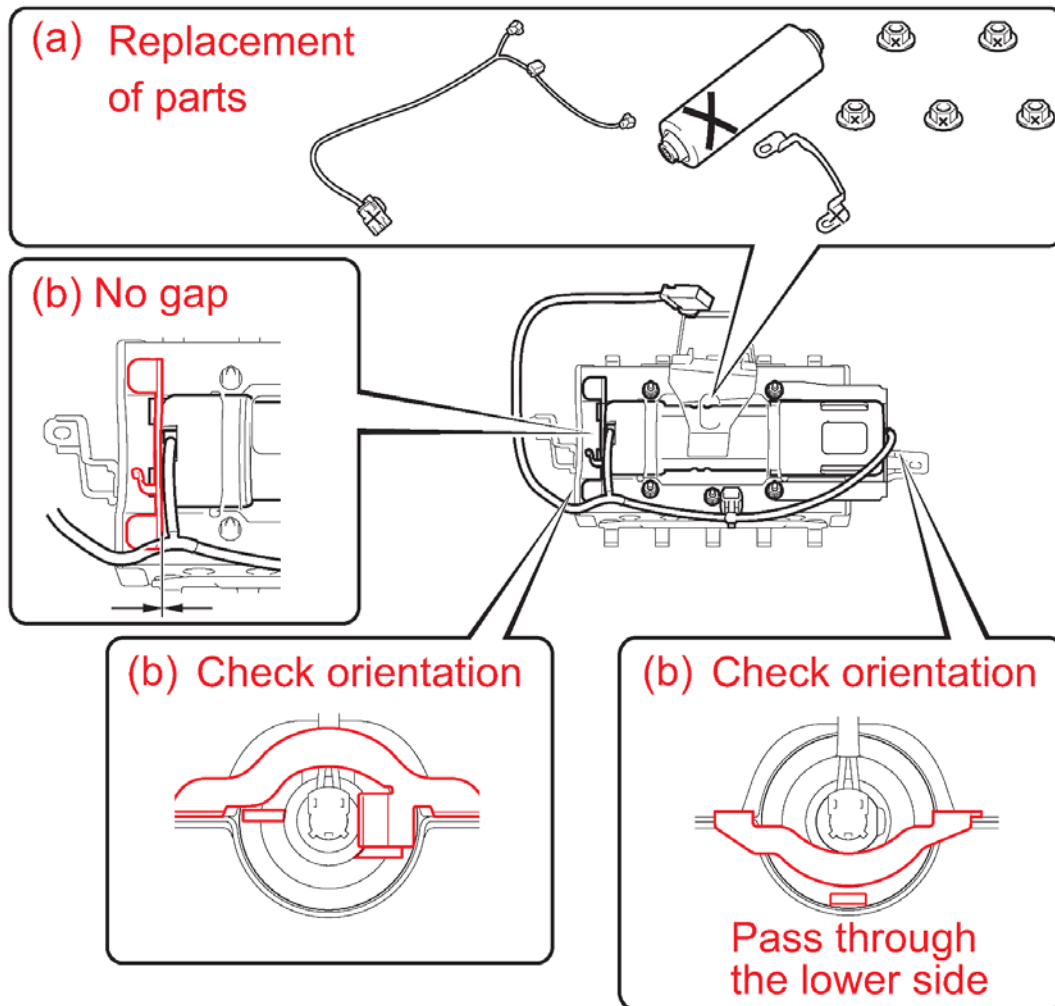
R1703080022

- Confirm the **NEW** inflator and 5 **NEW** nuts have been installed.
- Confirm the position of the inflator and position determining plates are correct.
- Confirm the routing of the inflator wire harness.
