Mercedes-Benz

Campaign No.2021040001, April 2021

SUBJECT: **Model E-Class Coupe and Cabriolet (C/A207) Vehicles**  
**Model Year 2012-2017**  
**Replace Front Passenger-side Airbag**

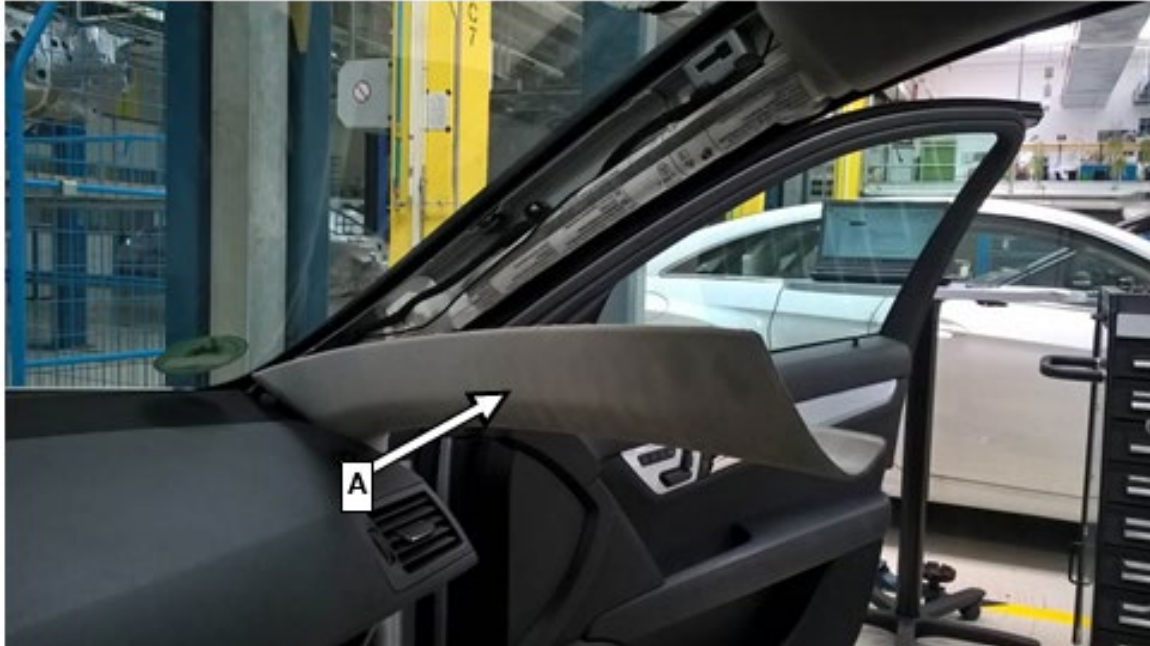
Figure 2

1. Disconnect ground line from the on-board electrical system battery.
2. Remove right A-pillar trim (A, figure 2).

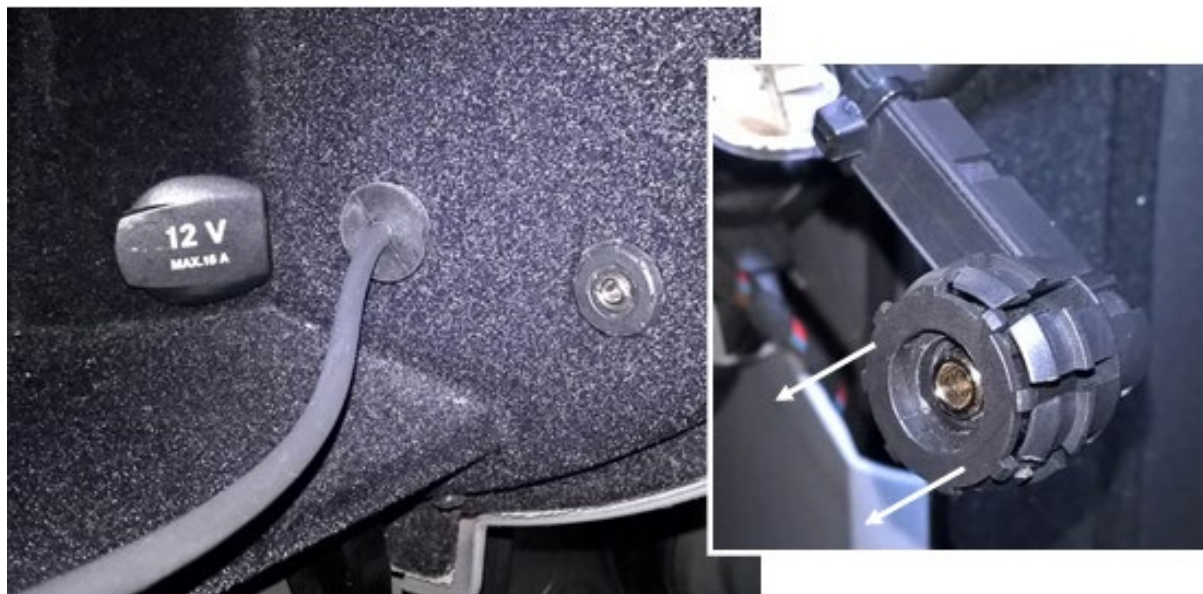
Figure 3

**i** Release inner retaining ring (**figure 3**) at the AUX connection towards the inside. The connection can then be removed from the glove box housing.

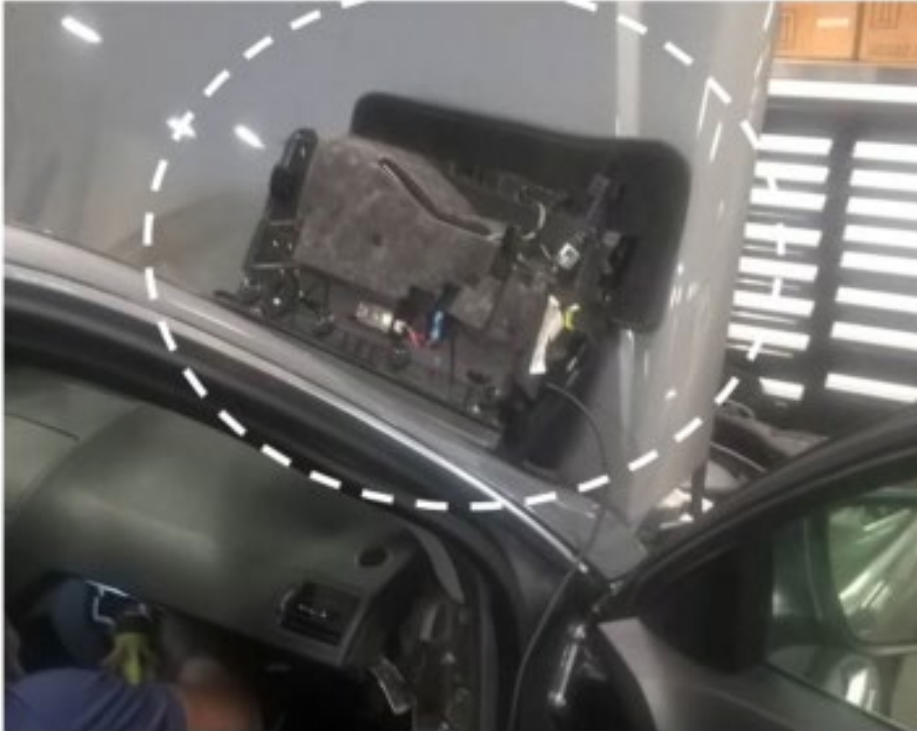
Figure 4

**i** Pull out the iPod cable as far as possible and set down glove box housing on the windshield **with** exterior iPod cable connected (**figure 4**).

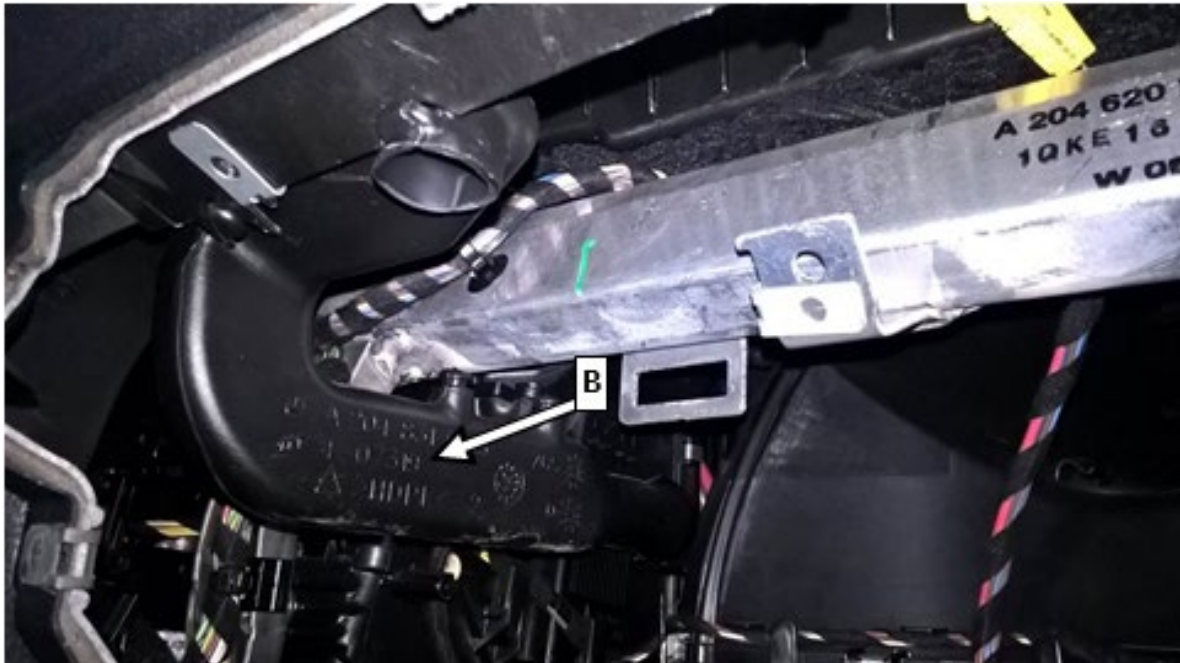
Figure 5

4. Remove air duct (**B**, figure 5) above the glove compartment.

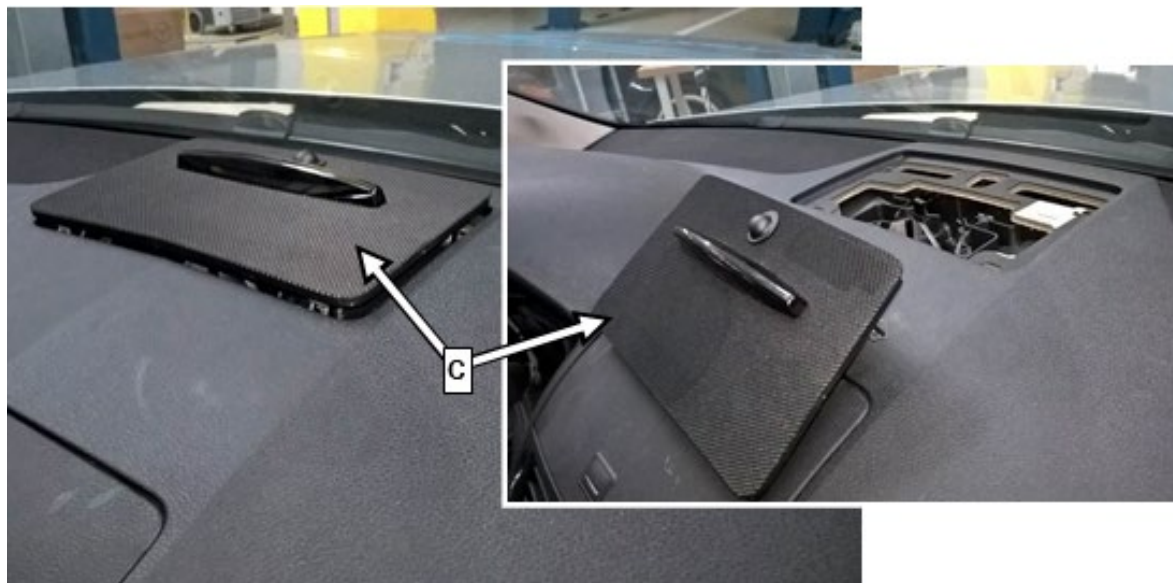
Figure 6

5. Unclip and remove cover (**C**, figure 6) at the instrument panel on top.
  - i** With a sound system, also remove speaker under the cover.

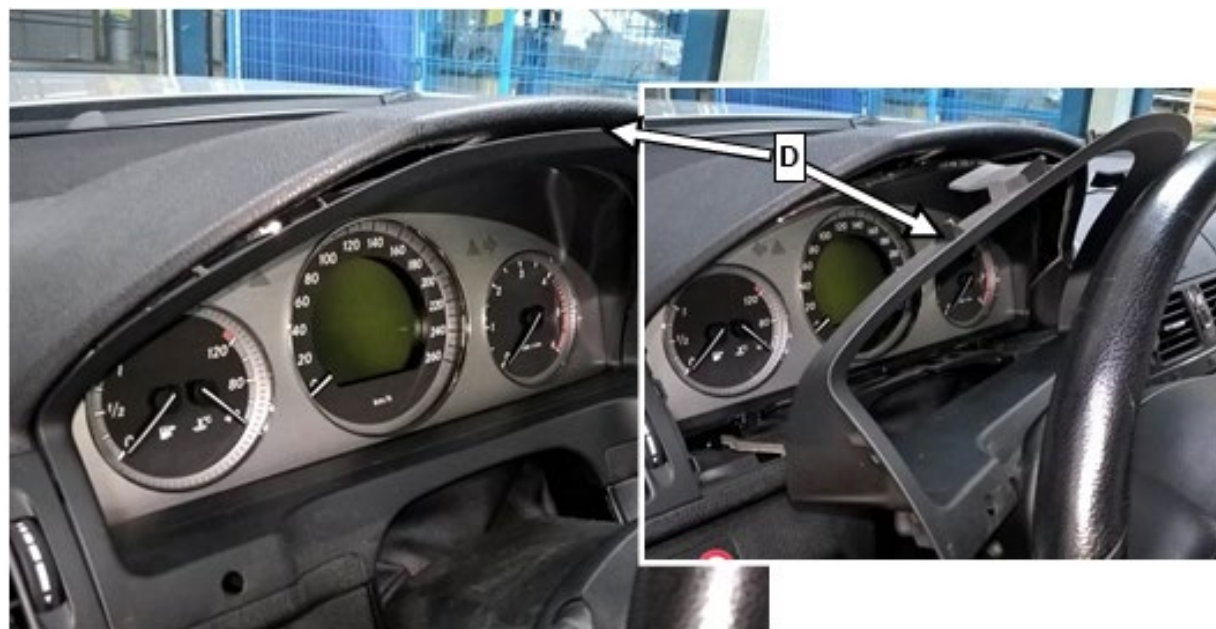
Figure 7

6. Remove center console (**AR68.20-P-2000CW**).
7. Remove automatic climate control and operating unit.
  - i** For basic data of model 207, see **AR83.25-P1124EC**.
8. Remove trim (**D, figure 7**) around the instrument cluster.
  - i** For basic data of model 207, see **AR54.30-P-6015EZ**.

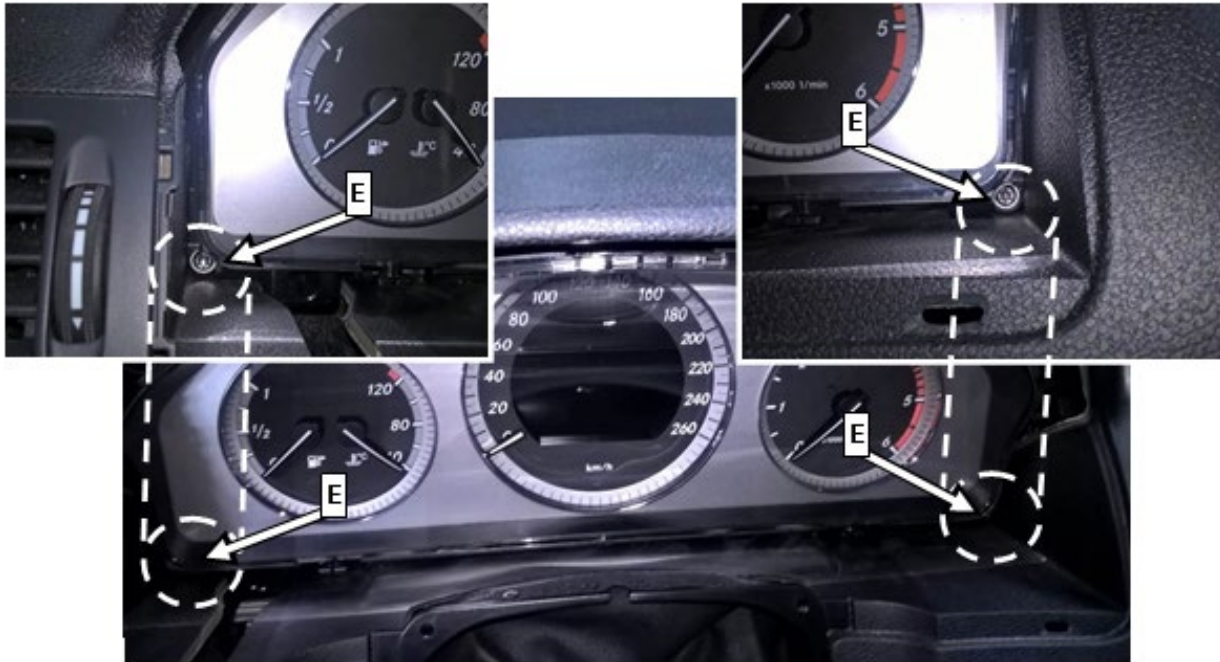
**Figure 8**

9. Remove the two bottom threaded connections (**E**, **figure 8**) of the instrument cluster.

**i** These screws are simultaneously fasteners for the instrument panel.

**i** The upper two screws do not need to be removed.

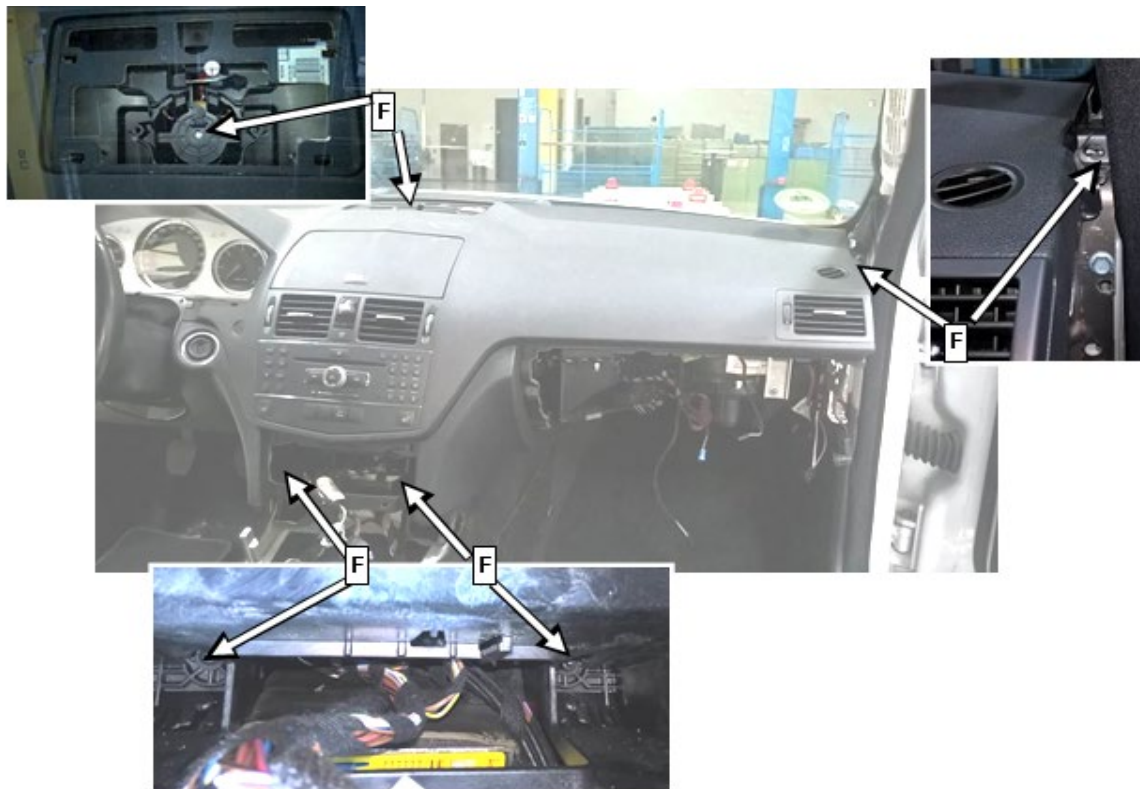
**Figure 9**

10. Remove four screws (**F**, **figure 9**) for fastening the instrument panel

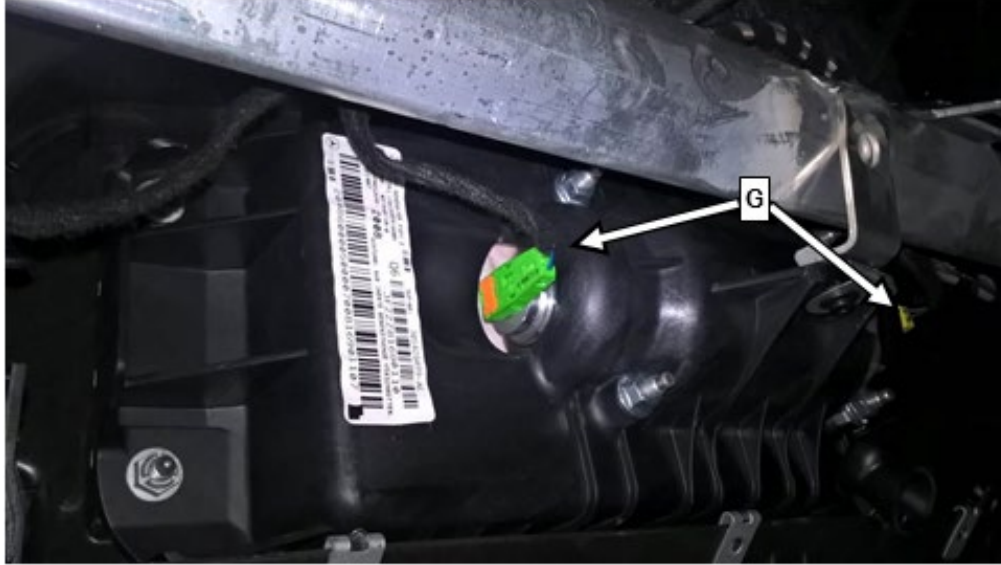
Figure 10

11. Disconnect electrical contacts (**G**, **figure 10**) at the front passenger airbag.

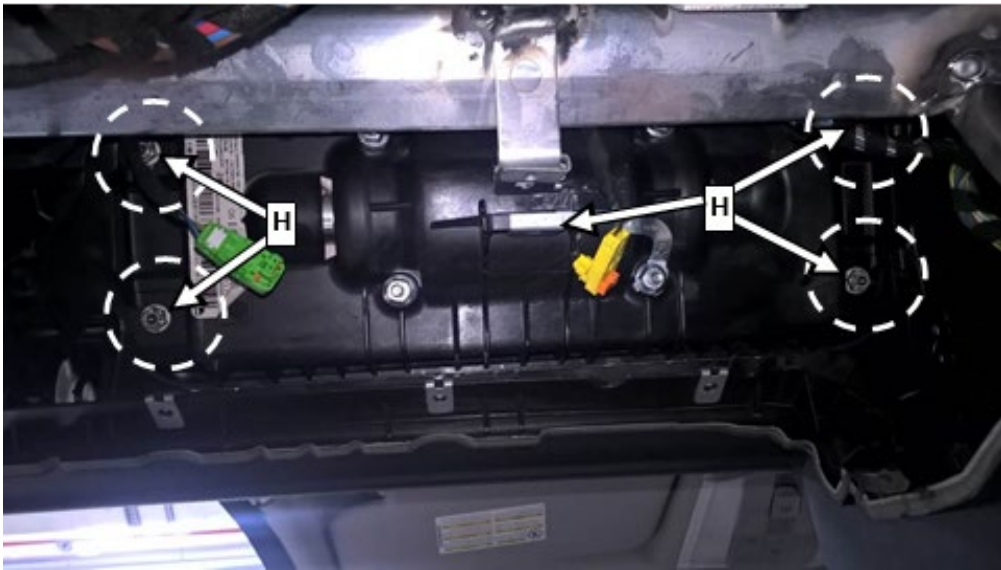
Figure 11

12. Remove lock nuts (**H**, **figure 11**) for the front the passenger airbag.

**i** Lock nuts should only be replaced if they are damaged. For more info see:  
**AH00.00-N-0001-01A / Modification notes 27.10.2016**

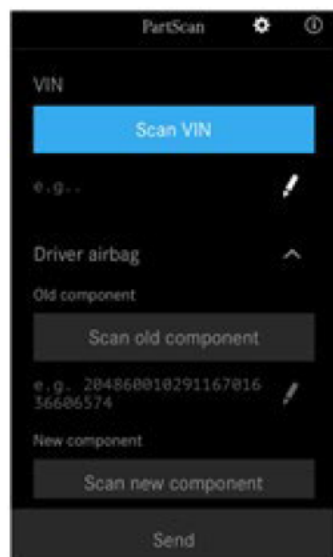
Figure 12

14. The PartScan App **must** be utilized properly for every Takata airbag recall repair. Use the "Scan VIN" button (**figure 12**) to scan the vehicle identification number either by the barcode or the text field.

**i** After scanning, compare the vehicle identification number that has been read in the app

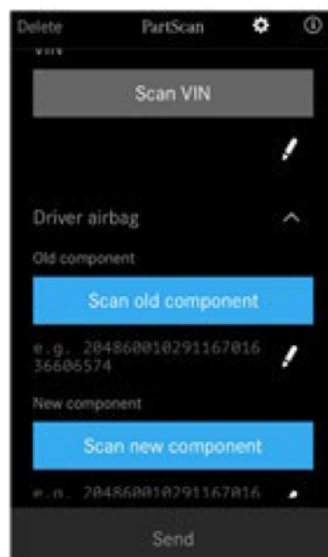
Figure 13

16. Scan barcodes of the removed passenger airbag using the button "Scan old component" (figure 13).

17. Scan the barcodes of the new passenger airbag using the button "Scan new component" (figure 13).

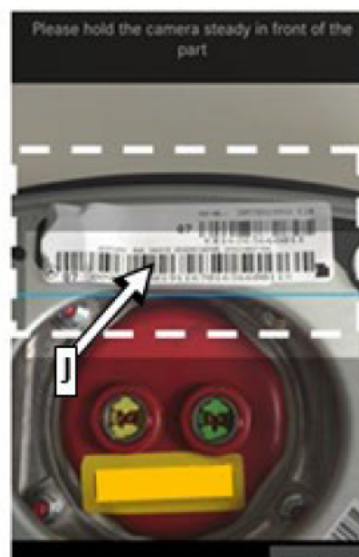
Figure 14

**i** Ensure that the lower barcode (J, figure 14) is scanned.

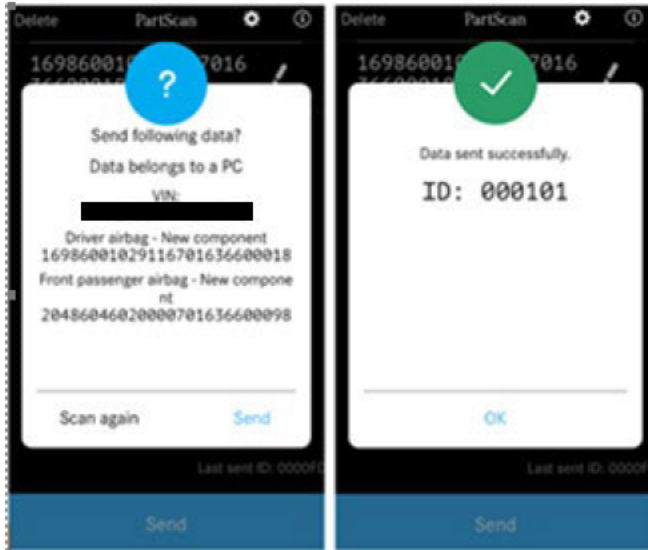
Figure 15

18. Create a scan ID via the "Send" button (figure 15).

**i** The generated scan ID (figure 16) must be recorded in writing in the workshop order and then stored in a tamper-proof manner.

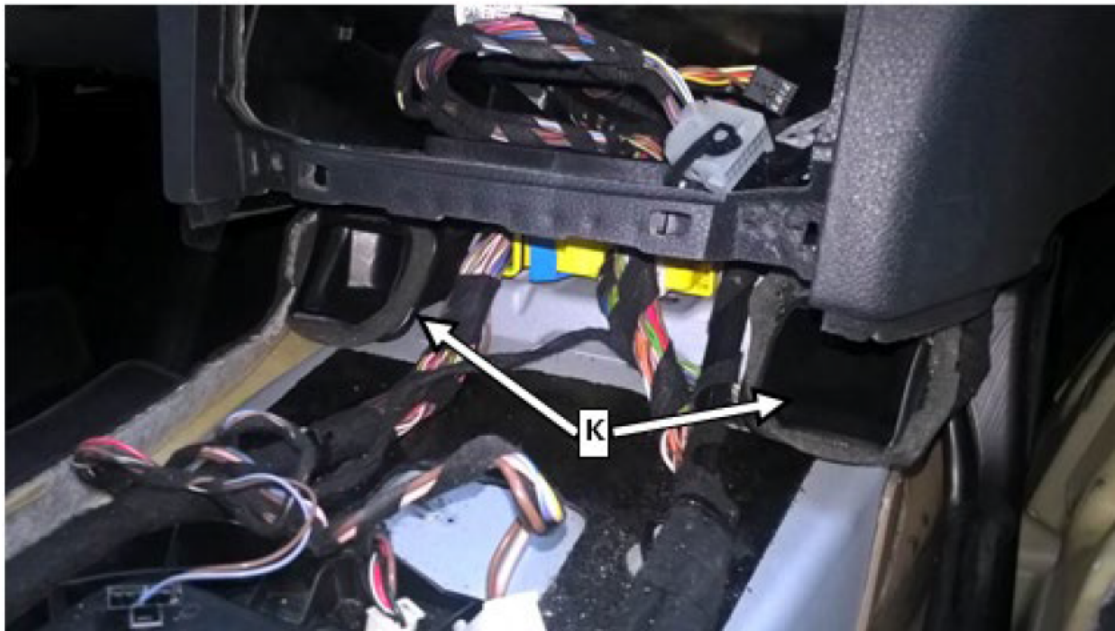
Figure 17

20. Place instrument panel back into position and install the air ducts (**K**, figure 17) correctly.

**i** The air ducts are pulled out when the instrument panel is raised.

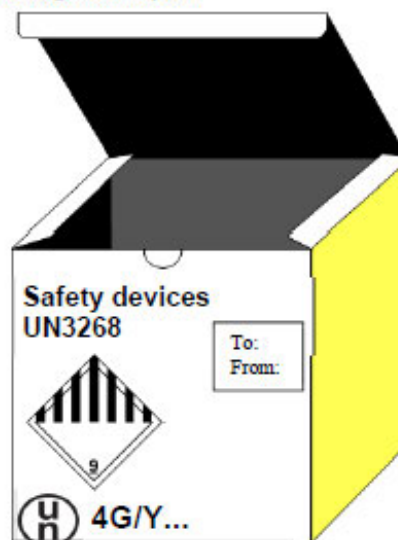
- Carefully open received box and remove new airbag. Keep box intact & save all contents!
- Place used airbag into replacement airbag box, re-using any packaging material (e.g., cardboard inserts) used for the new airbag. Package as the new airbag was packaged.
- Use plastic adhesive tape 50 mm wide to secure the box closed. Do not obscure labels or text on the box with the tape.
- Ensure that the 4G fiberboard box is not ripped or damaged.

- A Class 9 Miscellaneous label must be clearly visible on one side of the box.

- The following words ("marking") must also be clearly visible on the same side of the box as the Class 9 label:  
**Safety devices**  
**UN3268** (font size must be  $\geq \frac{1}{2}$  inch)
- Affix "To/From" address label to same or adjacent packaging face as the hazardous markings/labels.
- The UN 4G code preprinted near the bottom edge of the box must also be clearly visible.

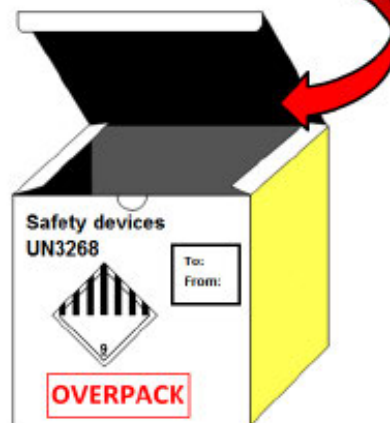
- Package each airbag in a separate UN spec box prepared with the labels/markings described above.
- Place each individual airbag box inside a larger non-UN spec box to keep the shipment together.
- This larger box is called an "OVERPACK."

- The OVERPACK must have the identical markings and label as the boxes contained inside.
- The OVERPACK must have the "OVERPACK" statement on the same face as the hazard markings and labels. **Package example:**
