TECHNICAL BULLETIN

501-20B: Supplemental Restraint System

SAFETY RECALL: Takata Passenger Airbag

MODEL:	MODEL YEAR:	VIN:	ASSEMBLY PLANT:
XF (X250)	2012	S10154-S61361	Castle Bromwich
XF (X250)	2009	R00169-R47002	Castle Bromwich

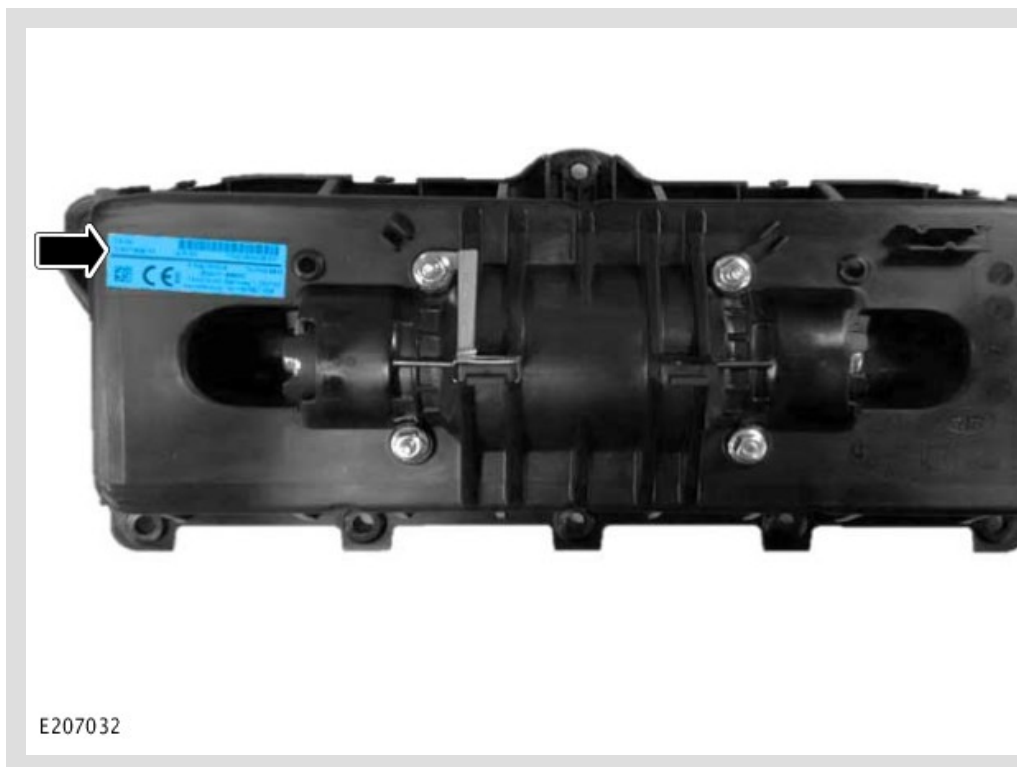
1

Locate the label on the NEW passenger airbag module.

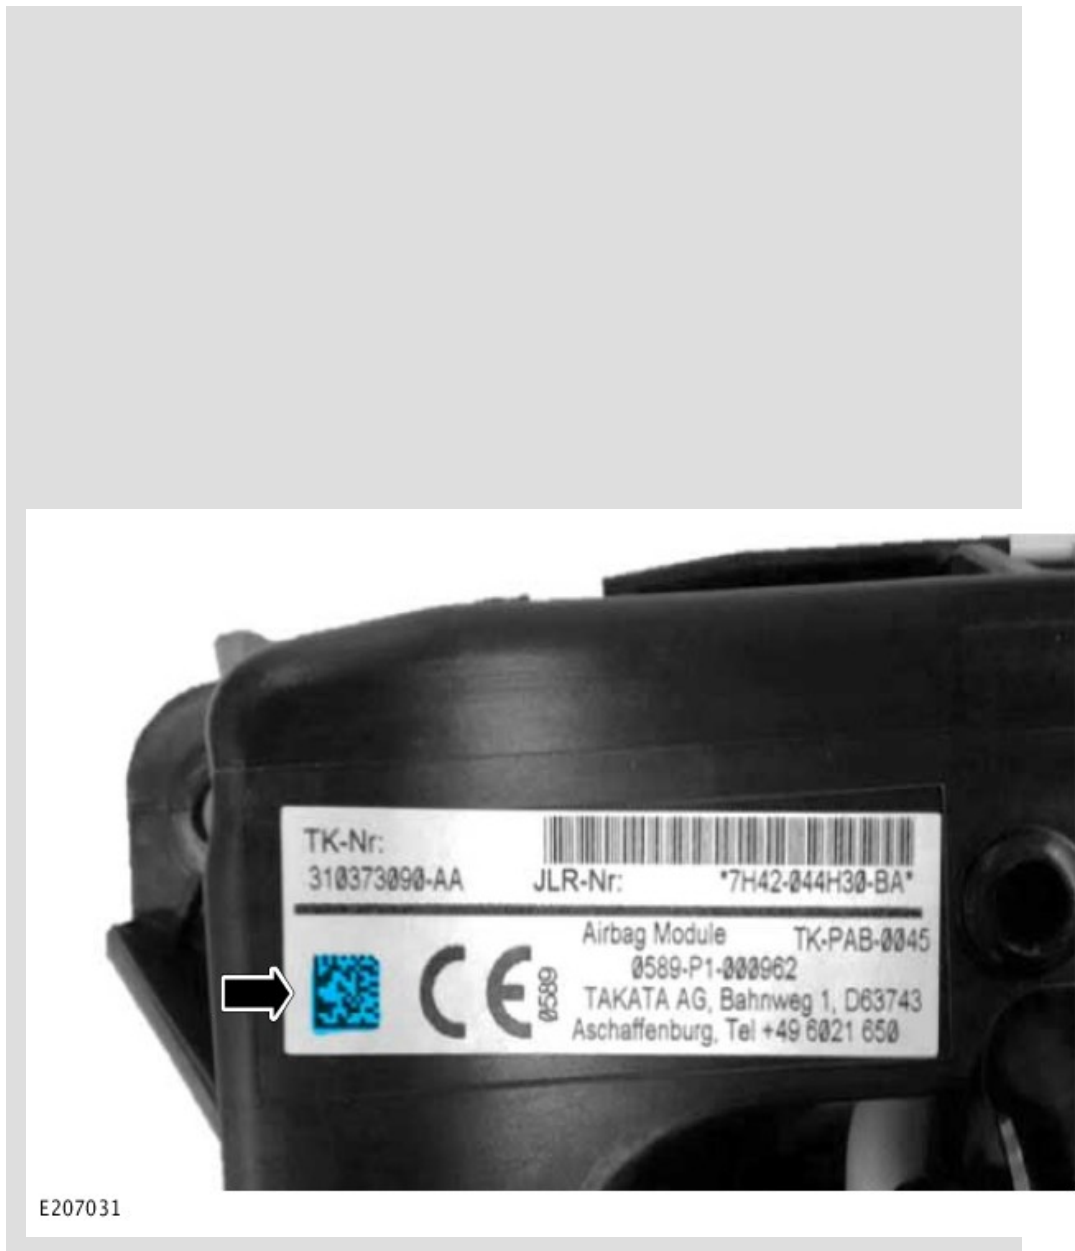
2

Locate the QR code on the NEW passenger airbag module label.
