December 7, 2018

Safety Recall: Front Passenger's Airbag Inflator Can Be Over-Pressurized (Phase 2)

Supersedes 17-001, dated February 1, 2017 to revise the information highlighted in **yellow**

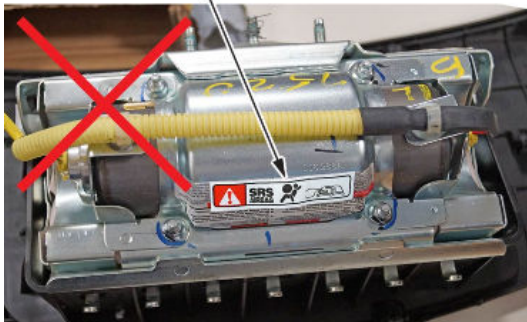
NON-STANDARD SAFETY LABEL

- If there is nothing unusual about the airbag or the inflator, continue with the inflator replacement procedure.
- If there are any unusual markings, like an incorrect label or a model year written in marker, the airbag and inflator may not be the correct airbag and/or inflator for the vehicle or it may be a counterfeit part. For more information about counterfeit airbags, you can refer to safercar.gov, enter keywords **MANAGING COUNTERFEIT**, and select **Recommended Dealer Guidance for Managing Counterfeit Air Bags** from the list. **If you suspect that the airbag or inflator is counterfeit, do not continue this procedure.** Contact your DPSM for assistance

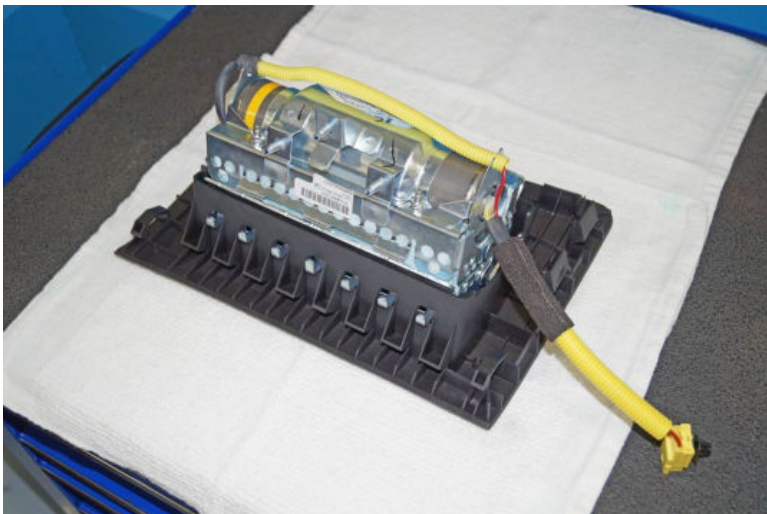
4. Place the airbag, face-down, on a clean shop towel.

- The orientation of the airbag is critical because if the inflator is installed incorrectly, the harness will be too short when you reinstall the airbag.
- The brackets between the various models are similar but may differ from the example shown.

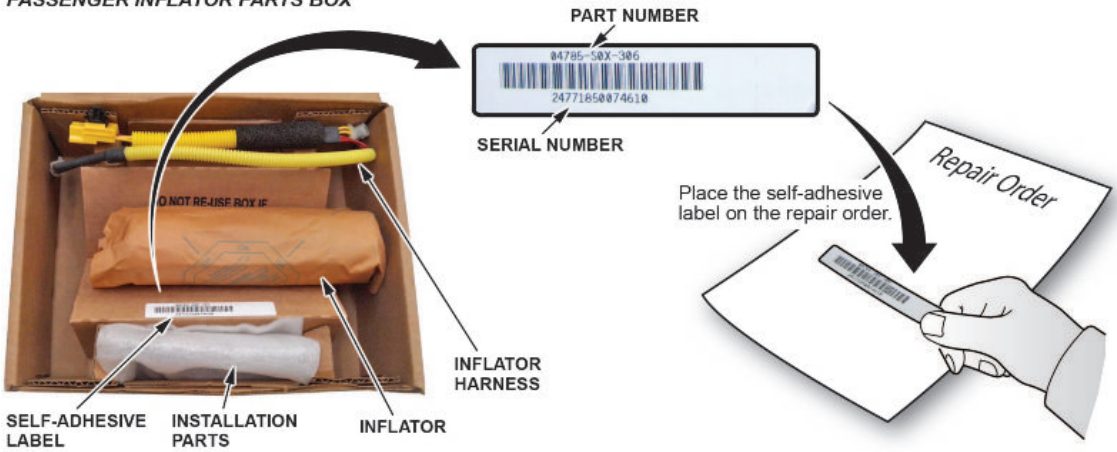
PASSENGER INFLATOR PARTS BOX

6. Peel the label located inside the inflator box from its backing and attach it to the RO. For the warranty claim to be paid, the **replacement inflator part number that you received** must be included in the warranty claim.

- The replacement part number is printed on the top part of the label and the serial number is printed on the bottom. **Make sure you attach the label to the RO and give it to the warranty clerk .**
- There may also be a colored sticker located in the kit, ignore it because it is not used.
- Not all inflator kits have a label included. In those cases, write the serial number and part number from the side of the inflator box on the RO. The part number always starts with 047.

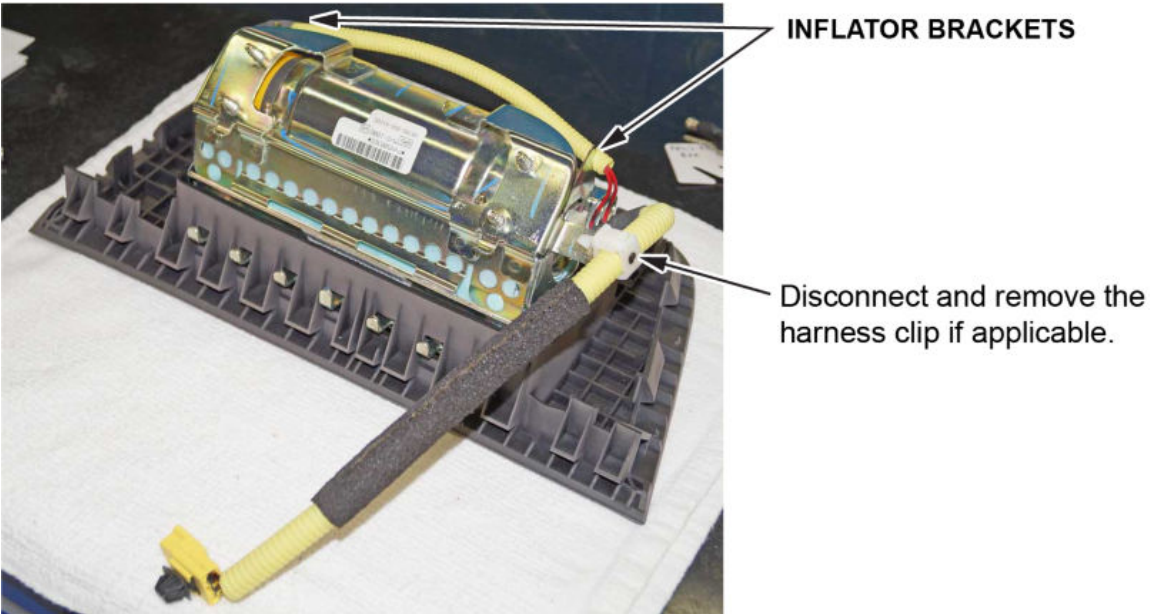
7. Remove the harness from both ends of the inflator bracket.

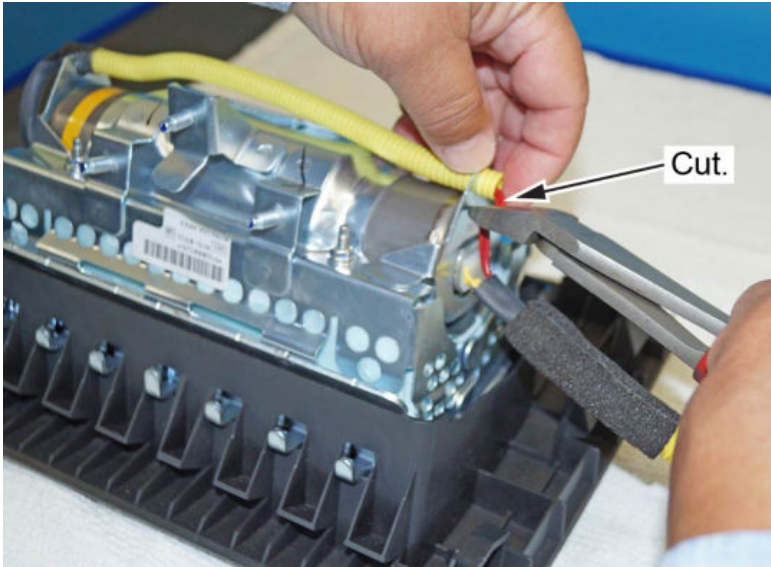
You must cut and short the wires as indicated to prevent accidental deployment.

8.1. Cut the red wires as shown.

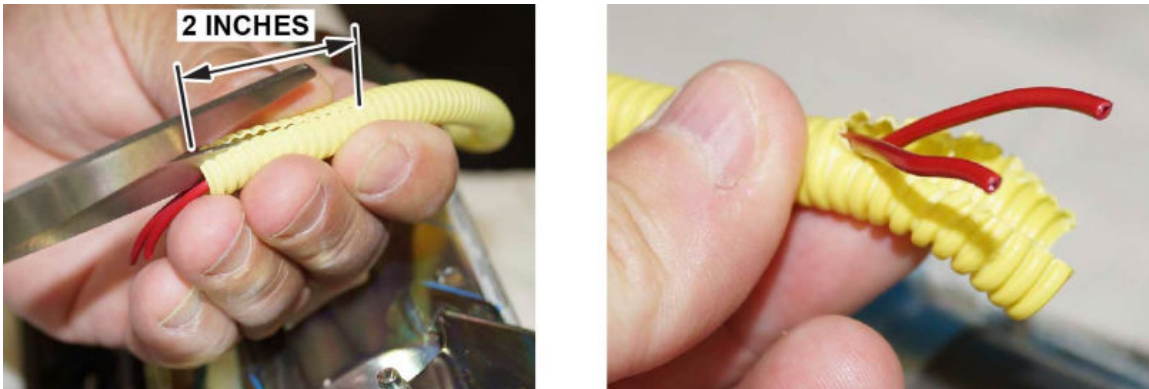
8.2. Cut about 2 inches of the corrugated tube, then pull out the two red wires.

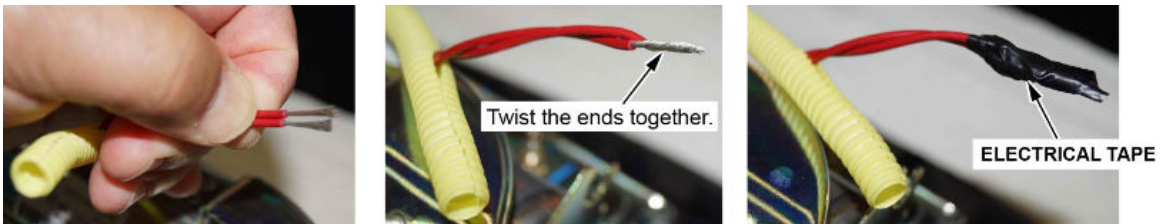
8.3. Strip away about 1 inch of the wire insulation, then twist the wires together.

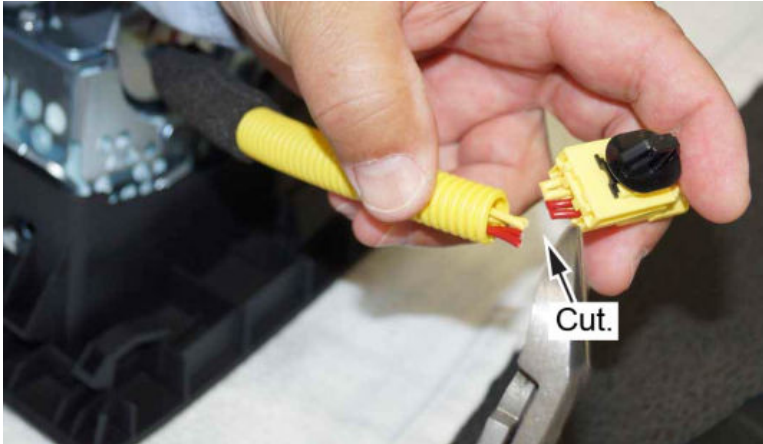
9.1. Cut all four wires to remove the connector.

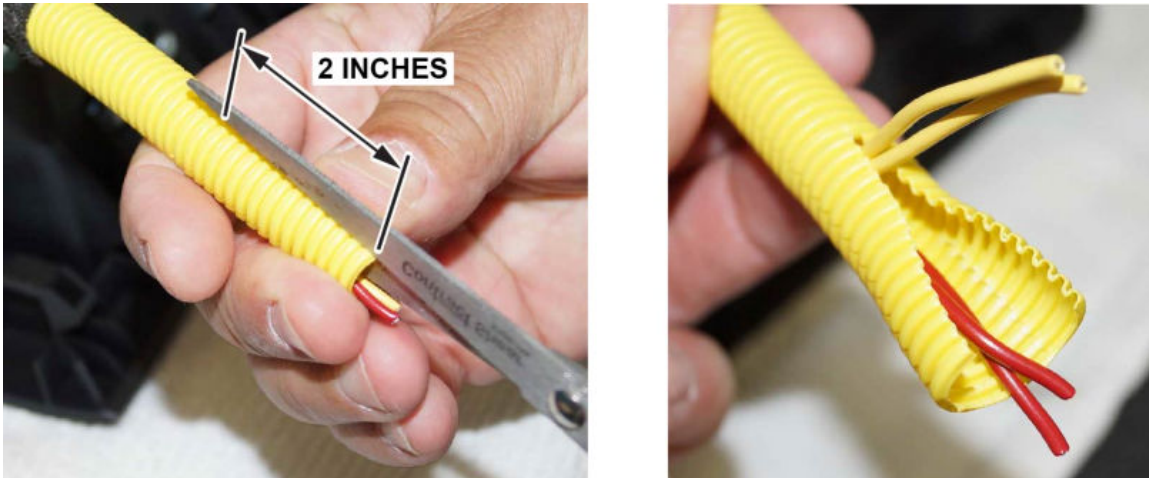
9.2. Cut about 2 inches of the corrugated tube, then pull out the yellow wires.

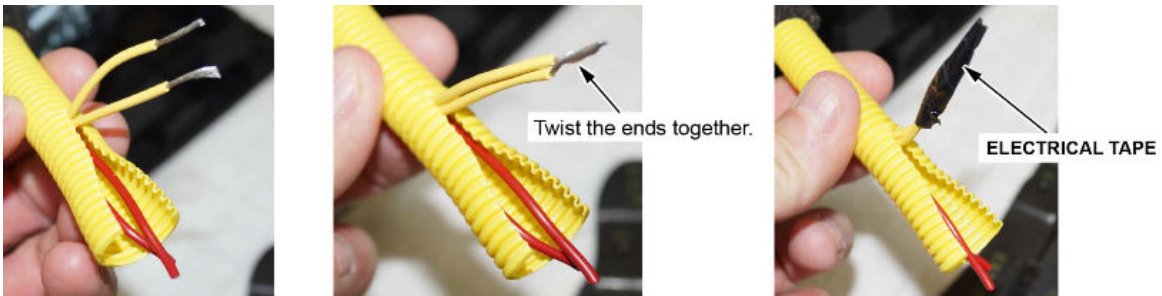
9.3. Strip away about an inch of the wire insulation, then twist the wires together.

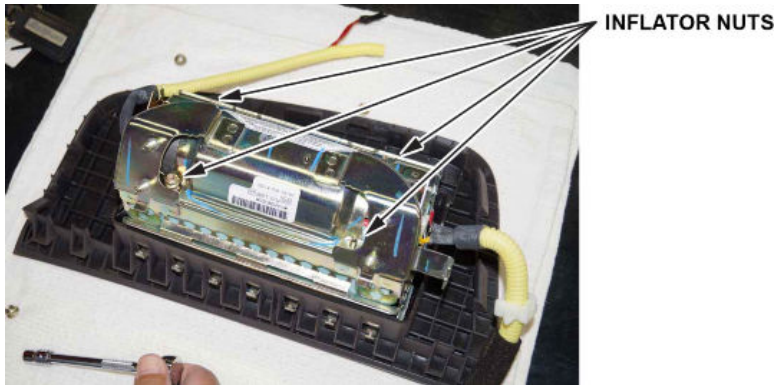
10. Remove the four inflator nuts.

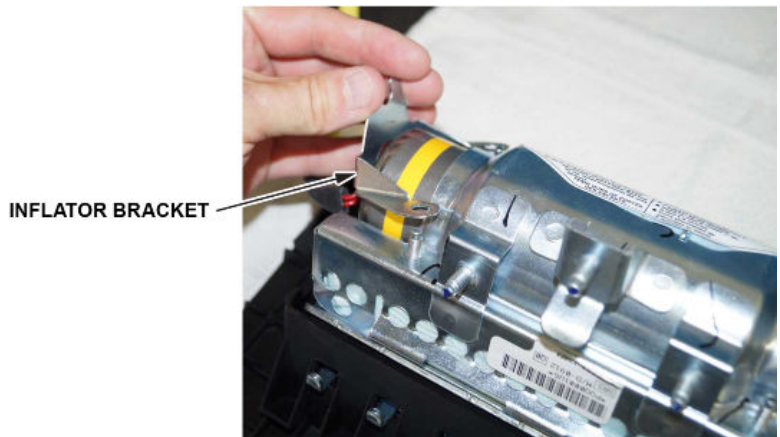
11. Remove the inflator bracket.

You can only remove one of the brackets, as the other is welded to the airbag housing.

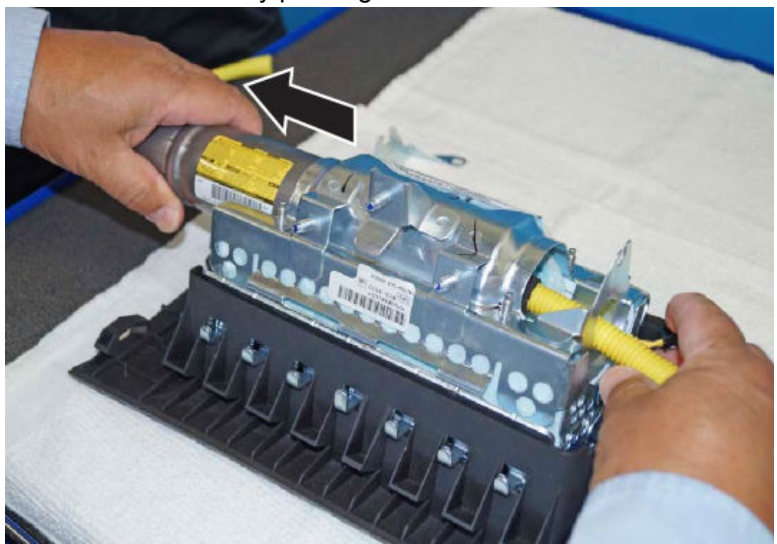
12. Remove the inflator by pushing it out.

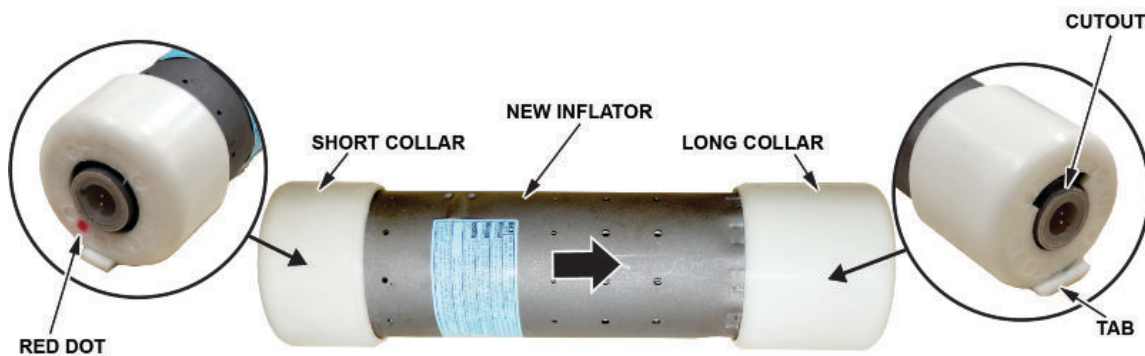
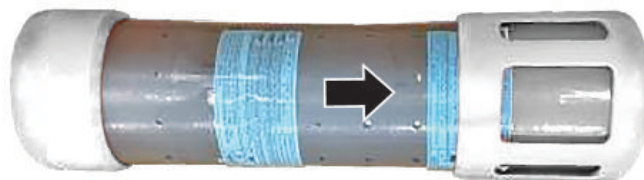
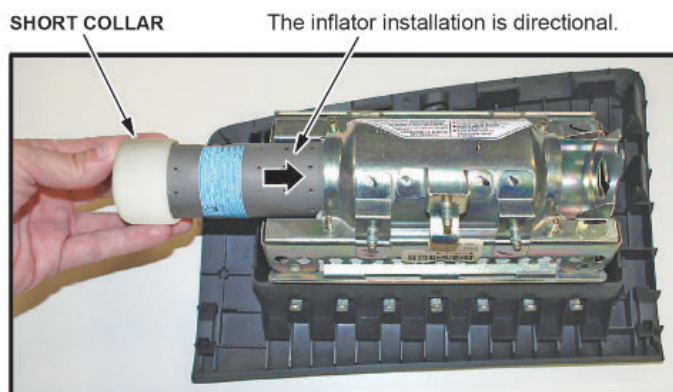
13.2. The collars on this inflator are white, not orange. One side of the inflator has a longer collar, a tab, a plastic cutout, and a small flat spot on the connector. The other side of the inflator has a shorter collar, no tab, and a red dot. Make sure you insert the end with the longer collar into the airbag first.

(Some part numbers have solid collars [above] and some part numbers have collars with slots [below])

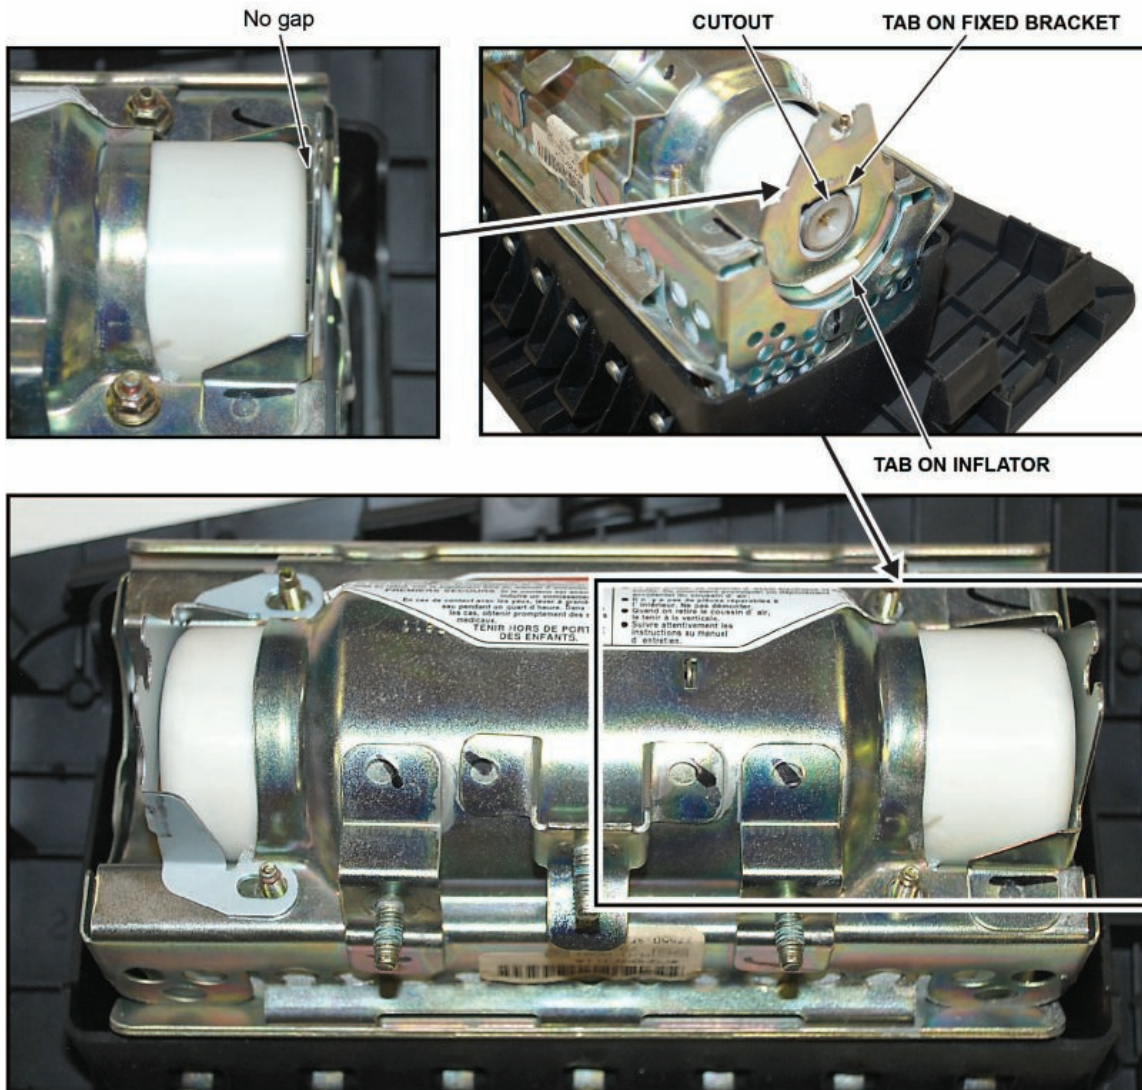
FIXED BRACKET END

13.3. Slide the inflator in until the plastic cutout and the small flat spot align with the tab on the bracket. There should be no space or gap between the inflator and bracket.

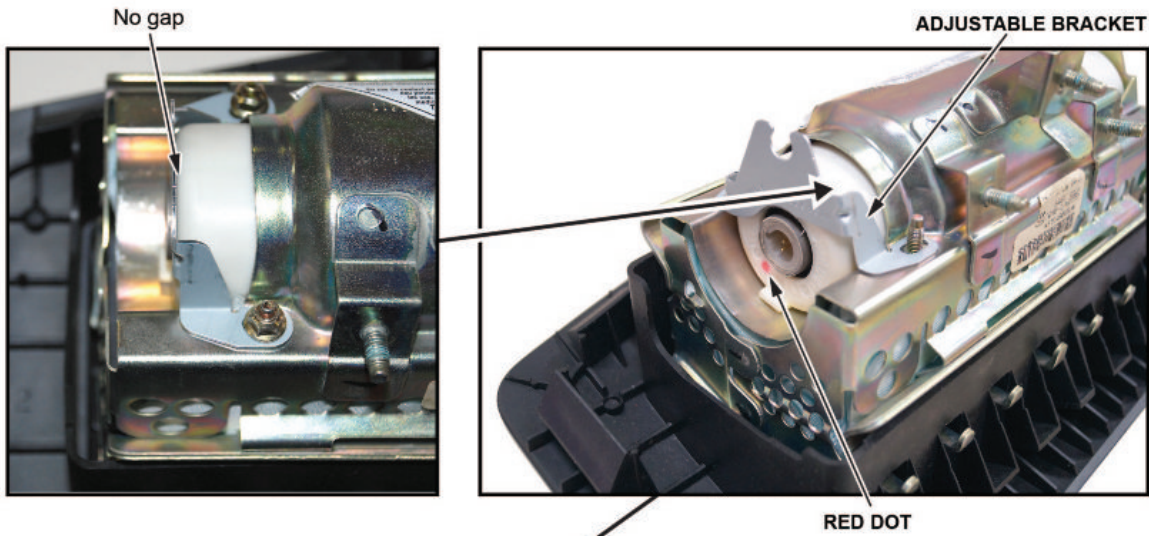
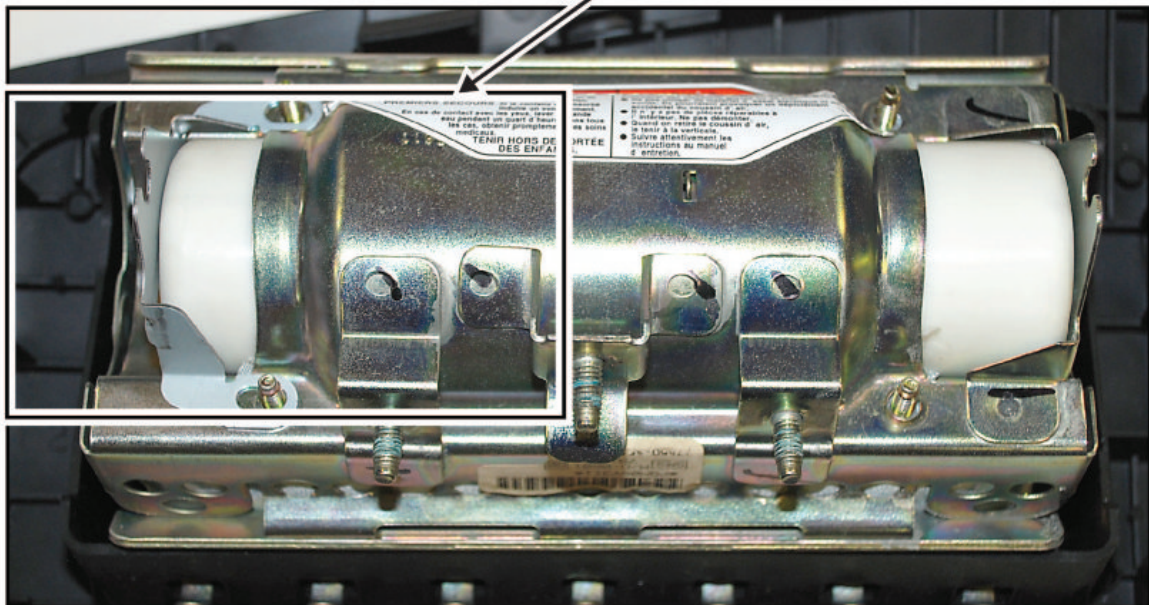
ADJUSTABLE BRACKET END

13.4. Install the bracket included in the kit onto the airbag module. There should be a red dot visible on the end of the plastic connector. There should be no space or gap between the inflator and bracket.

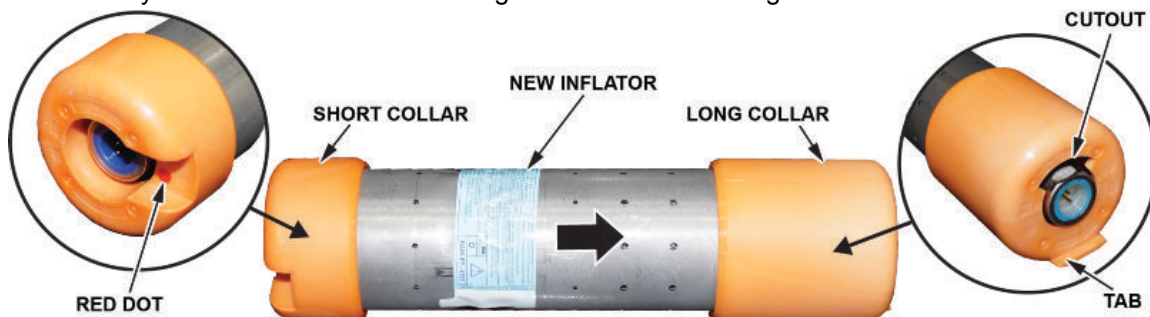
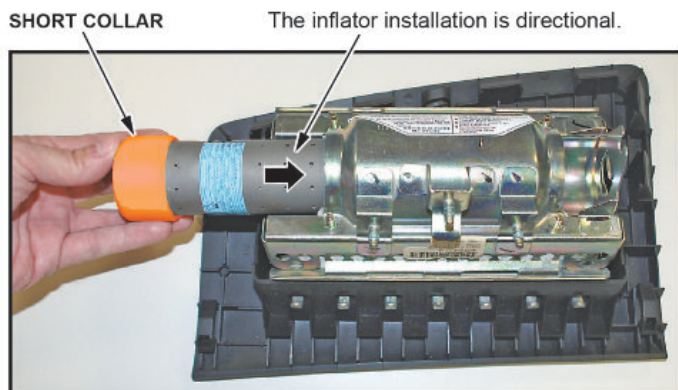
13.2. Collars on this inflator are orange, not white. One side of the inflator has a longer collar, a tab, a plastic cutout, and a small flat spot on the connector. The other side of the inflator has a shorter collar, no tab, and a red dot. Make sure you insert the end with the longer collar into the airbag first.

(Some part numbers have solid collars [above] and some part numbers have collars with slots [below])

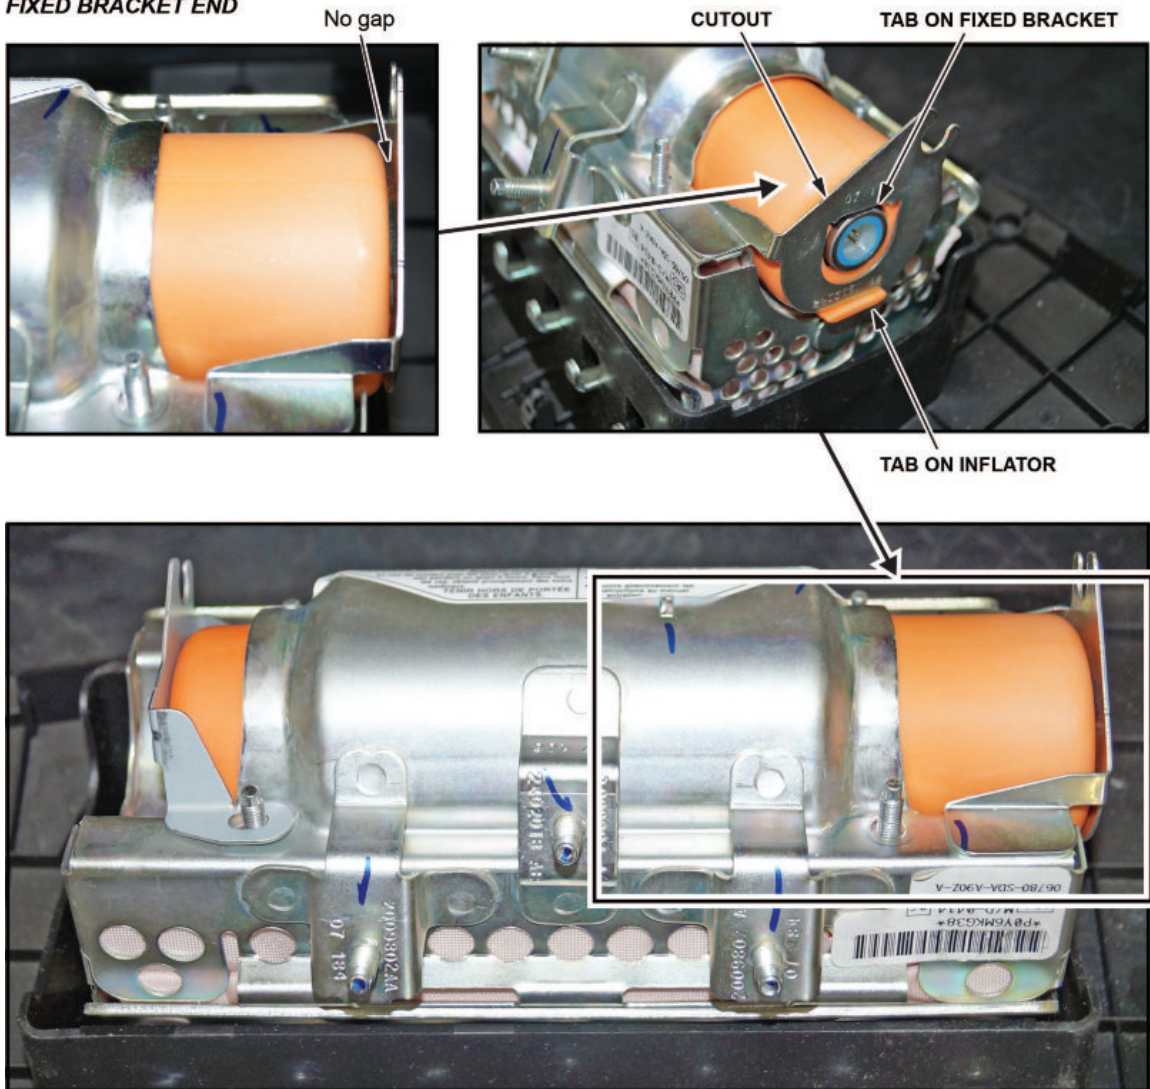
FIXED BRACKET END

13.3. Slide the inflator in until the plastic cutout and the small flat spot align with the tab on the bracket. There should be no space or gap between the inflator and bracket.

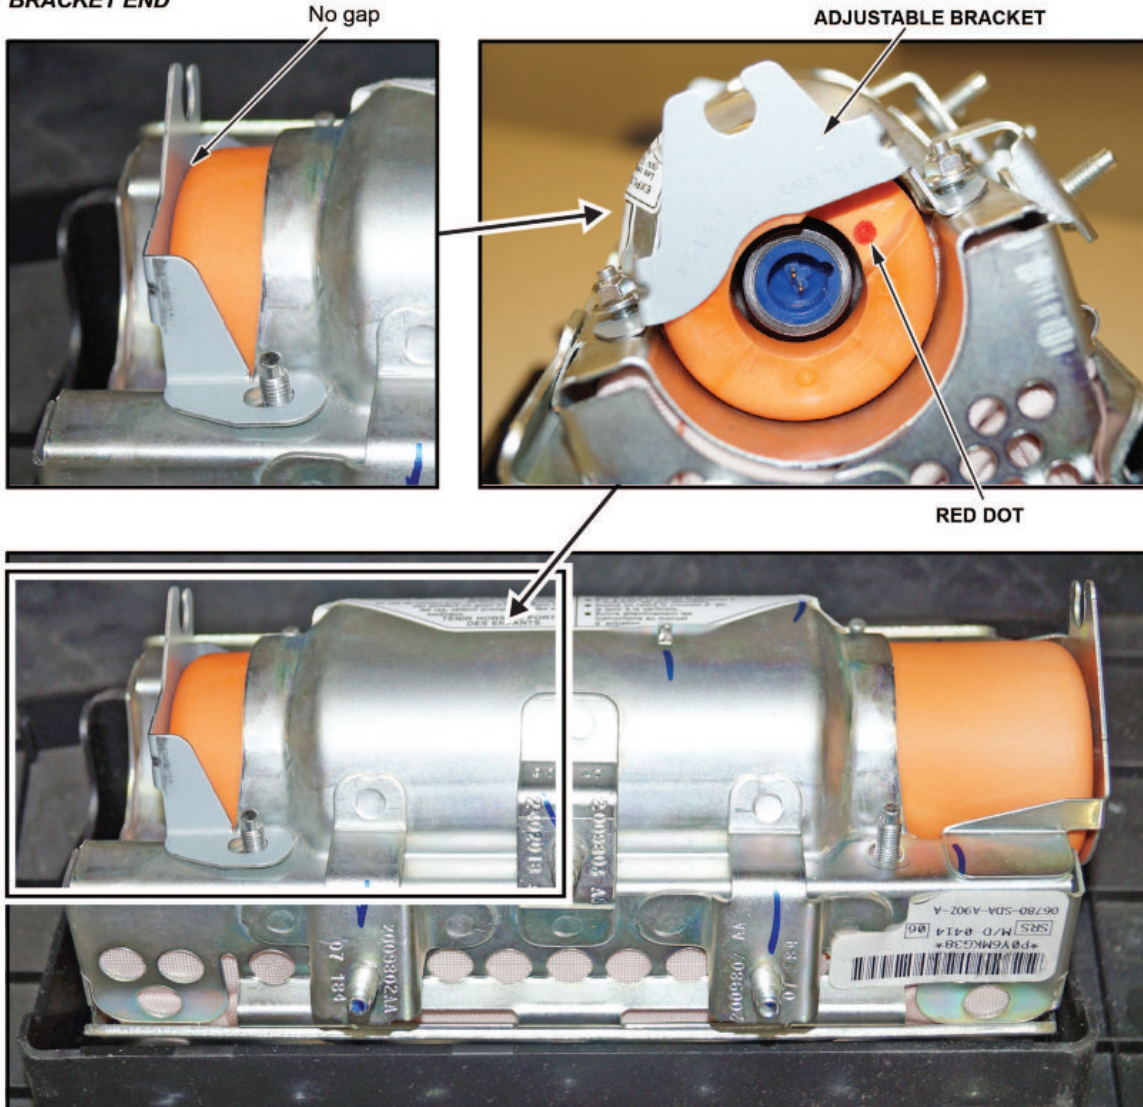
**ADJUSTABLE
BRACKET END**

13.4. Install the bracket included in the kit onto the airbag module. There should be a red dot visible on the end of the plastic connector. There should be no space or gap between the inflator and bracket.

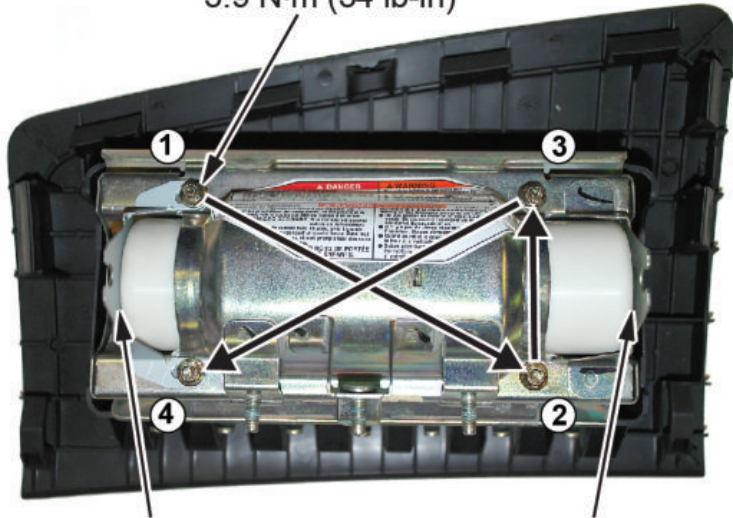
LOCK NUTS (4)
3.9 N•m (34 lb-in)

14. Install the new 5 mm locknuts and torque them in sequence to **3.9 N•m (34 lb-in)** .

Be sure there are no gaps between the inflator ends and the inflator brackets

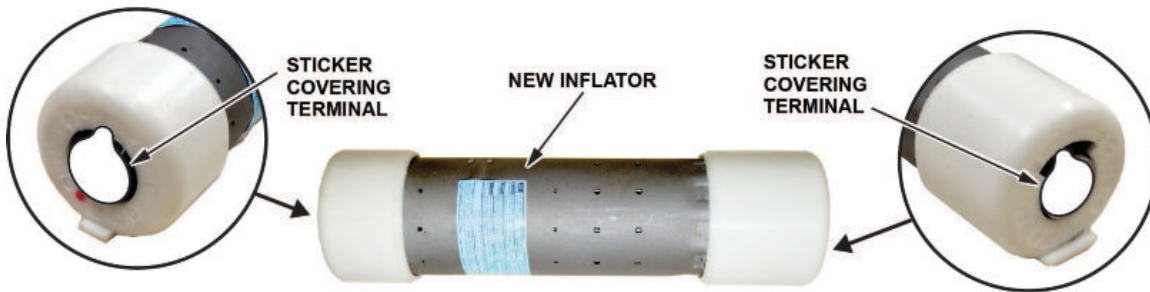
15. Remove the stickers covering the terminals on both sides of the new inflator.

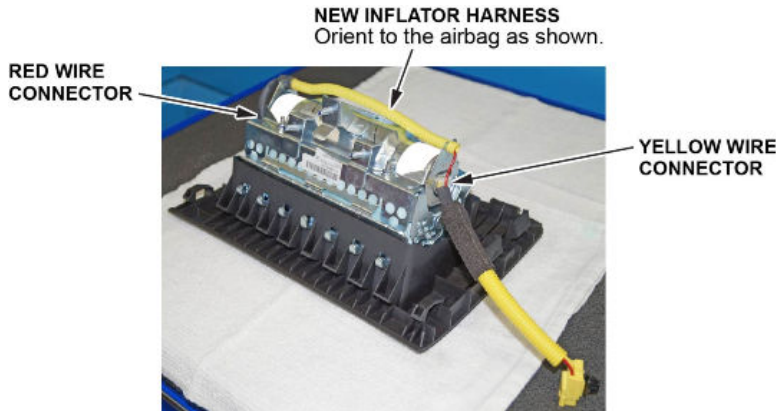
16.1. Make sure the airbag and harness are aligned as shown.

- **Make sure you have the orientation correct as shown below.** If you connect the harness incorrectly, the harness cannot be removed, and you will not be able to reinstall the airbag because the harness will be too short.
- On the replacement inflators with plastic collars, connect the red wire connector to the connector with the red dot.

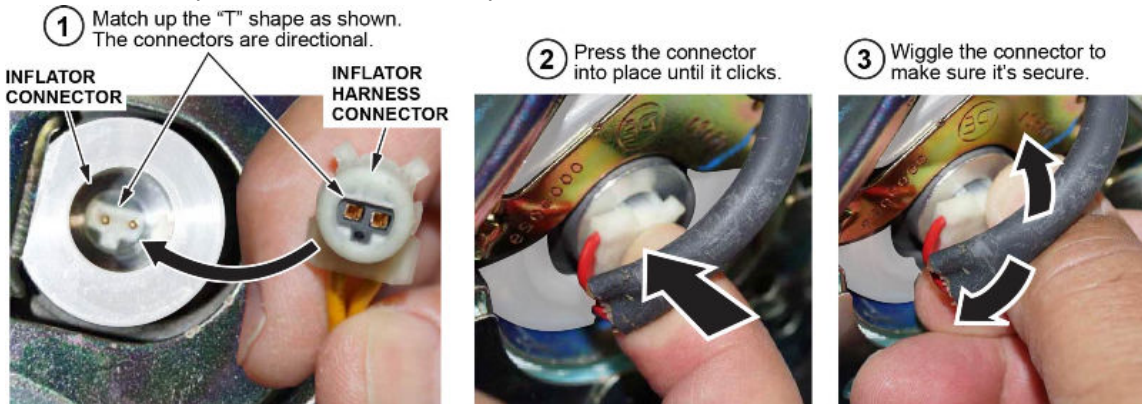
16.2. Connect the two connectors. Align the "T" shape in the inflator harness connector with the T-shaped inflator connector, then press the connector into place.

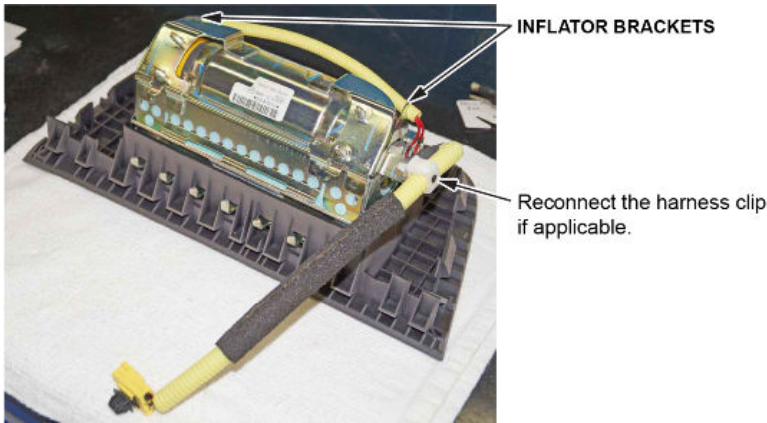
17.1. Insert the side without the shrink wrap tubing first. Insert the harness at the third “valley” in the corrugated tube.

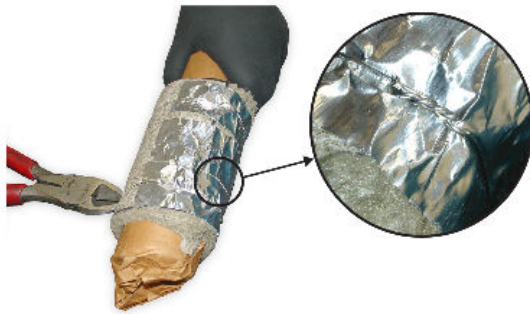
- Wear disposable gloves and protective glasses. The insulation is not toxic or dangerous, but some people may be sensitive to the insulation.
 - Dispose of the insulation and wrapping paper to avoid getting the insulation dust/fibers on you or the airbag assembly.
 - Do not reuse the insulation or wrapping paper. You do not need to wrap the inflator being removed from the vehicle when it is returned.
1. Cut the wires off from the opposite side from where they are tied (twisted) together.

Do not cut the insulation.

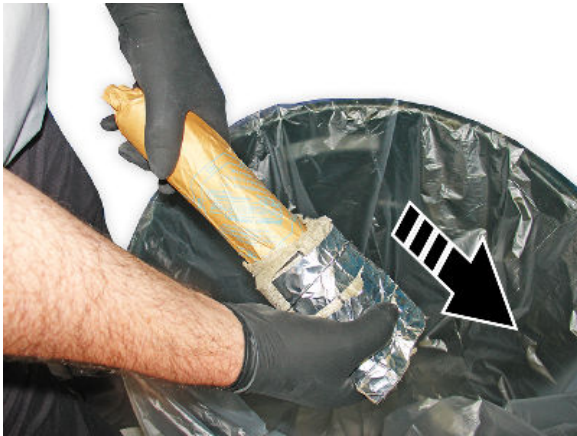
2. Hold the paper wrapping the inflator with one hand and slide the insulation off into the trash.

The insulation is securely wrapped around the inflator. You may have to use some force to slide the insulation off. Do not cut the insulation and be careful that you do not move the white or orange plastic ends.

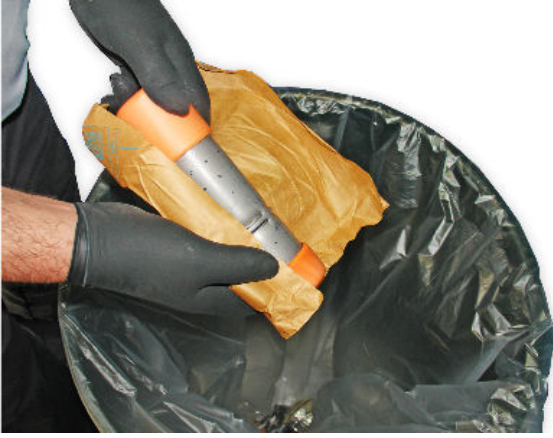
3. Remove the wrapping paper and drop it into the trash.

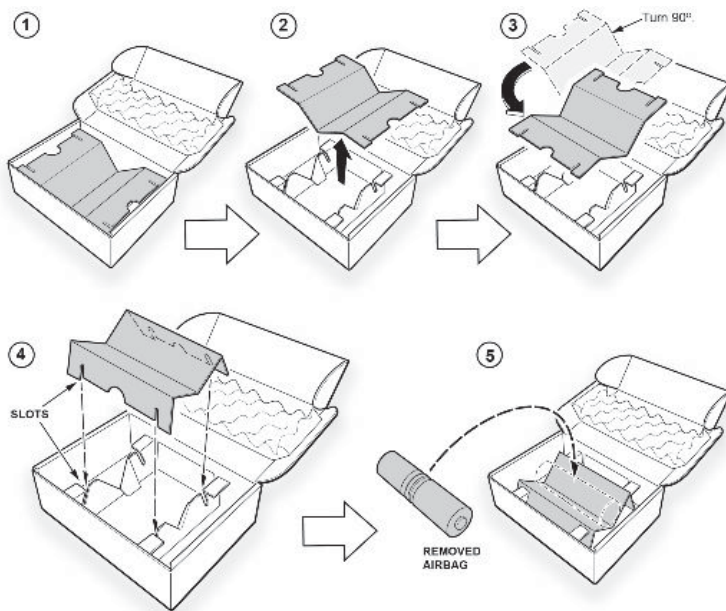
4. To return the original inflator, remove the cardboard insert and turn it 90 degrees. Then insert the cardboard into the slots as shown.

- **Do not reuse the shipping insulation.**
- The cardboard insert needs to be adjusted to send back the original inflator otherwise the original inflator removed from the vehicle will rattle around and may be rejected by the courier.
