Safety Recall

Code: 69P6

Subject	Takata Passenger Frontal Airbag Inflator (DIR2)													
Release Date	March 15, 2018													
Affected Vehicles	<p>U.S.A.: Certain 2005-2009 MY Audi Vehicles with Takata Passenger Frontal Airbag Inflator</p> <p>CANADA: Certain 2005-2011 MY Audi Vehicles with Takata Passenger Frontal Airbag Inflator</p> <p><i>Check Campaigns/Actions screen in Elsa on the day of repair to verify that a VIN qualifies for repair under this action. Elsa is the <u>only</u> valid campaign inquiry & verification source.</i></p> <ul style="list-style-type: none"> ✓ Campaign status must show "open." ✓ If Elsa shows other open action(s), inform your customer so that the work can also be completed at the same time the vehicle is in the workshop for this campaign. 													
Problem Description	The front passenger airbag may explode in a crash with airbag deployment. Sharp metal fragments can hit people and cause serious injury or death.													
Corrective Action	<p>Perform an interim repair to replace the passenger frontal airbag inflator with a newly manufactured version.</p> <p>The National Highway Traffic Safety Administration (NHTSA) has concluded, based o

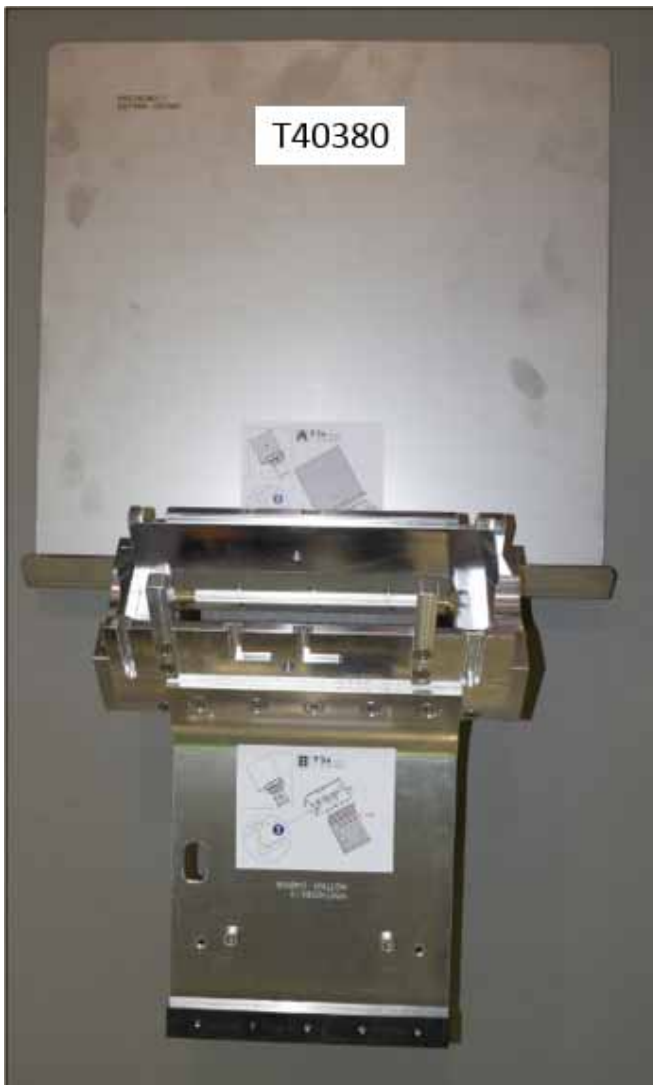
- Inflator Tool Kit:
 - Airbag Support – T40380
 - “Monclova” Alignment Tool – T40380/3
 - Bracket – T40380/4
 - “Freiberg” Alignment Tool – T40380/5
 - Support Bracket – T40380/6
 - Support Bracket – T40380/7
 - Removal Tool – T40380/8
 - Short and Long Knurled Bolts
 - Installation Tool

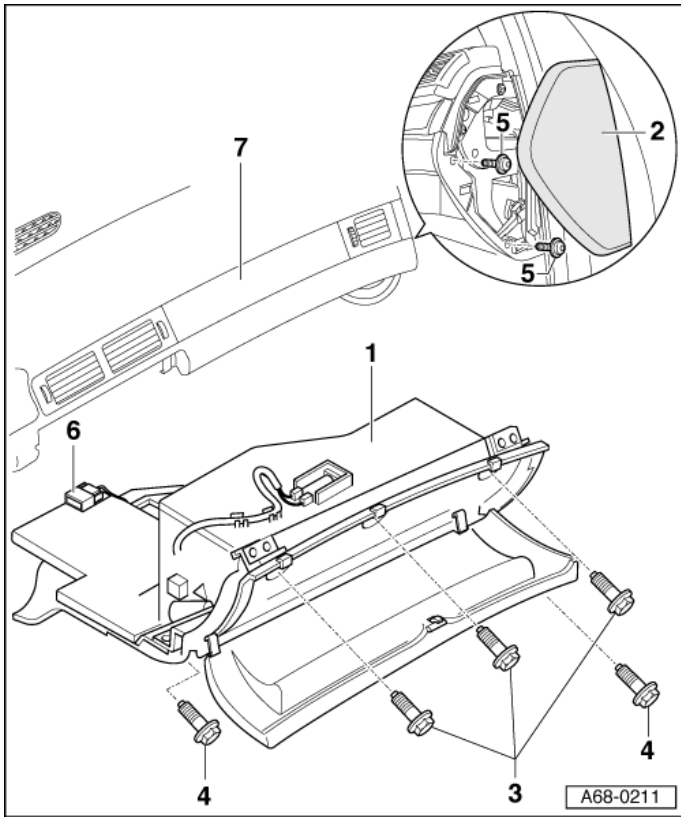
- Disconnect instrument panel cover <2>.
- Open glove compartment cover.
- Remove three bolts <3> at top in depressions of glove compartment <1>.
- Remove outside bolts <5>.
- Remove bolts <4>.
- Remove glove compartment downward.
- Remove connector <6> from glove compartment light.

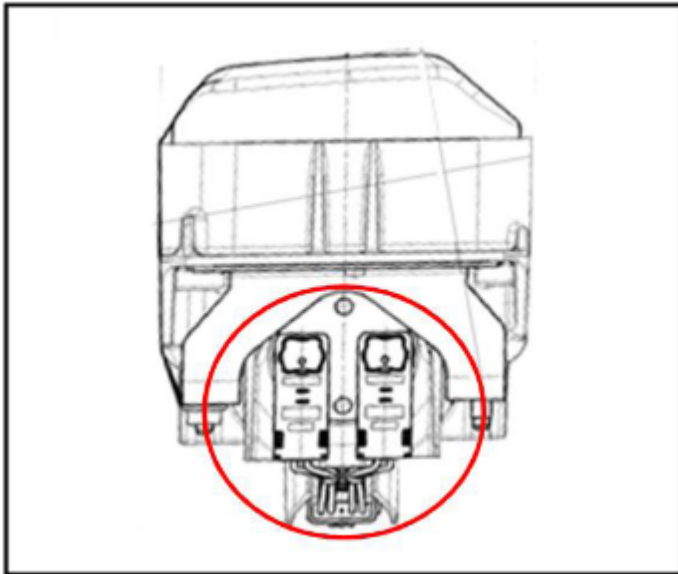
- If the passenger airbag inflator connectors are configured side by side <as shown>, the airbag was not manufactured by Takata and NO further work is required:
 - Reassemble glove box and **Continue to Section I.**

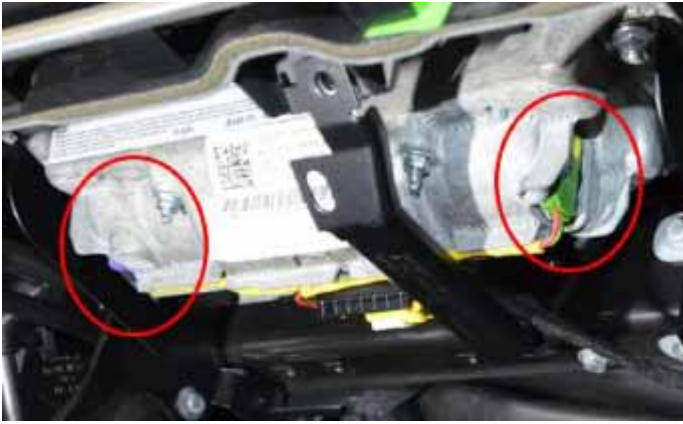
- If the passenger airbag inflator connectors are configured on the ends <as shown>, the airbag was manufactured by Takata and will require replacement.

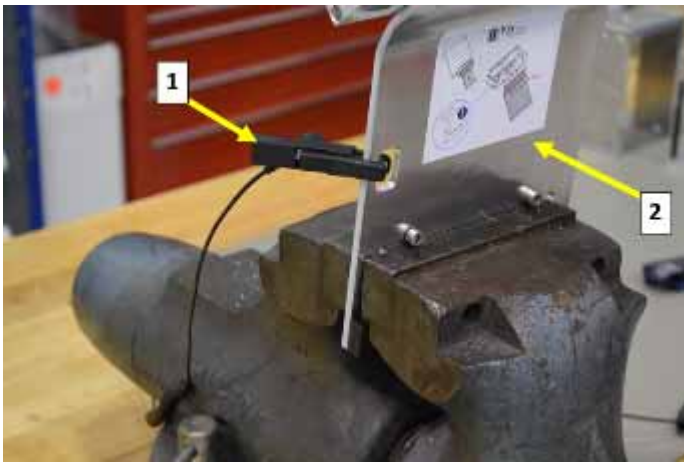
- Clamp Airbag Support -T40380- <2> into the vice.
- Connect crocodile clip <1> to airbag support <2> and ESD workplace -VAS 6613-.

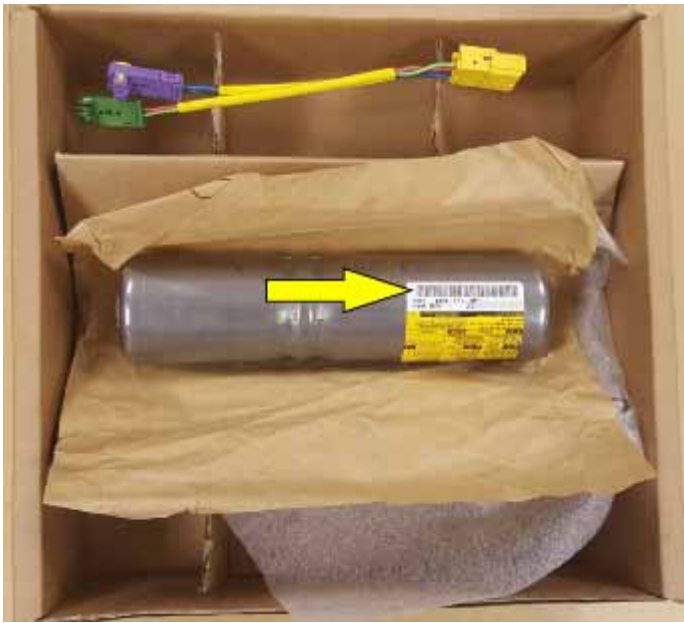
- Place the new inflator on the ESD mat.
- Scan the bar code of the new inflator <arrow> at a distance of about 15 cm, then follow the instructions on screen.

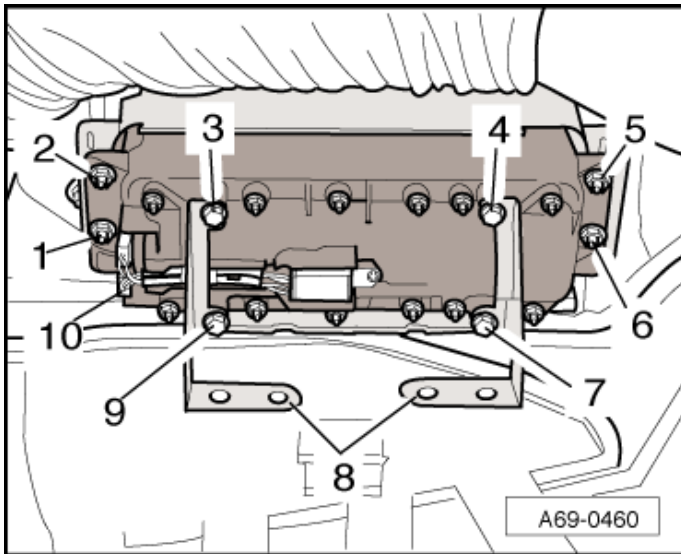
- Remove and discard bolts <3, 4, 7 and 9> and remove airbag unit bracket <8>.
- Remove and discard nuts <1, 2, 5 and 6>.
- Remove passenger airbag.

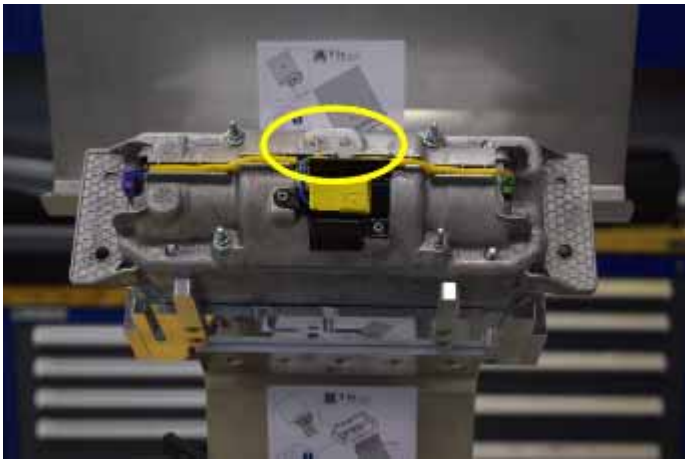
- Place the passenger airbag into support -T40380- with the date code <circle> on top as shown.

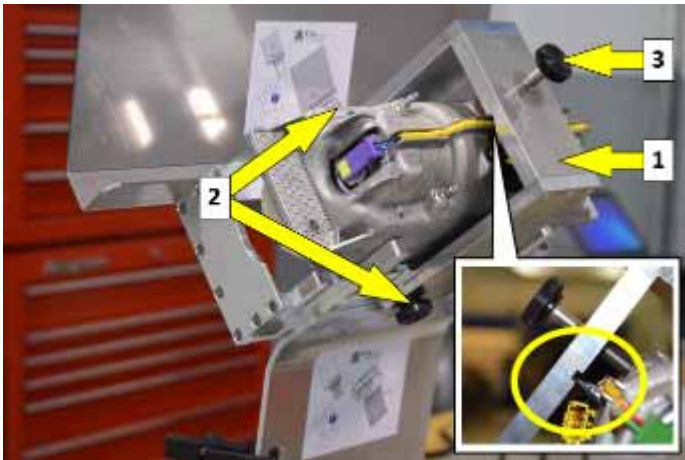
- Install Support Bracket -T40380/6- <1>:
 - Slide -T40380/6- down on Airbag Support -T40380- and then slide to the right.
 - Install short knurled bolts <2> hand tight.
 - Install long knurled bolt <3> until it touches the airbag case.

If long knurled bolt <3> is over tightened, the airbag case could crack and replacement of the passenger airbag will be required. Replacement of the passenger airbag due to a cracked case will not be covered under this action.

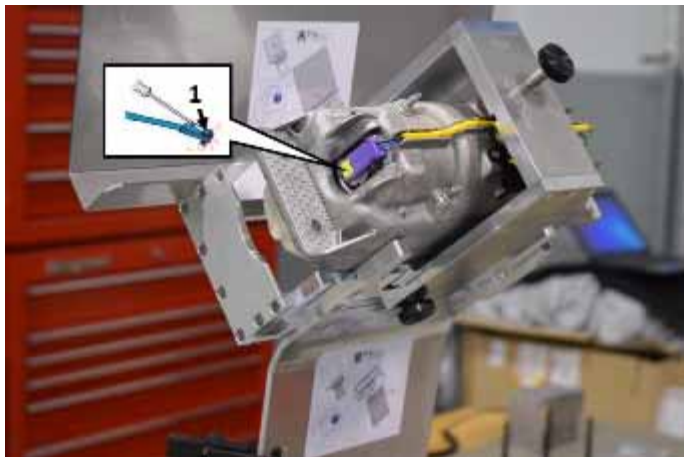
- Disconnect inflator connectors using a small flat bladed screwdriver to disengage connector lock <1>.

Left side is shown. Remove connectors on both sides of the inflator.

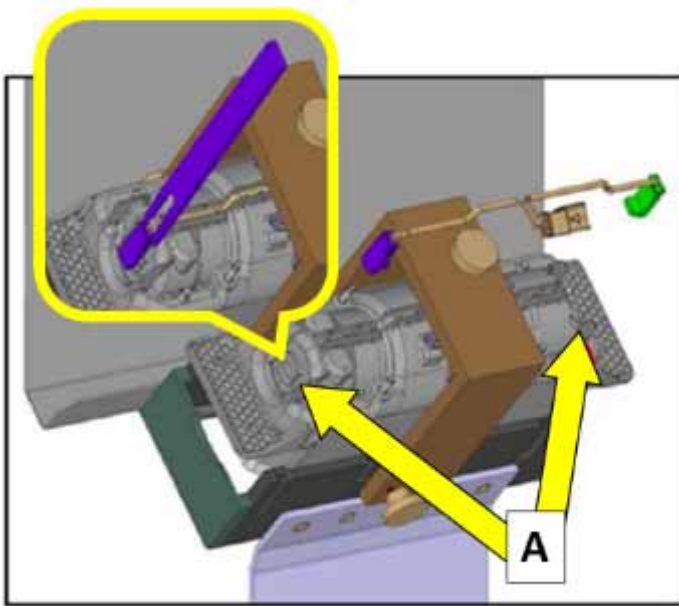
- Disconnect inflator connectors <A> by prying out with -T40380/9-.

Needle nose pliers may be required to aid in removal of the connector.

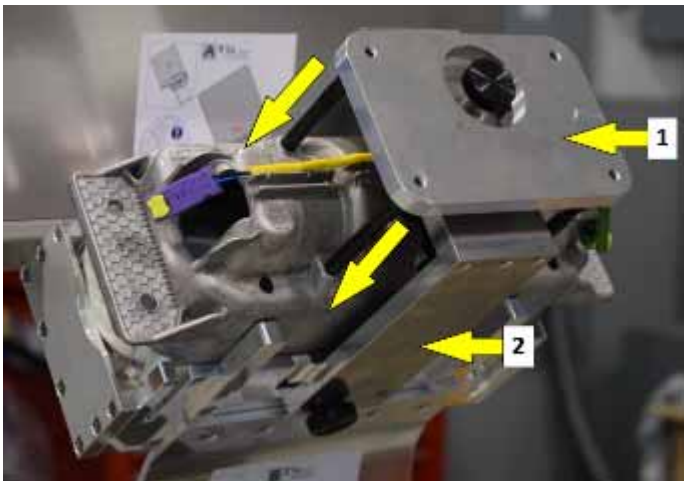
- Place -T40380/8- over the case studs.
- Using even pressure, press -T40380/8- down <arrows> so the case is seperated.
- Remove the -T40380/8- <1>.
- Remove the -T40380/6 <2>.
- Remove case cover and place on ESD mat.

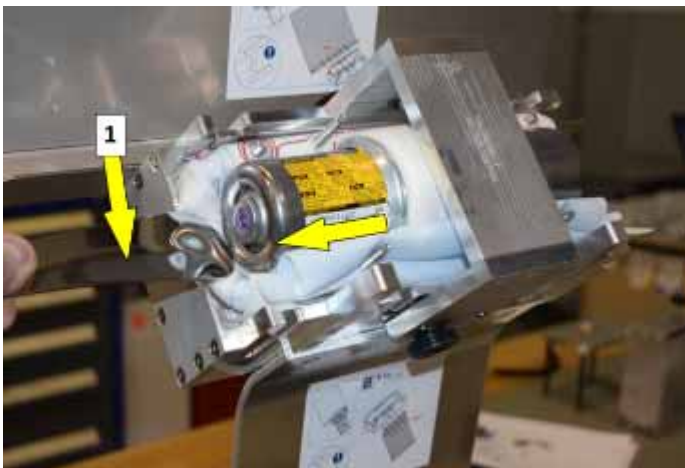
- If necessary, use tool <1> to press the airbag material down.
- Carefully remove the inflator in <direction of arrow> and place in the original packaging.

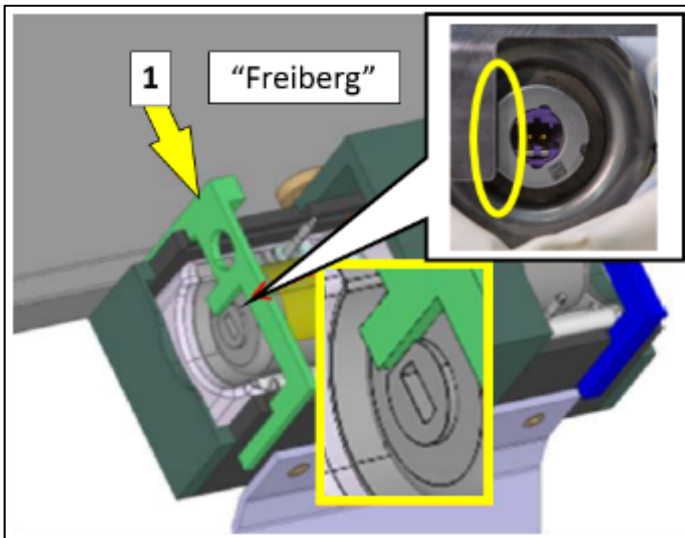
- Install -T40380/5- <1>.
- Ensure the edge of the inflator is parallel with the -T40380/5- as shown.

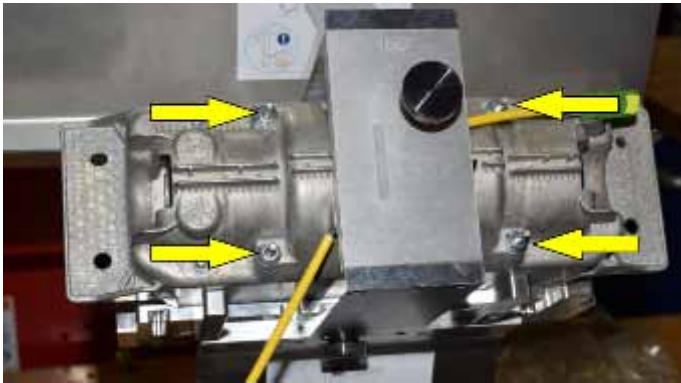
- Install nuts <arrows> and torque to 5.5 Nm in a cross pattern.

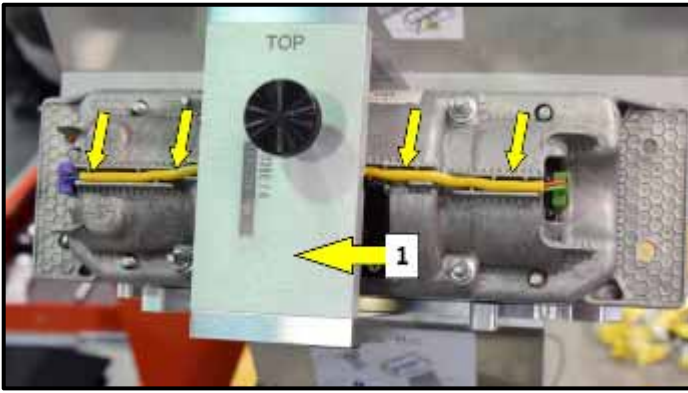
- Carefully press the connector harness into the channel on the airbag case <arrows>.
- Remove airbag support -T40380/6- <1>.

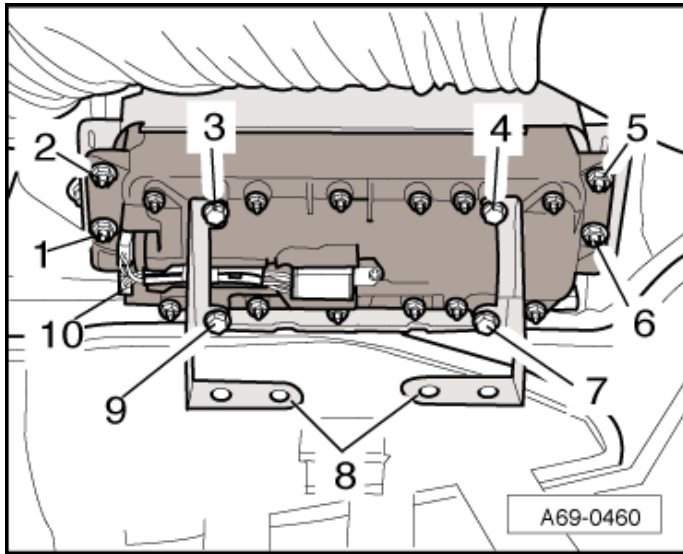
Part Number	Part Description
N 02300213	M6 Self Locking Nut <1, 2, 5 and 6>
N 10305302	M6 x 20 Bolt (airbag bracket to airbag) <3, 4, 7 and 9>
