Thor Motor Coach Recall Repair Instructions

Recall # **17V-038**

Description/Title: **2017 Aria 3901 Seatbelt Length**

Affected Product Line(s): **Certain 2017 Aria 3901 Motor Homes**

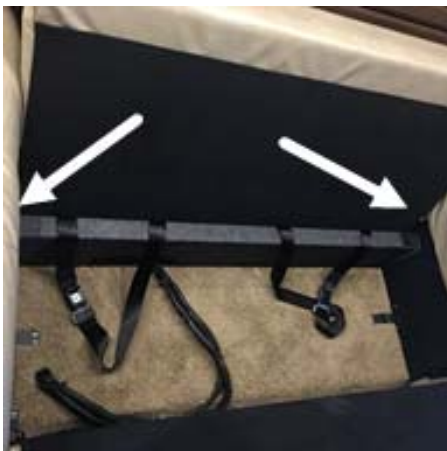
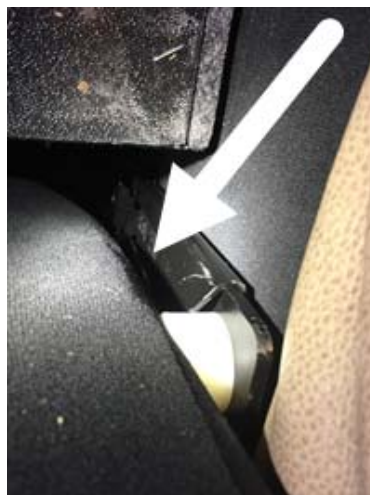
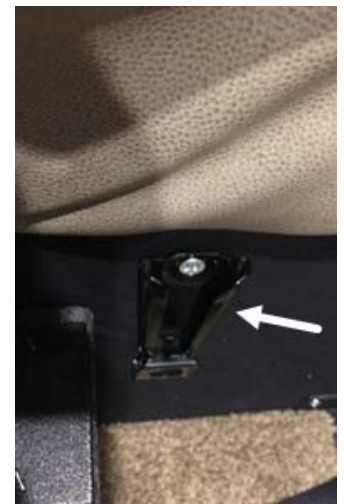
1. Deploy the slide out.
2. Deploy the TV behind the sofa.
3. Remove the sofa's seat cushions and put them in a safe place.
4. Remove the back of the sofa by releasing the latches on the sides of the sofa back where it meets the seat frame.

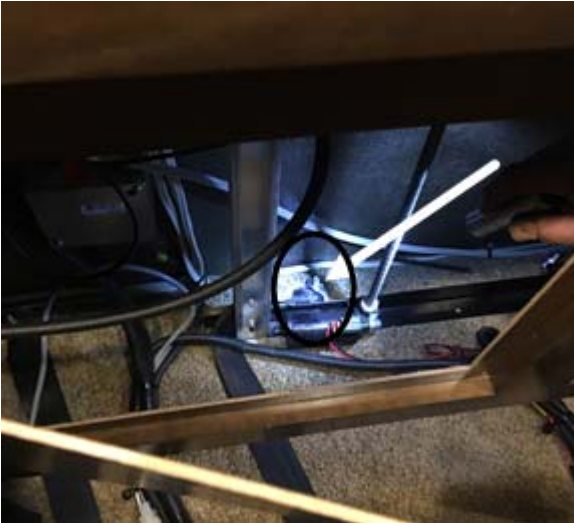
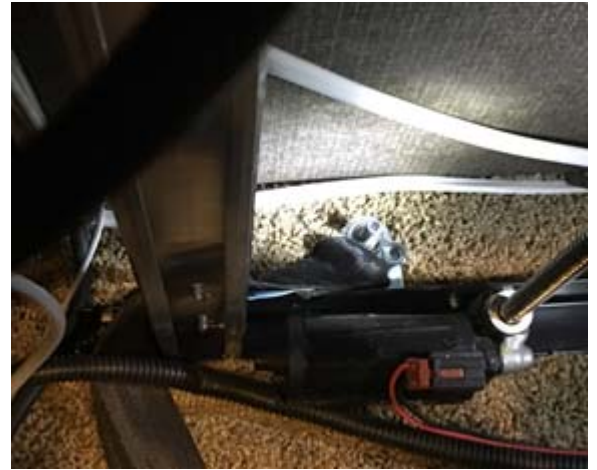
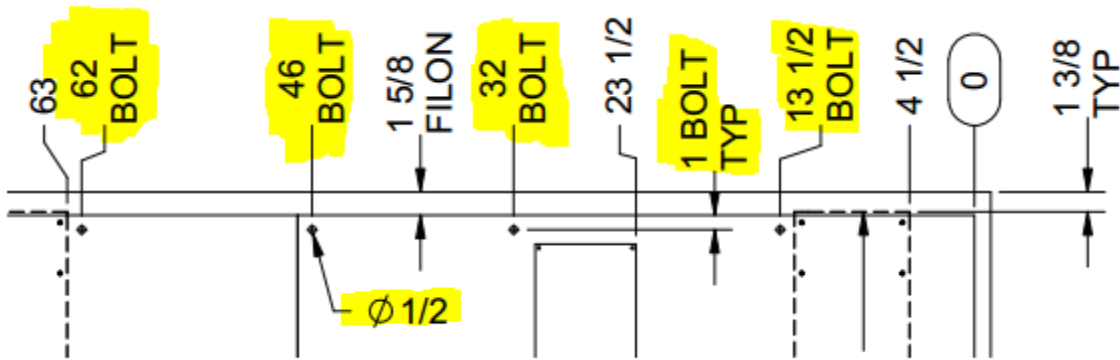
6. Locate the seat belt anchor bolts. Measure the location of the bolts and make sure it matches the diagram below. If it does not, you will need to add bolts in the correct location. Leave the existing bolts in place.

5. Loosen the panels below the TV ensuring that they are not damaged in the process.

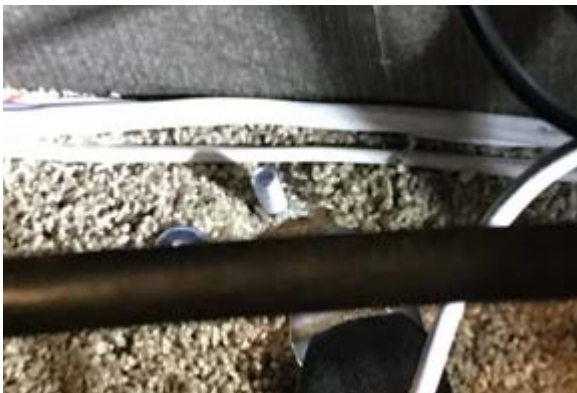
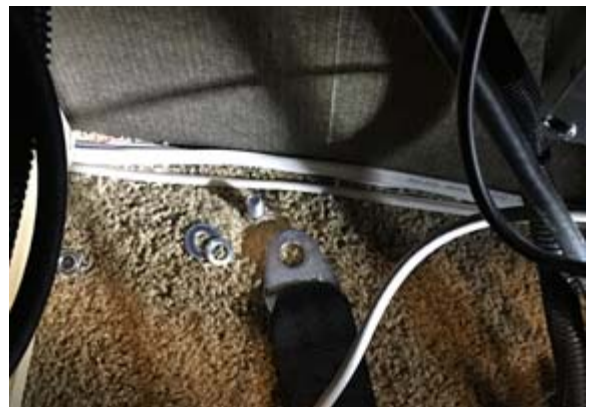
7. Remove the existing seat belt from the anchor bolt. Retain the washers and nuts for later use. Repeat for the other 3 anchor bolts.

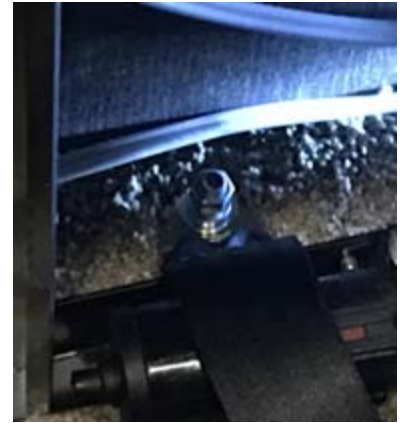
8. Place the new seatbelts so that they do not interfere with the TV lift assembly.

9. Install the new seatbelts by putting the tongue of the belt assembly on the bolt first, then the flat washer, then the split lock washer, and finally securing everything with the nut. Repeat for the other 3 anchor bolts.

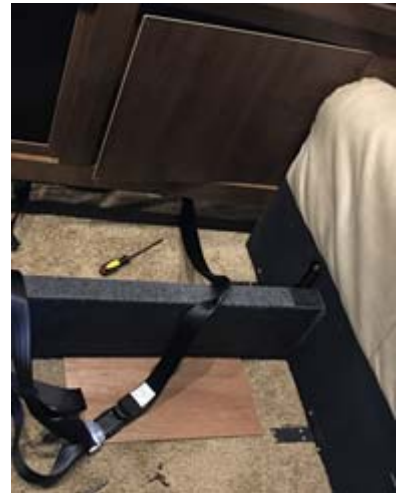
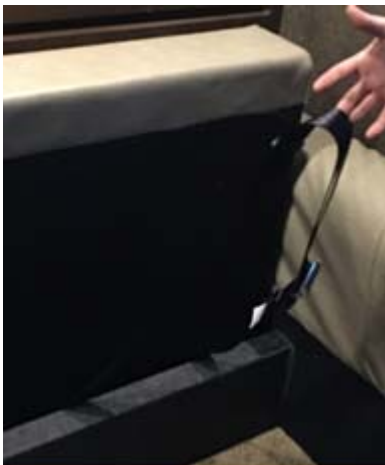
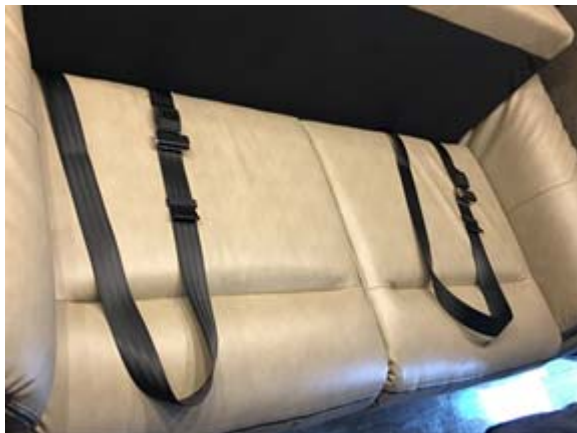
13. Hold or drape the seatbelts up off the floor and reinstall the sofa seat. The seatbelts should be laying on the seat once this step is complete.

10. Drape the newly installed seatbelts over the carpeted cross bar.

11. Re-secure the panels that were loosened for access.

12. Reinstall the sofa back.

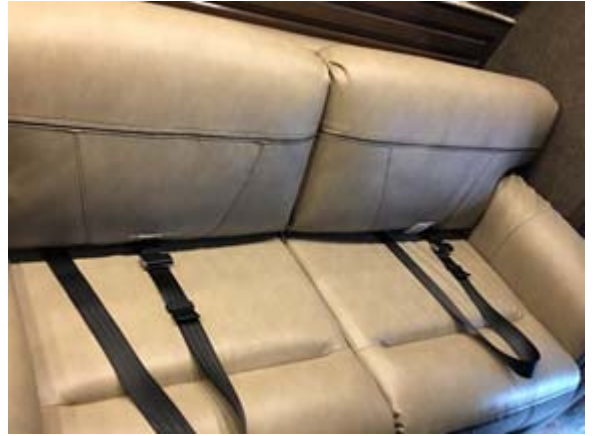
14. Reinstall the sofa back cushions.
