# Rear Impact Guard Inspection

**Issue Overview:** This inspection covers specific model years of 2015 and 2016 for the Walker TTT with a 54" tandem setting. There is a potential for cracks to develop in the rear impact guards (Fig 1-3). Specific locations of the welded brackets require inspection until units can be repaired.

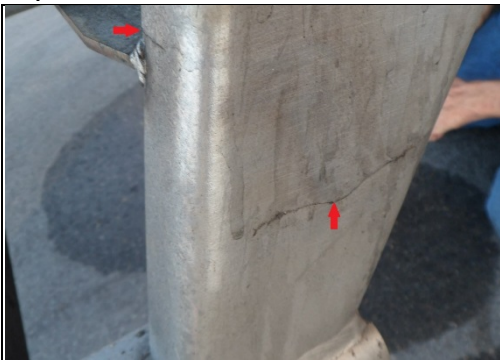
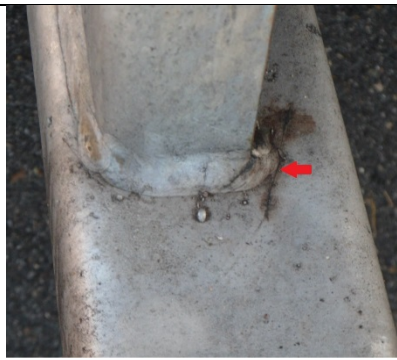
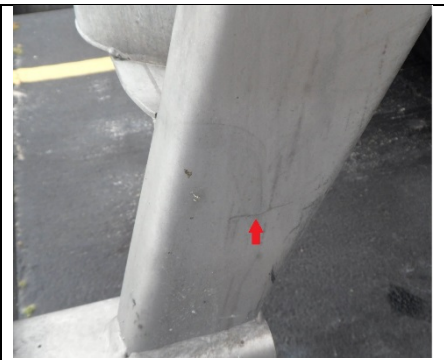
Cracks in rear impact guard

**Next Steps:** A bumper modification bulletin is available and the Warranty group is working on a list of service providers who can perform it. For any questions, please contact the Warranty group at 608-562-7813.

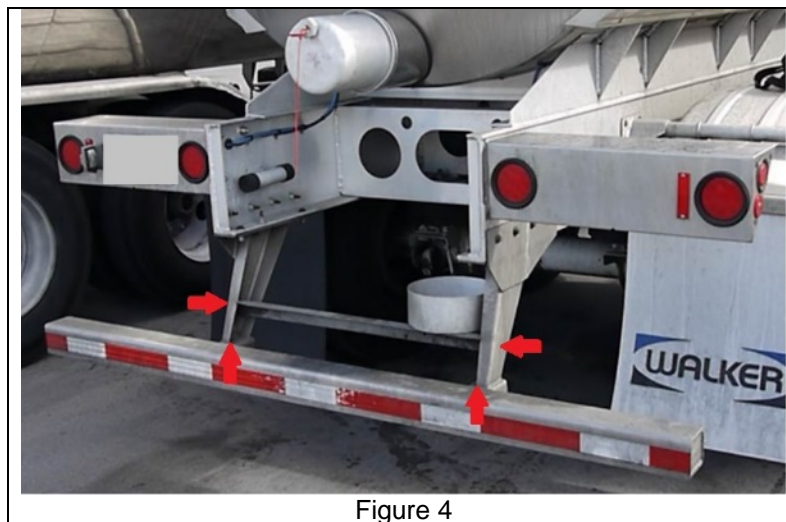
Figure 4

Arrows indicate areas of inspection

**Inspection:** Inspect the welded bracket(s) for cracks (Fig 4). Rear impact guards with cracks need addressed ASAP.
