## Furrion cook top LP line

On certain Toy Hauler fifth wheel trailers manufactured with a Furrion cook top. The LP hose might be pushing against the oven causing stress on the LP hose connector at the cook top. This could result in a gas leak and could causing unsafe operation, which could lead to an increased risk of injury and/or damage to property.

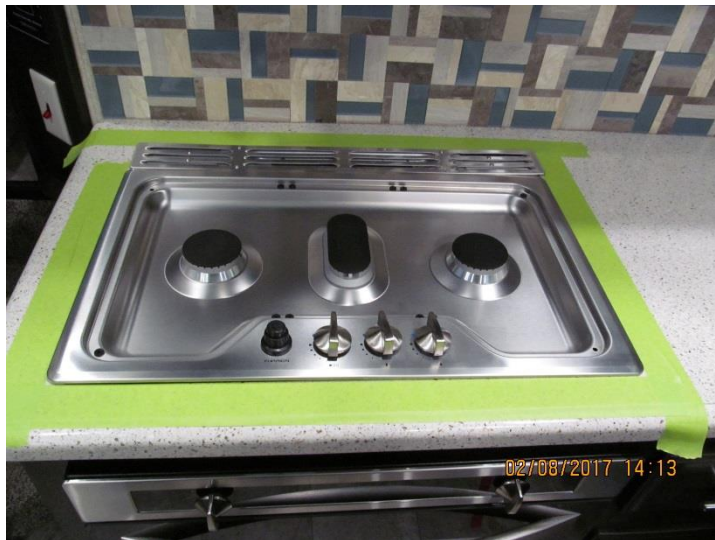
1. Turn off LP Gas at Both tanks.
2. Remove grates and set aside.

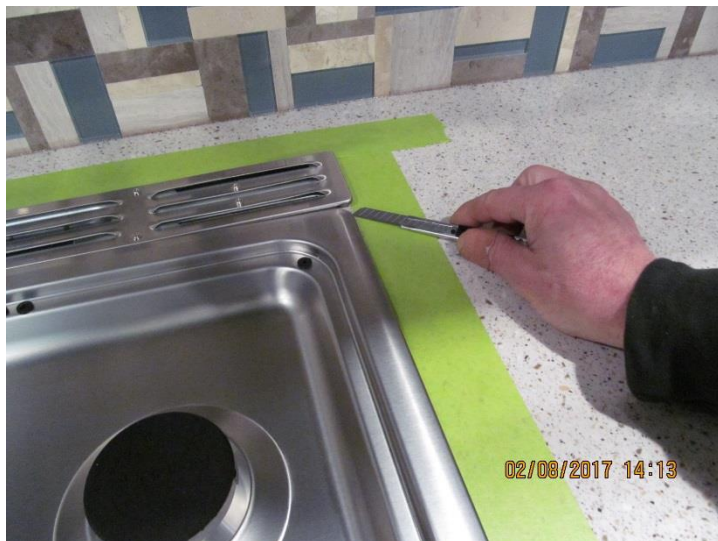
3. Lay masking tape along the edge to prevent damage to the counter top.

- Using a utility knife run the knife along the 3 edges to cut loose the butyl tape.

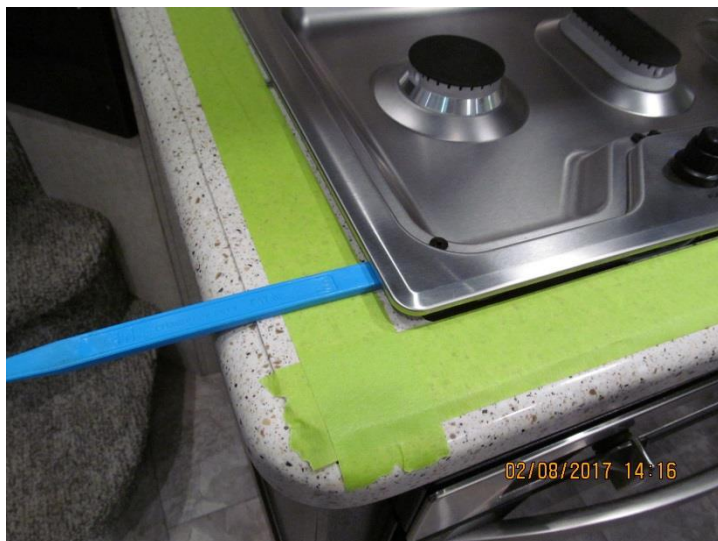
- Softly pry up the edges of the cook top and lift off counter.

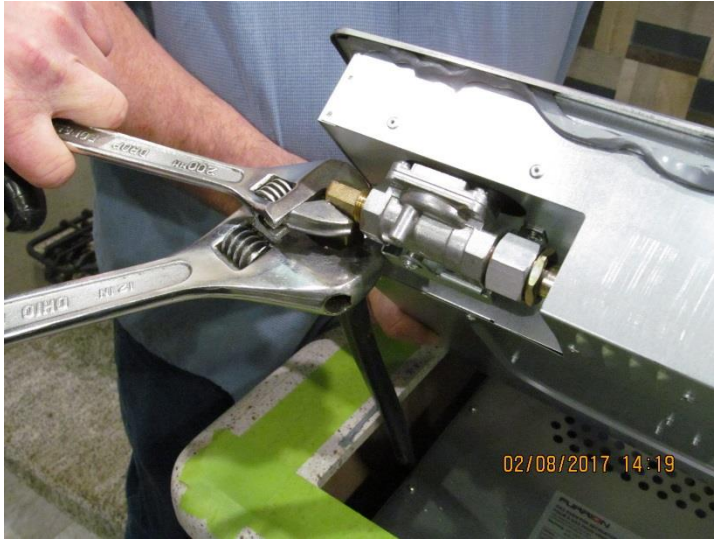
6. Remove the LP hose, be sure to use a back-up wrench to hold valve to prevent damage.

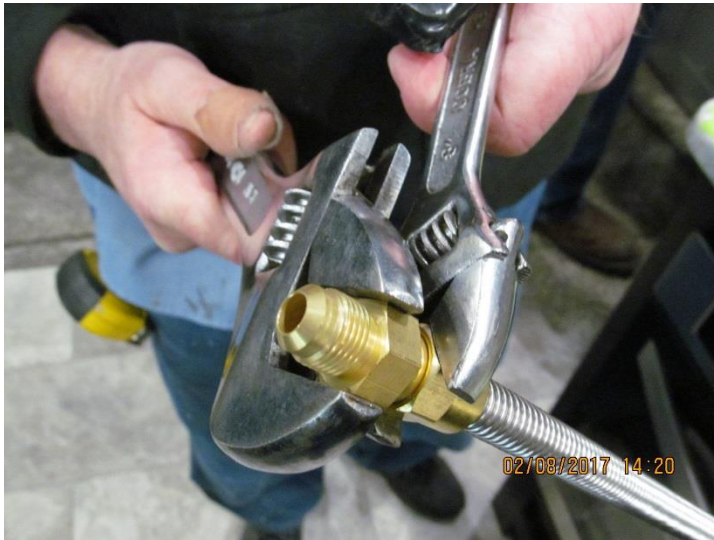
7. Tighten the fitting on the end of the flexible gas connector.

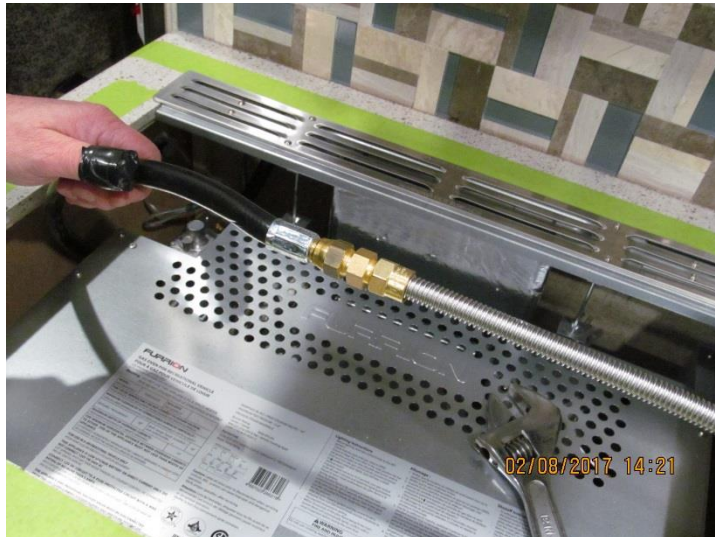
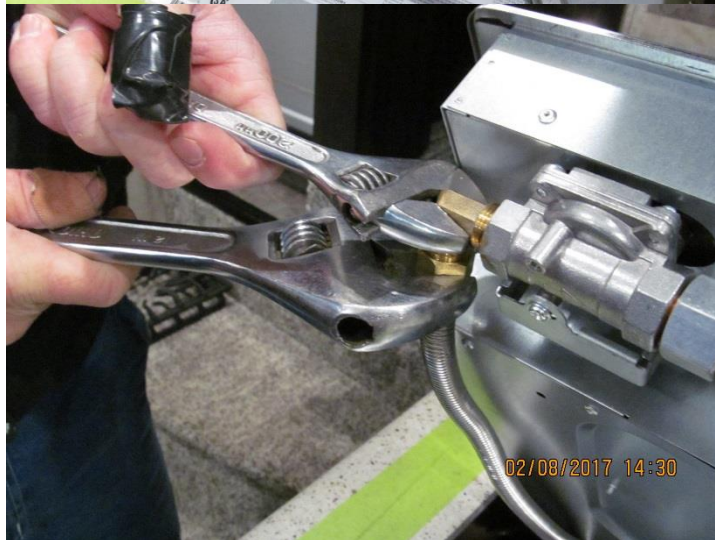
8. Install one end of the flexible gas connector to the LP hose and the other to the cook top. Be sure to hold the valve with a back-up wrench to prevent damage.

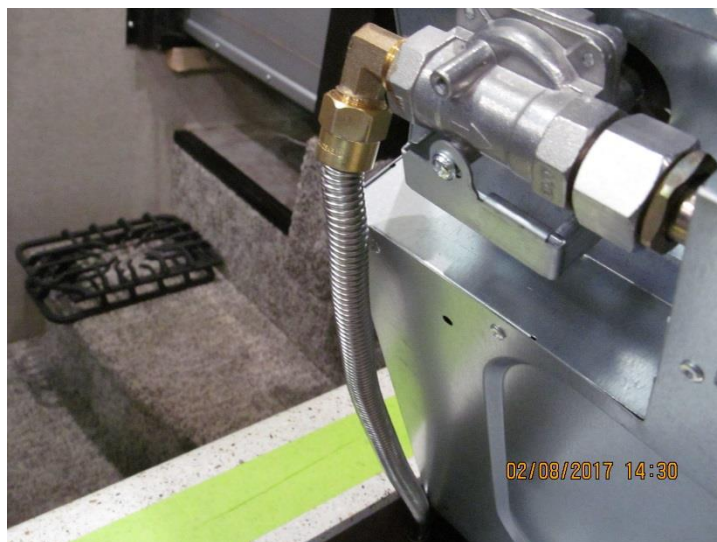
9. Bend or flex the flexible gas connector so that it is against the bottom of the cook top.

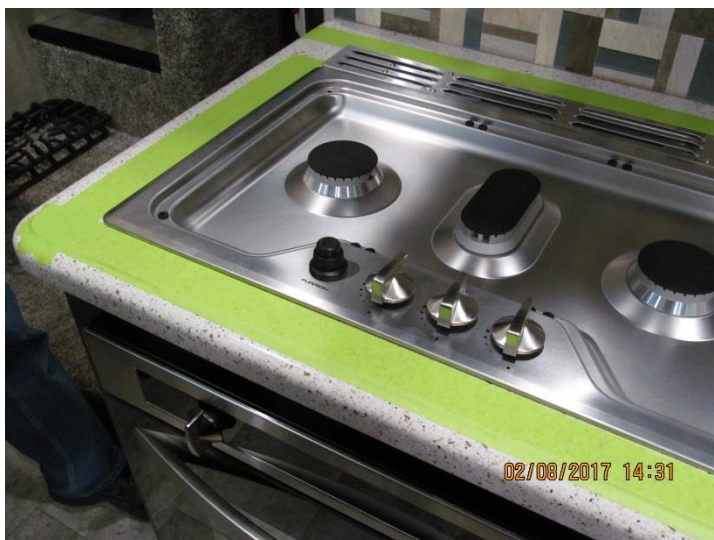
10. Perform gas drop pressure test, before securing cook top to counter.  
Time for test included with repair
11. Install butyl tape and secure cook top to counter top, and remove masking tape.
