INSTRUCTIONS TO PERFORM RECALL CAMPAIGN 144

- Certain 2016 and 2017 model year Winnebago Travato[®], Models 259G and 259K, motorhomes.

These motorhomes were manufactured from April 17, 2015 through January 24, 2017.

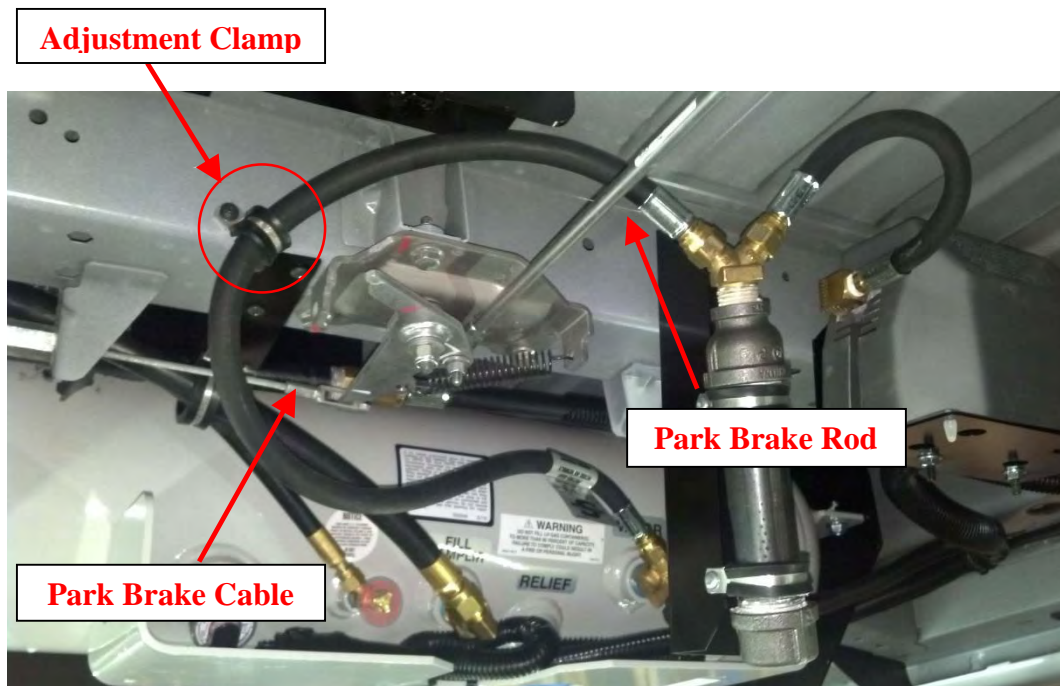
- Ensure there is adequate clearance between the park brake rod and park brake cable.

NOTE: *The vehicle will need to be elevated to visually inspect the LP hose.*

1. Visually inspect the LP hose for clearance. If adjustment is needed, loosen the adjustment clamp and move LP hose to ensure the hose is not coming in contact with the park brake rod and park brake cable. The hose should not touch anything other than the rubberized clamp.
2. Replace the LP hose if any damage is noticed. Contact Part Sales at 1-800-556-9670 to order a replacement LP hose.
