# Safety Recall

## Code: 01B9

| <b>Subject</b> | <b>Tire Information Label</b> |
| <b>Affected Vehicles</b> | <b>U.S.A. &amp; CANADA: Certain 2017 MY Volkswagen Beetle &amp; Jetta GLI</b><br><i>Check Campaigns/Actions screen in Elsa on the day of repair to verify that a VIN qualifies for repair under this action. Elsa is the <u>only</u> valid campaign inquiry &amp; verification source.</i> <ul style="list-style-type: none"><li>✓ Campaign status must show "open."</li><li>✓ If Elsa shows other open action(s), inform your customer so that the work can also be completed at the same time the vehicle is in the workshop for this campaign.</li></ul> |

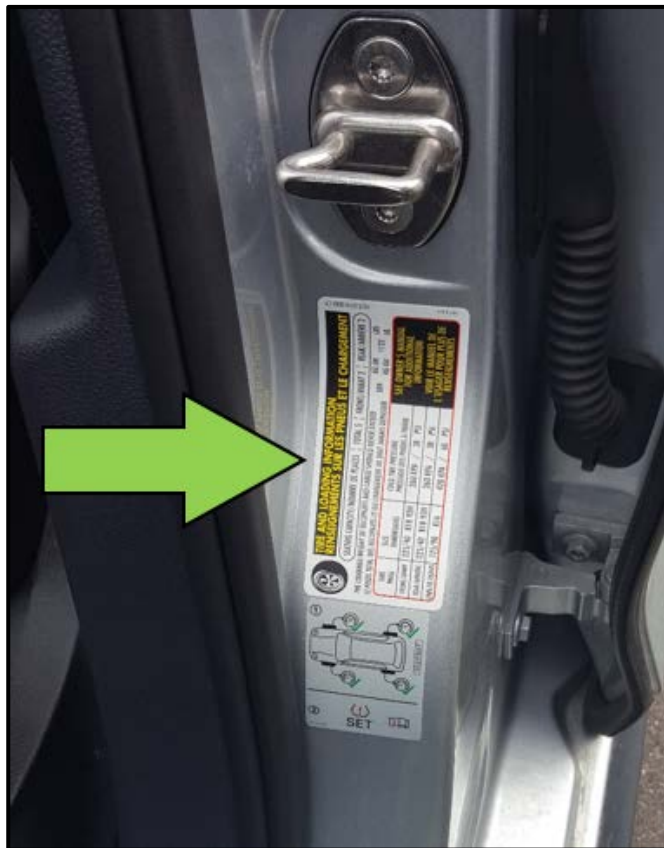
- Open the driver front door.
- Locate the “Tire and Loading Information” label on the B-pillar.
- Clean the surface of the existing label.
- Peel the replacement label off the backing paper.
- Affix the replacement label <arrow> over the existing label.

- Ensure minimal air bubbles are created when installing the new label.

- The surface of the existing label must be clean, dry, and free from oil residue prior to applying the replacement label.
- The replacement label **MUST** cover the existing label completely.
- Handle the replacement label carefully. Do not touch the adhesive backing.
