Safety Recall

Code: 6908

Subject	Autoliv Rear Seat Safety Belt Pretensioners
Release Date	June 23, 2017
Affected Vehicles	U.S.A. & CANADA: 2017 MY Audi A5 Cabriolet/S5 Cabriolet <i>Check Campaigns/Actions screen in Elsa on the day of repair to verify that a VIN qualifies for repair under this action. Elsa is the <u>only</u> valid campaign inquiry & verification source.</i> <ul style="list-style-type: none">✓ Campaign status must show "open."✓ If Elsa shows other open action(s), inform your customer so that the work can also be completed at the same time the vehicle is in the workshop for this campaign.
Problem Description	Affected vehicles have safety belt pretensioners manufactured by Autoliv. Due to a manufacturing defect, the micro-gas generator within the pretensioner could detach during a crash with high load/safety belt pretensioner deployment. If this happens, the micro-gas generator could enter the passenger compartment, possibly striking and injuring vehicle occupants (even though the safety belts will perform as designed).

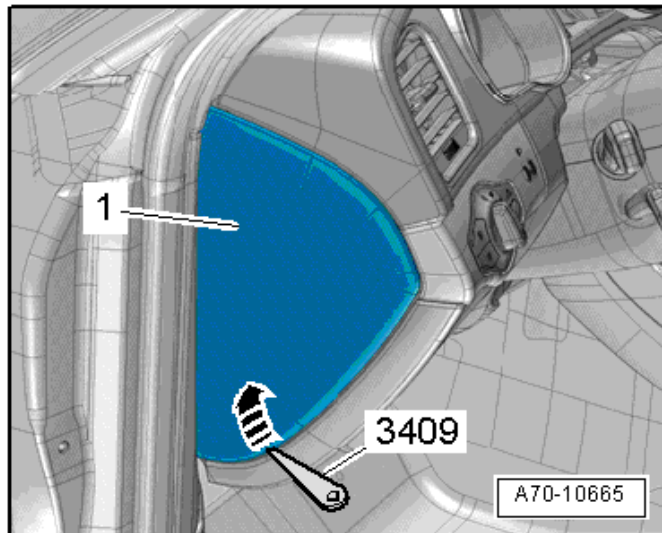
- Open the convertible top.
- Pry off the instrument panel side cover <1> using the Trim Removal Wedge -3409-.

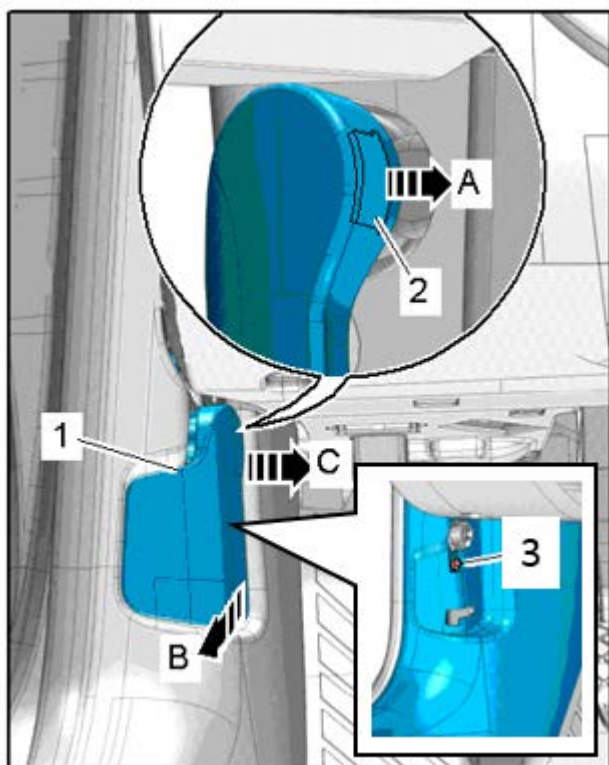
- Remove the hood release lever by pulling the securing clip <2> out of the operating lever <1> slightly in direction of <arrow A> using a small screwdriver.
- Pull the operating lever back <arrow B> to release the hood and hold it in this position.
- At the same time, pull the operating lever level with the center of the vehicle and out of the mount <arrow C>.
- Remove lower A-pillar trim bolt <3>.

Driver side is shown. For vehicles with Criteria HR,01, only the passenger side lower A-pillar trim will need to be removed and removal of the hood release lever is not necessary.

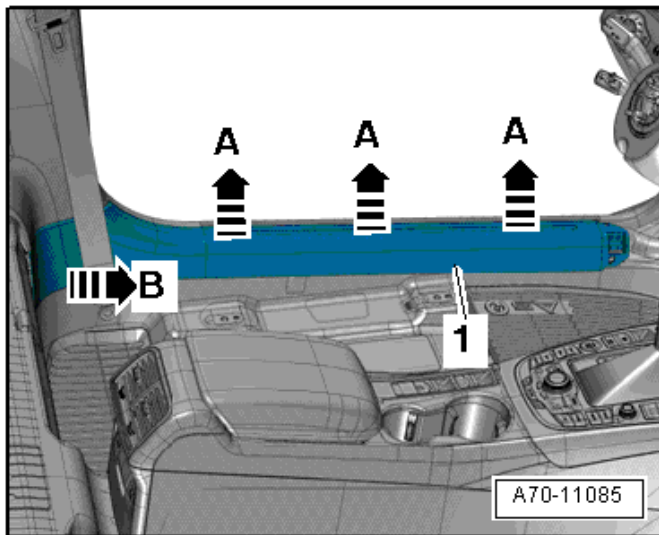
- Unclip lower A-pillar trim panel from the sill <1> using the -3409-.
- Pull the lower A-pillar trim back and remove it from the upper A-pillar trim.
- Adjust the front seat and seatback all the way forward.
- Unclip sill panel strip <1> from the sill starting at the front using the -3409- <arrows A>.
- Remove the sill panel strip from the side trim by sliding in direction of <arrow B>.

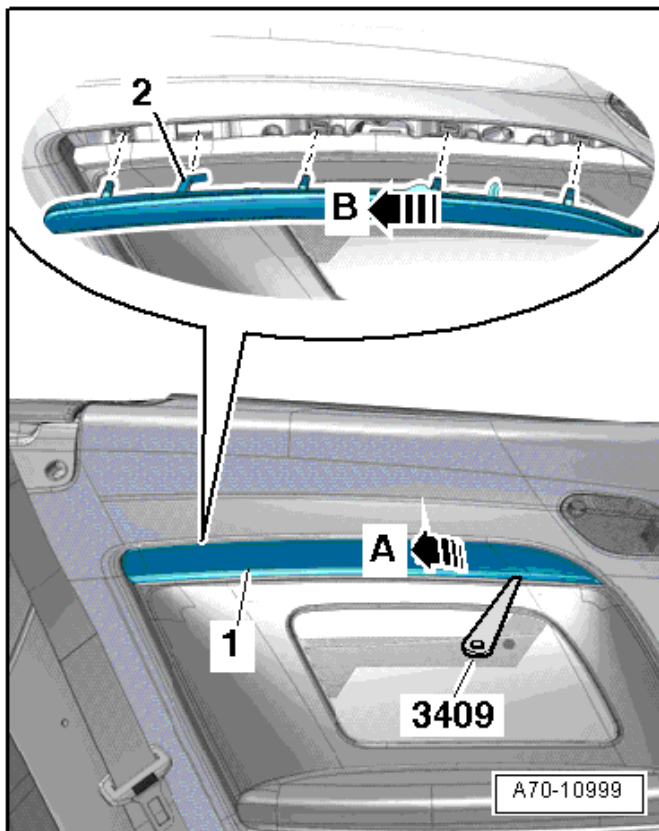
- Unclip the trim strip <1> starting at the front using a clean -3409- <arrow A> and remove toward the rear <arrow B>.

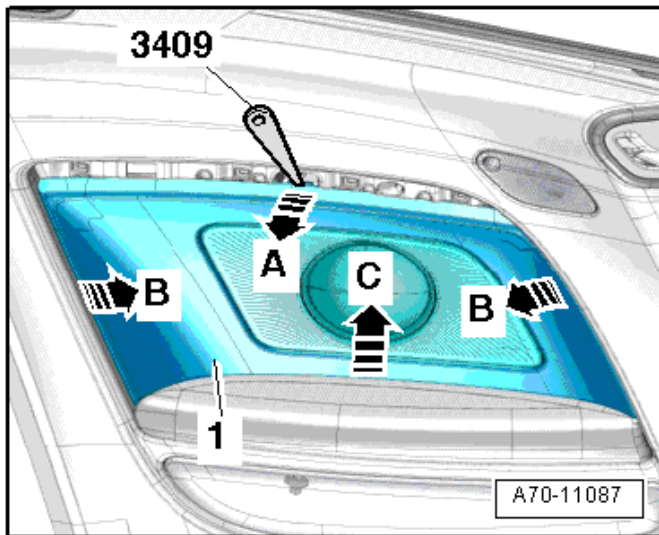
- Starting at the top, carefully unclip the side trim panel insert <1> using a clean -3409- in direction of <arrows A and B>.
- Remove the side panel insert in the direction of <arrow C>.

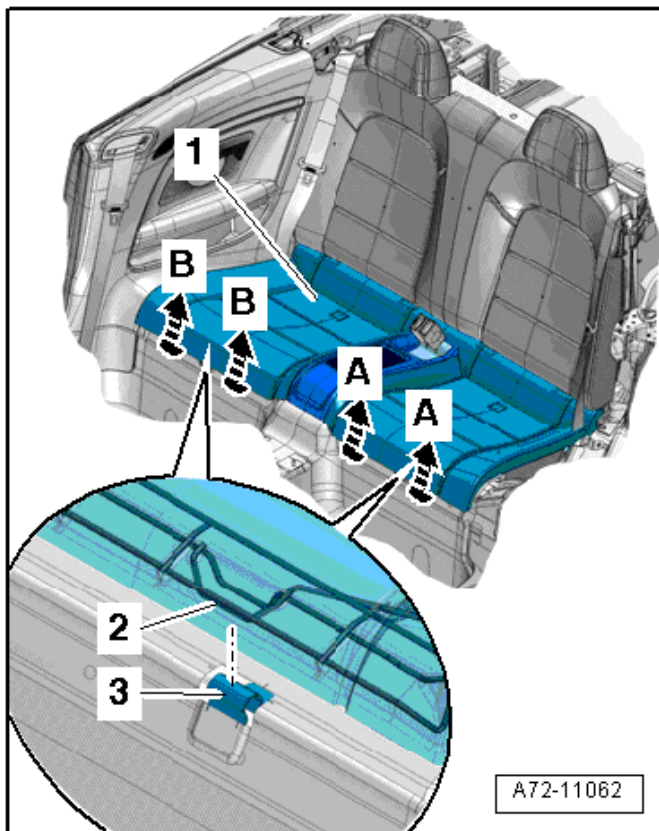
- Reach under the seat frame with both hands on one side of the seat.
- Pull the bench seat <1> up with both hands in direction of <arrows A> so the seat frame <2> on the bench seat disengages from the mountings <3>.
- Repeat the procedure on the other side of the bench seat in direction of <arrows B>.
- Vehicles with seat heating: disconnect the seat heating connector.
- Remove the bench seat from vehicle.

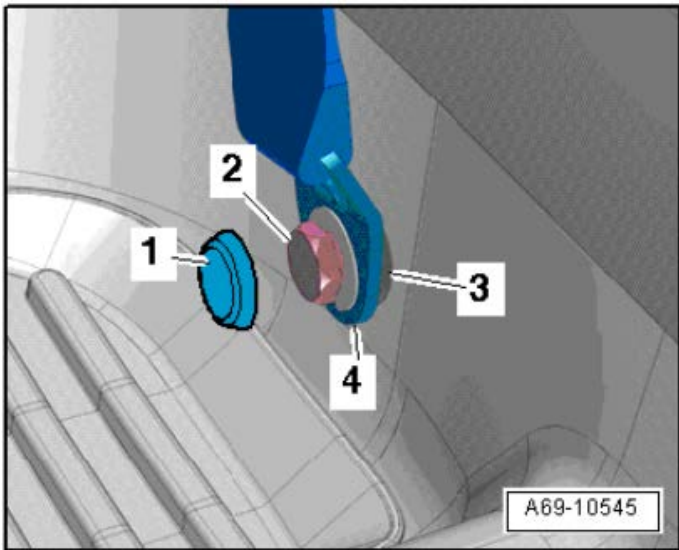
- Remove the front seat belt anchor bolt <2> after removing cap <1>.

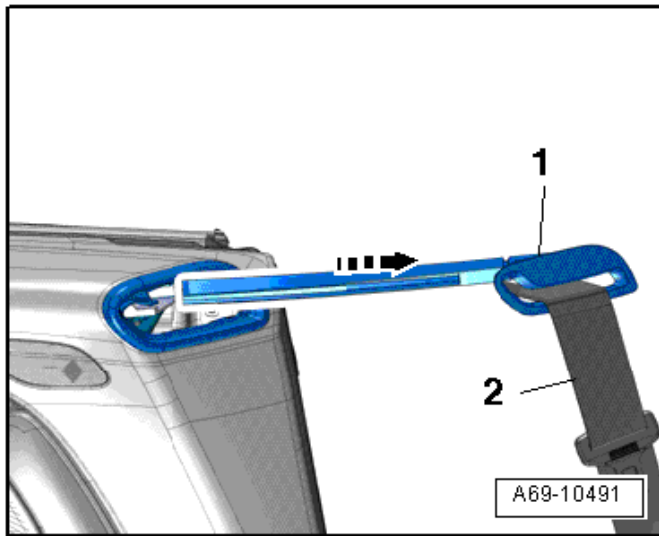
- Pull the seat belt positioning arm <1> out of the seat belt positioning motor in direction of <arrow>.
- Thread the seat belt webbing <2> with the seat belt tongue out of the seat belt positioning arm <1> and remove the positioning arm from the vehicle.

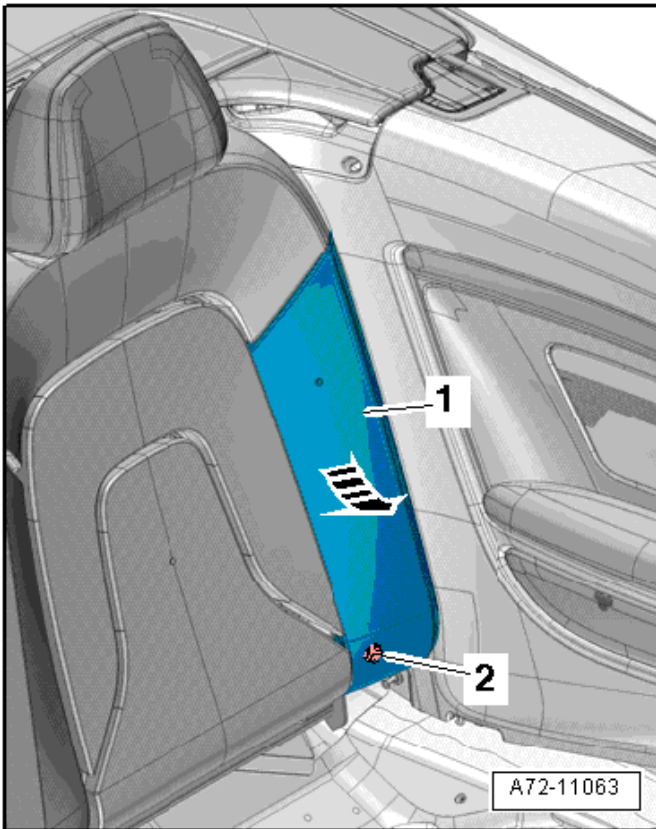
- Remove the nut <2>.
- Pull the bottom of the side upholstery <1> off the stud.
- Pull the side upholstery downward <arrow> and remove it from the vehicle.

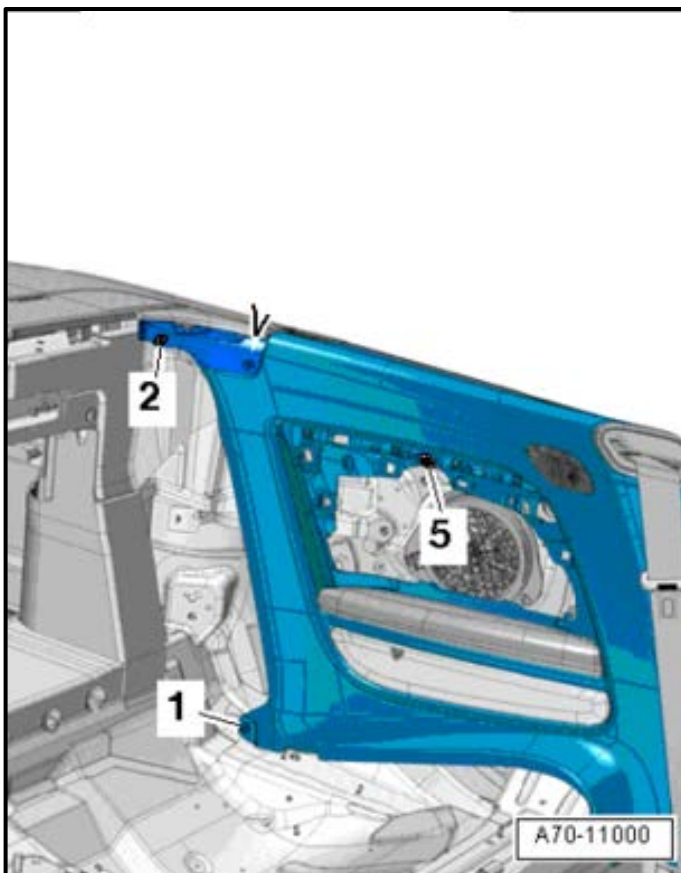
- Remove expanding clip <1> using the -80-200-.
- Open the trunk.
- Unlock the rear seat backrest and fold it forward.
- Remove bolts <2 and 5>.

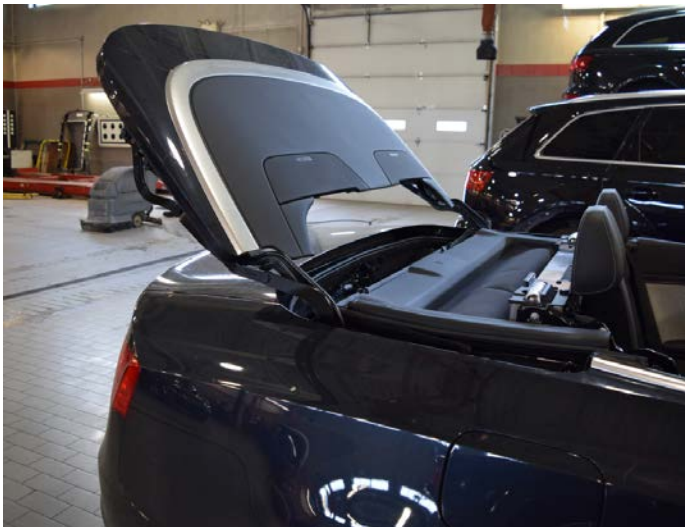
- Close the trunk, move the convertible top to the position shown and turn off the ignition.

- After approximately 6 minutes the convertible top control module will bleed the hydraulic pressure and the convertible top compartment cover could fall down uncontrolled.
- The convertible top compartment cover must be in the position shown so the weight of the cover does not allow it to close on its own once the hydraulic pressure has been bled.

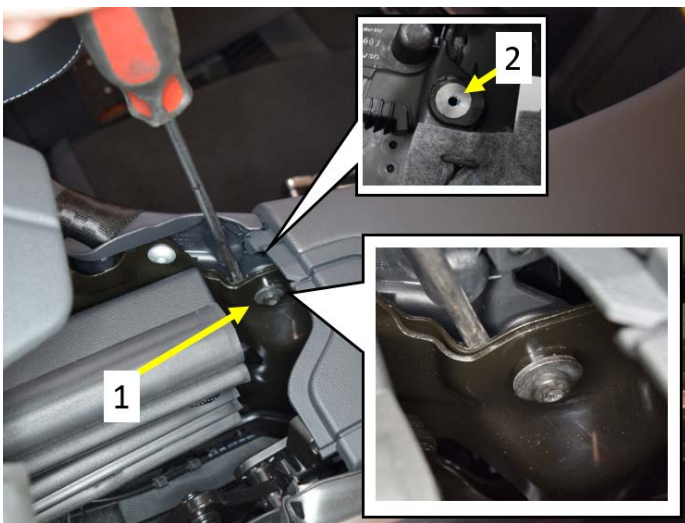
- Remove bolt <1>.

- Passenger side is shown.
- When removing bolt <1>, a flat bladed screwdriver will need to be inserted between the body and the trim panel as illustrated. Slight pressure will need to be applied between the body and the trim panel to keep the metal thread insert <2> from spinning in the trim panel.

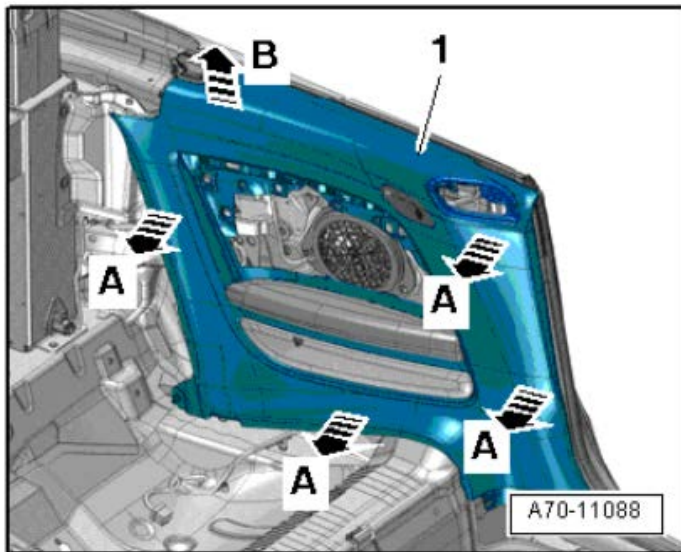
- Starting on the side and bottom unclip the side trim panel <1> in direction of <arrows A>.
- Tilt the side trim panel toward the center of the vehicle and remove in direction of <arrow B>.
- Vehicles with treble speaker: Disconnect the connector
- Remove the rear seat belt webbing from the belt guide.
- Guide the front seat belt webbing with the seat belt tongue through the side trim panel and remove the side trim panel.
- Switch the ignition on and re-open the convertible top.

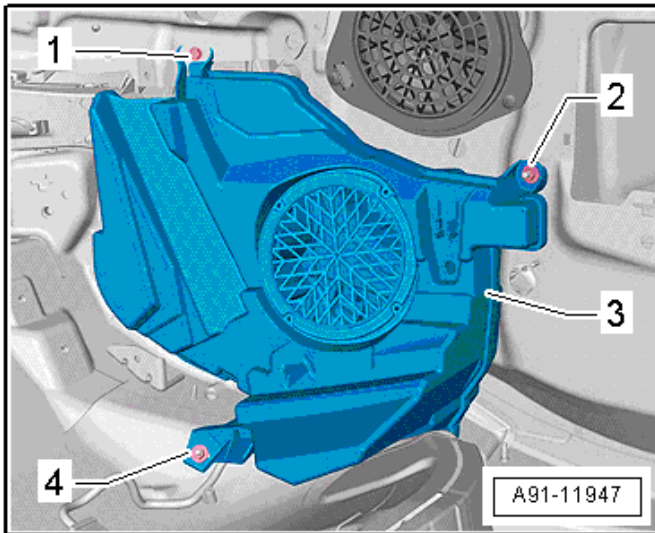
- If equipped, remove the rear subwoofer.
 - Remove the bolt <1> and the nuts <2 and 4> from the rear subwoofer <3>.
 - Unlock and disconnect the connector and then remove the subwoofer <3>.

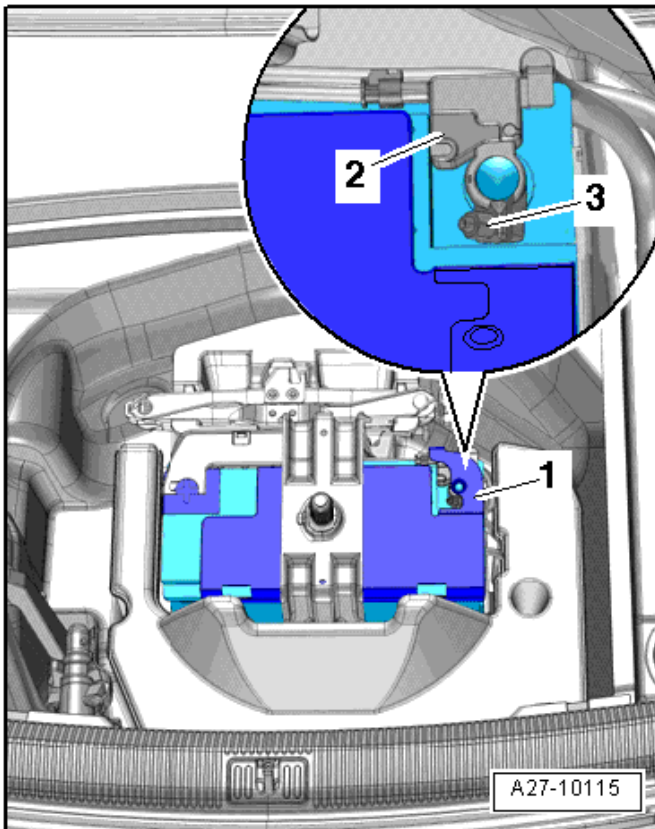
- Open the trunk.
- Lift the luggage compartment floor and engage it on the body.
- Remove the spare tire.

- Open the cover <1> over the battery negative terminal.
- Loosen the nut <3> several turns.
- Remove and isolate the battery ground cable terminal <2> from the battery terminal.

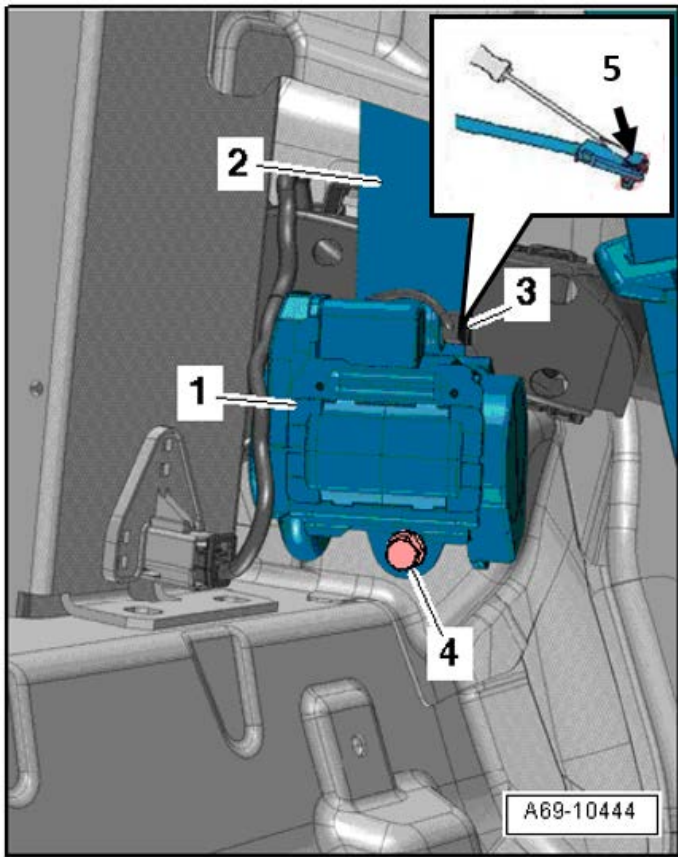
- Disconnect connector <3> using a small flat bladed screwdriver or pick tool to disengage connector lock <5>.
- Remove the bolt <4>.
- Thread the seat belt webbing <2> downward and remove the three-point seat belt <1>.
- Install the new seat belt with the anti-twist mechanism in the mount and torque the bolt <4> to 45 Nm.

- Install connector <3> and engage the lock.

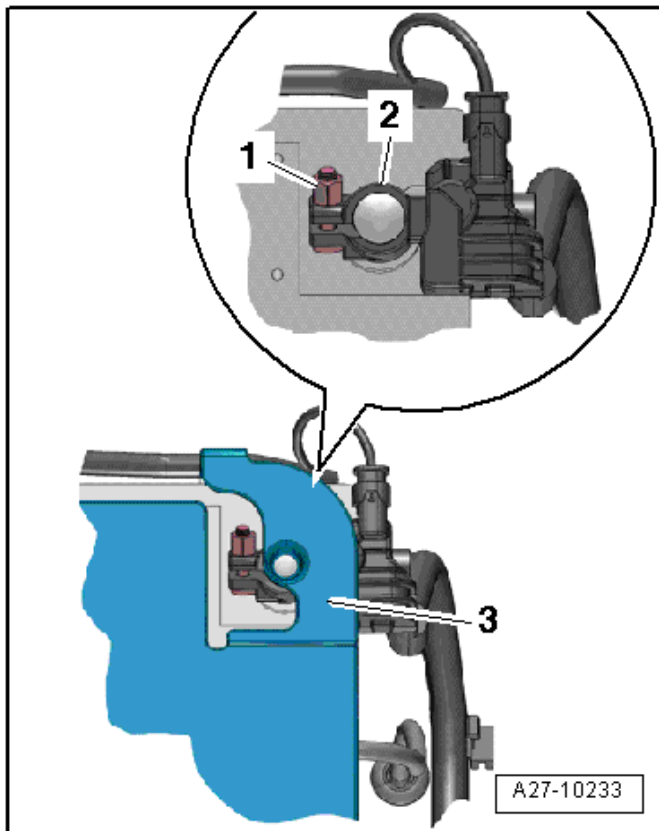
- Disconnect the connector <2> from the Battery Monitoring Control Module -J367-.
- Attach the battery ground cable clamp by hand to the battery negative terminal and torque the nut <1> to 6 Nm.
- Reconnect the connector to the Battery Monitoring Control Module -J367-.
- Re-install the spare tire and luggage compartment floor.
- Cycle the ignition off and back on.

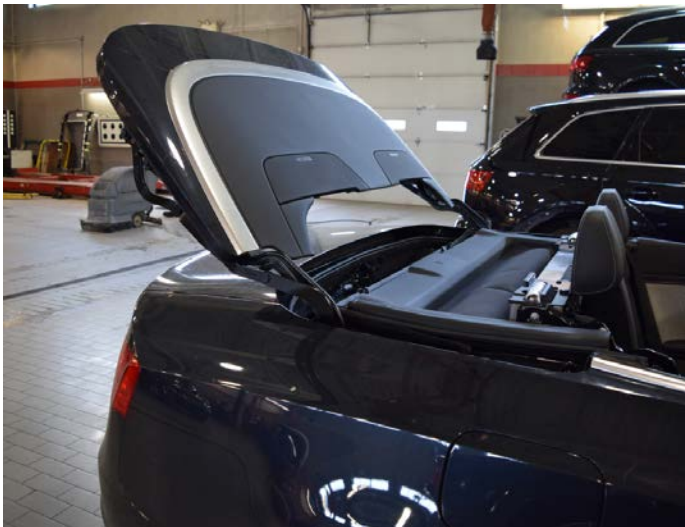
- Close the trunk, move the convertible top to the position shown and turn off the ignition.

- After approximately 6 minutes the convertible top control module will bleed the hydraulic pressure and the convertible top compartment cover could fall down uncontrolled.
- The convertible top compartment cover must be in the position shown so the weight of the cover does not allow it to close on its own once the hydraulic pressure has been bled.

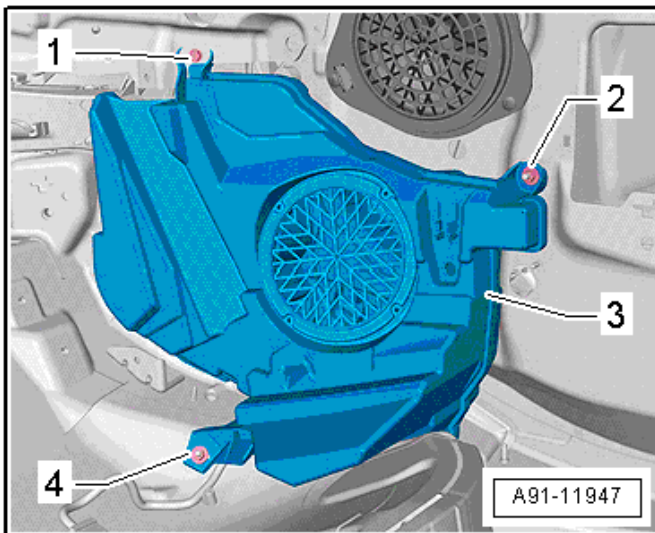
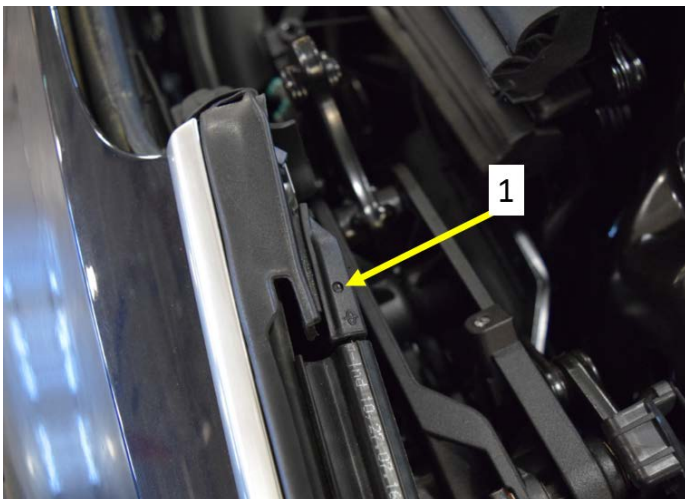
- If equipped, install the rear subwoofer.
 - Install the bolt <1> and the nuts <2 and 4> and torque to 3.5 Nm.
 - Connect and lock the connector.

- Ensure the seal <1> is installed as shown.

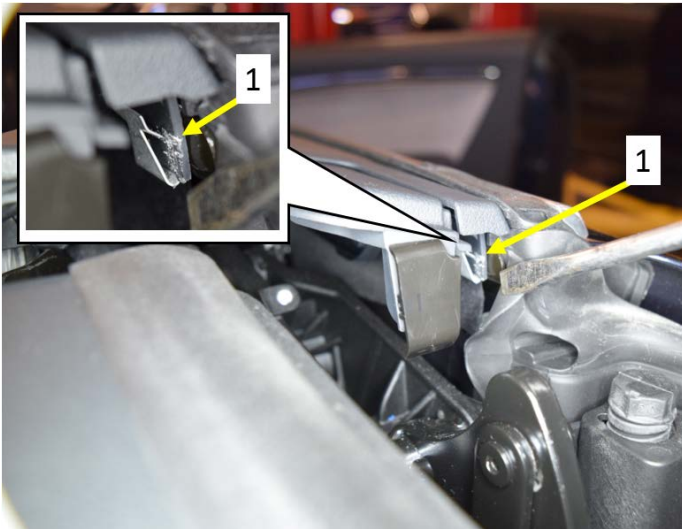
- When installing the side trim panel in the following step, ensure the tab <1> on the trim panel is installed in the clip as shown.

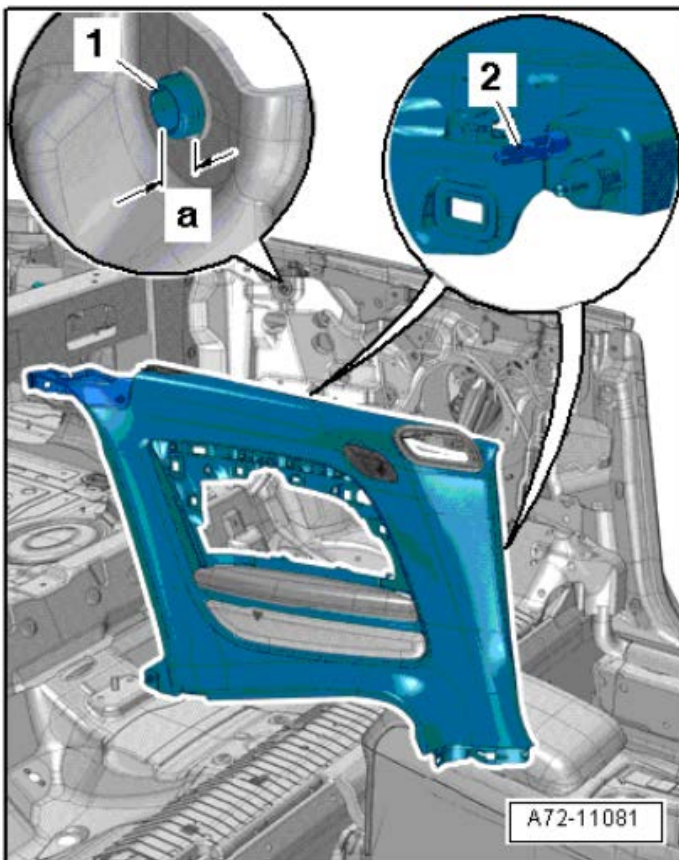
- Install the side trim panel.
 - Ensure the adjusting sleeve <1> is adjusted to 2.4 mm <dimension a>.
 - Insert the centering pins <2> on the back of the side trim panel into the holes in the body.
 - Stretch the door seal lip over the side trim.

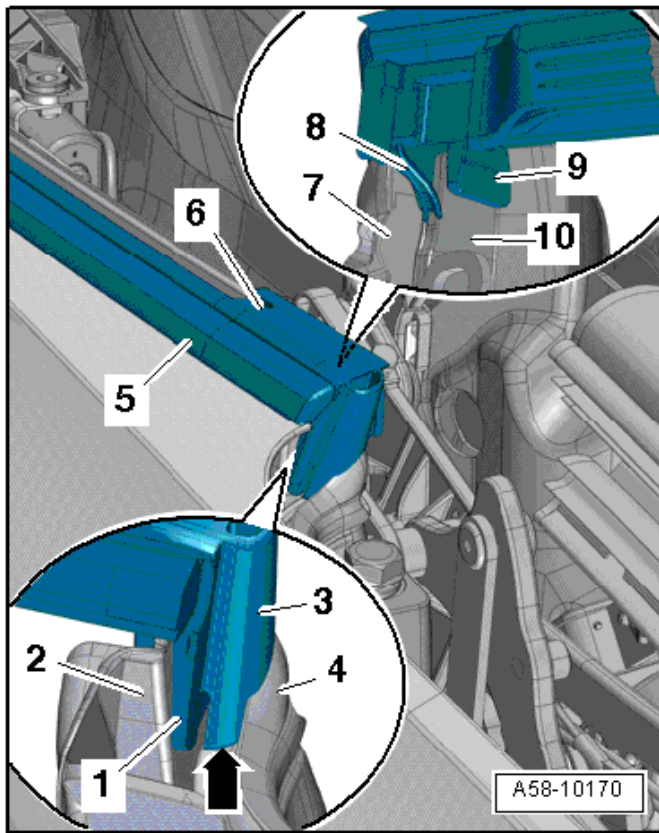
- Water will get into the passenger compartment if the outer/inner window shaft strip and the convertible top compartment cover seal are not installed correctly.
- Verify the outer window shaft strip seals are installed correctly.
 - The end <1> of the seal must touch the outside of the convertible top compartment cover seal <2>.
 - The water drain opening <3> must be in full contact with the inside of the convertible top compartment cover seal <4 and arrow>.
 - The lug <9> on the inside of the window shaft strip must touch the outside of the window shaft strip <10> as illustrated.
 - The water drain channel <8> must touch the convertible top compartment cover seal <7> completely.

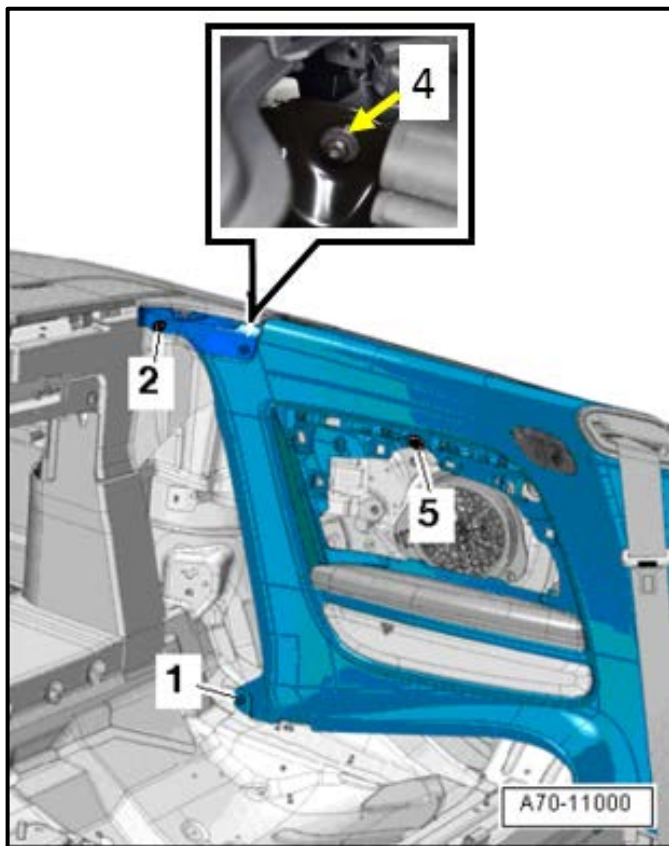
- Install bolts <2, 4 and 5> and torque to 9 Nm.
- Close rear seat backrest(s).
- Install expanding clip <1>.
- Install the side panel insert.
- Install the trim strip.

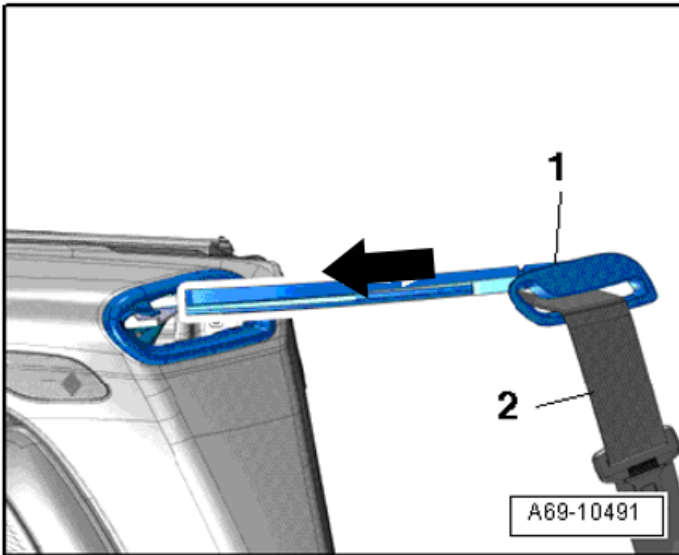
- Guide the seat belt through the seat belt positioning arm <1>.

- Install the seat belt positioning arm <1> into the positioning arm motor in direction of <arrow>.

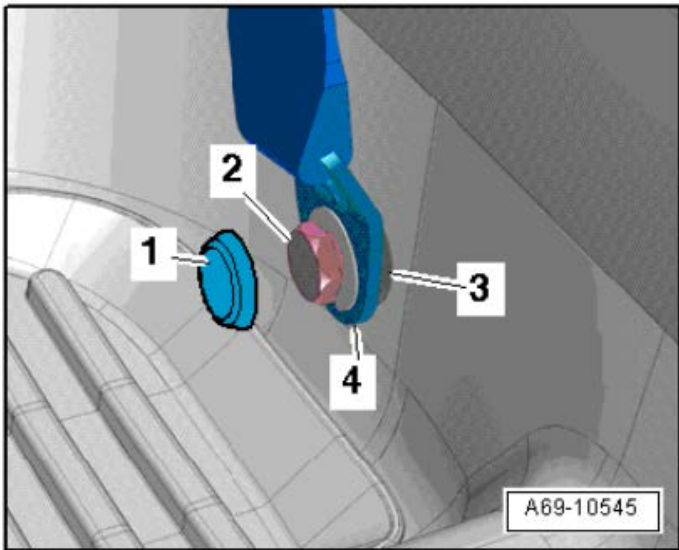
- Ensure the seat belt webbing is not twisted between the positioning arm and the belt anchor.
- Ensure the spacer is installed on the bolt between the body and belt anchor.

- Install front belt anchor <3> and torque bolt <2> to 45 Nm.
- Install cap <1>.

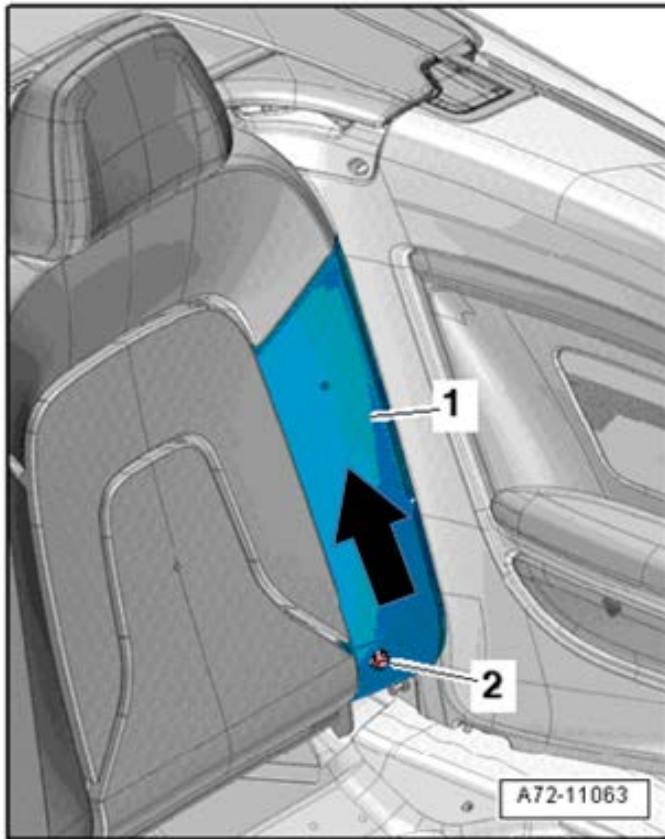
- Install side cushion <1> in direction of <arrow> and torque bolt <2> to 4 Nm.

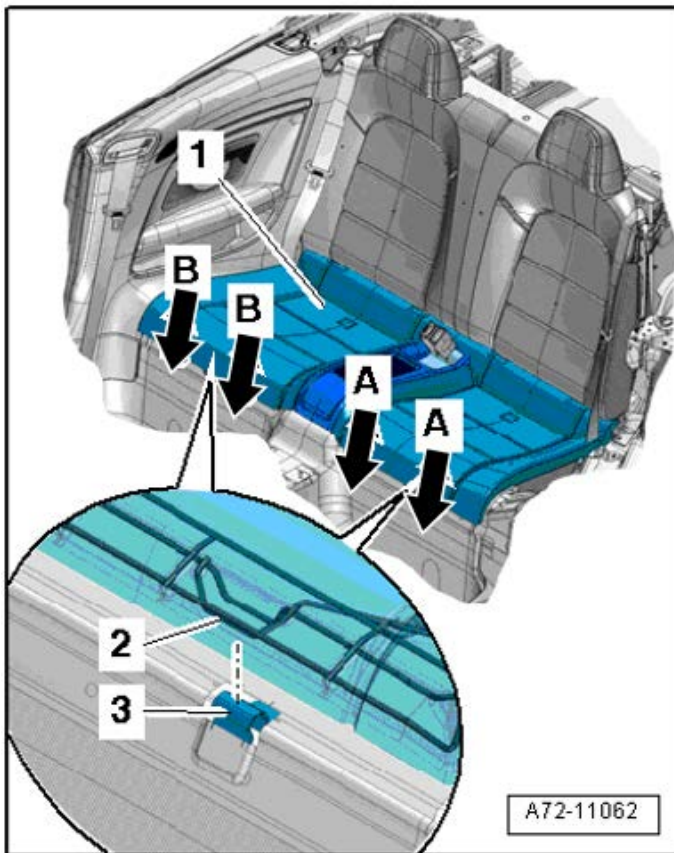
- Make sure the eyelets on the seat bench correctly fit around the connecting tube on the backrest frame.
- Press on the rear seat bench downward into the mount until it audibly engages.

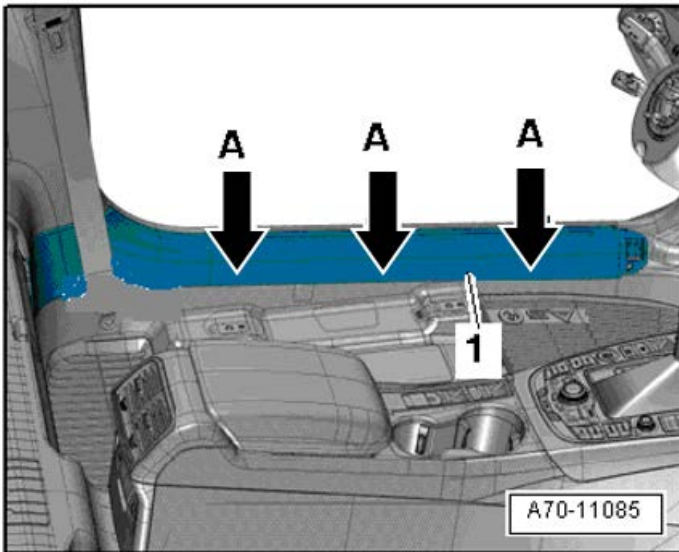
- Remove any trim clips remaining in the body using Omega Clip Tool -T40280- (or equivalent) and install into the trim panels.
- Install sill panel <1>.
- Install A-pillar trim.
- Install hood release lever if necessary.
