# Safety Recall

## Code: 20Z4

<b>Subject</b>	<b>Fuel Pump Flange</b>
<b>Release Date</b>	July 25, 2017
<b>Affected Vehicles</b>	<b>U.S.A. &amp; CANADA: Certain 2007-2010 MY Touareg</b> <i>Check Campaigns/Actions screen in Elsa on the day of repair to verify that a VIN qualifies for repair under this action. Elsa is the <u>only</u> valid campaign inquiry &amp; verification source.</i> <ul style="list-style-type: none"><li>✓ Campaign status must show "open."</li><li>✓ If Elsa shows other open action(s), inform your customer so that the work can also be completed at the same time the vehicle is in the workshop for this campaign.</li></ul>
<b>Problem Description</b>	On certain vehicles, the fuel pump flange may develop fine cracks or fissures, which could result in a fuel leak. Leaking fuel, in the presence of an ignition source, could lead to a fire causing injury and/or damage to property.
<b>Corrective Action</b>	If cracks, leaks, and/or yellow discoloration are present, the fuel pump flange will be replaced and a protective film installed onto the fuel pump flange. If no cracks, leaks, and/or yellow discoloration are present, a protective film will be installed onto the fuel pump

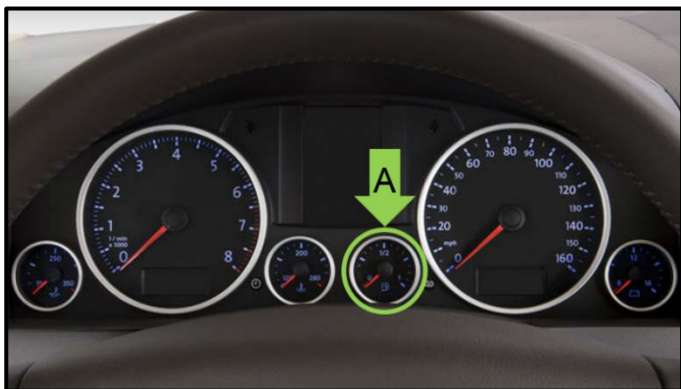
- Turn the ignition to the ON position and check the vehicle fuel level displayed on the instrument cluster <A>.
- Record the vehicle fuel level on the repair order.

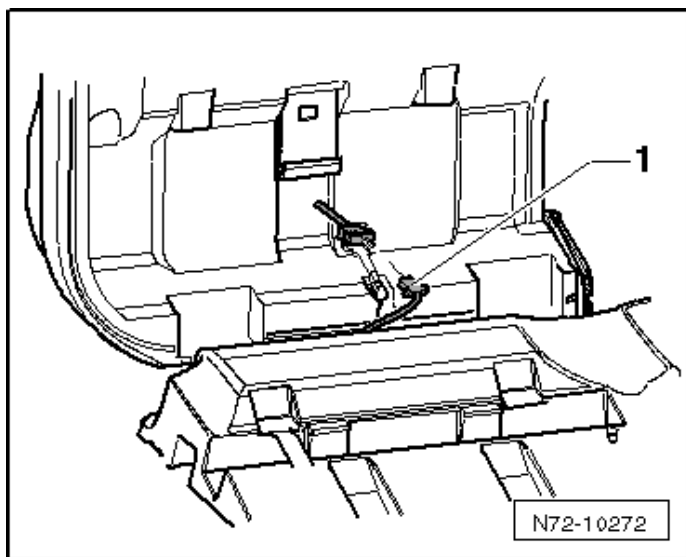
N72-10272

- For vehicles equipped with rear bench seat heating, disconnect seat heating wiring harness <1> from left and right sides.

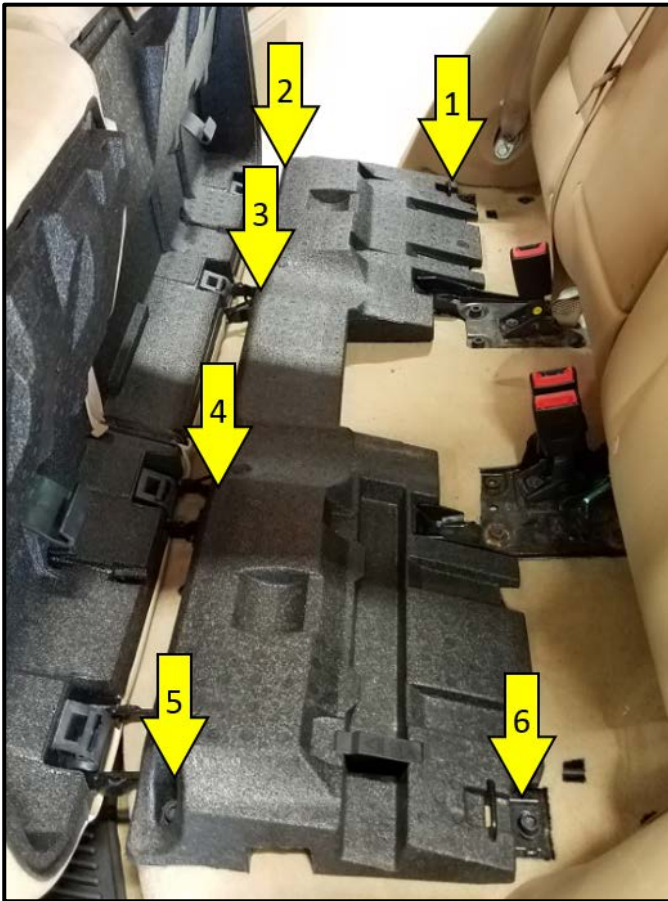
- Remove rear bench seat bolts <1 through 6>.
- Remove rear bench seat with support piece from vehicle.

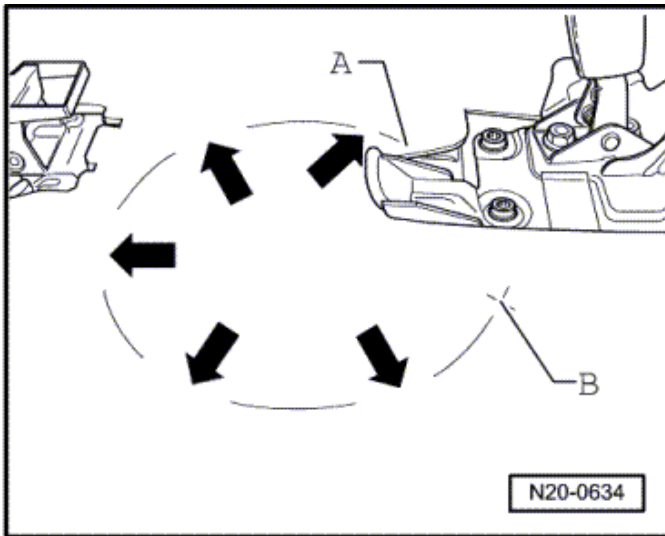
- If necessary, cut open the carpet on the left side from point <A> to point <B> in the precut area <arrow>.

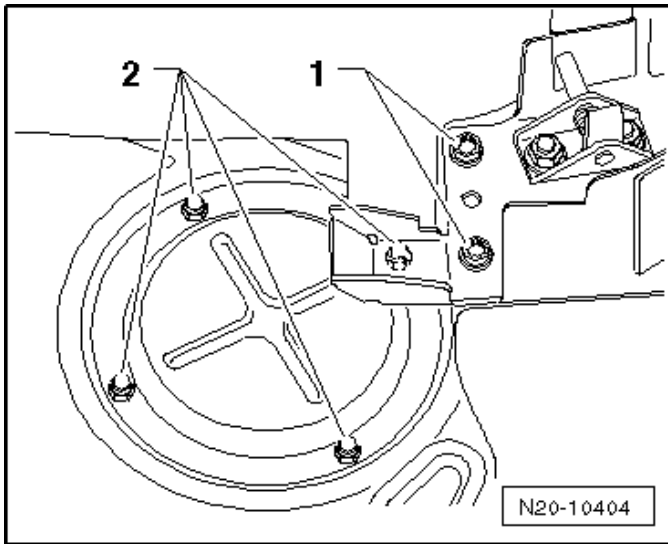
- Remove nuts <2>.

- Remove the bolts <1> and pry the mounting bracket up slightly. Remove the nuts <2> and remove the cover.

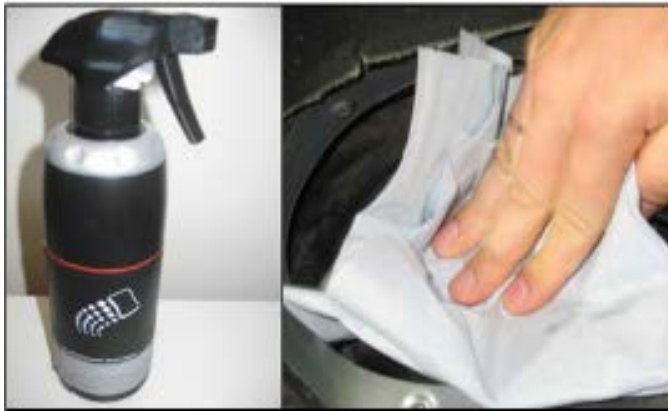
- Clean the top of the fuel filter flange with a suitable plastic cleaner.

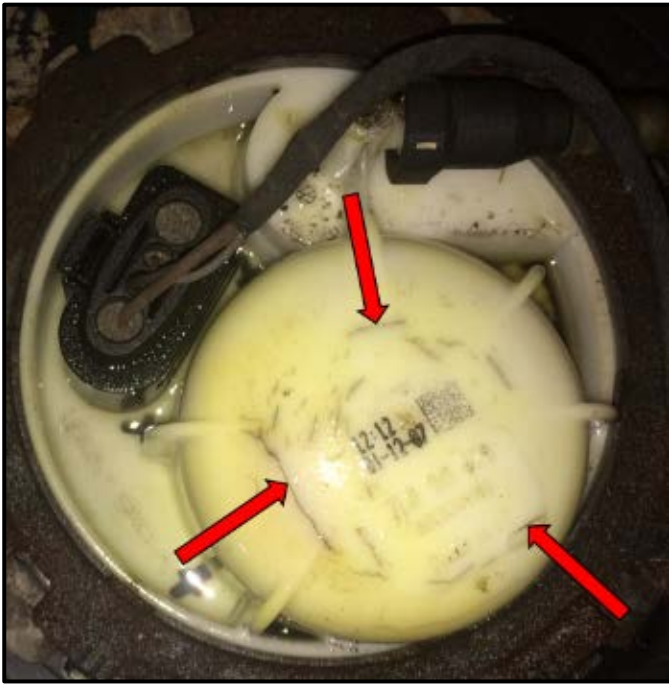
- If there is a visible presence of leaking fuel;
  - **Continue to Section D and Replace the Fuel Filter Flange and install the protective film.**
  - **All others continue to the next step.**

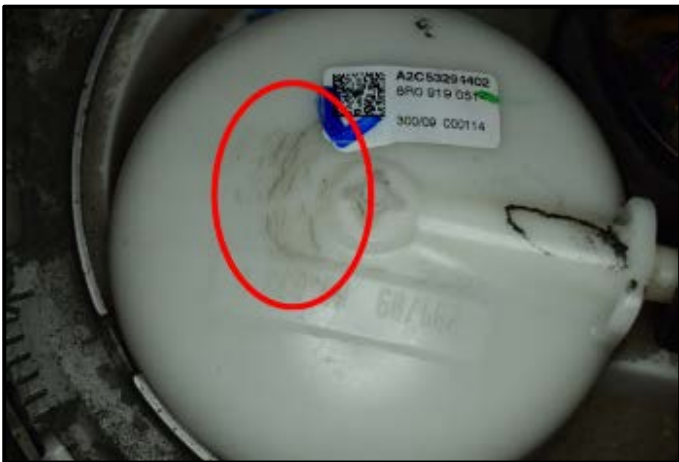
- If there are no signs of leaking present, but there **ARE** cracks <circle> and/or yellow discoloration present;
  - **Continue to Section D and Replace the Fuel Filter Flange and install the protective film.**
  - **All others continue to the next step.**

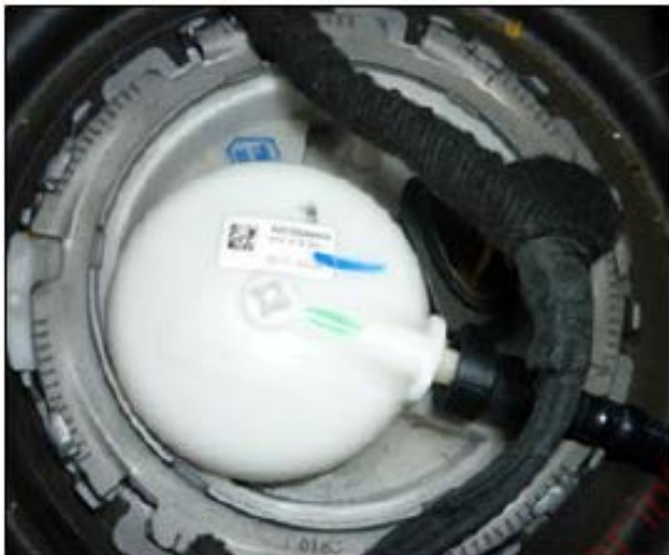
- If there are **NO** cracks, leaks, and/or yellow discoloration present;
  - **Continue to Section C and install the protective film.**

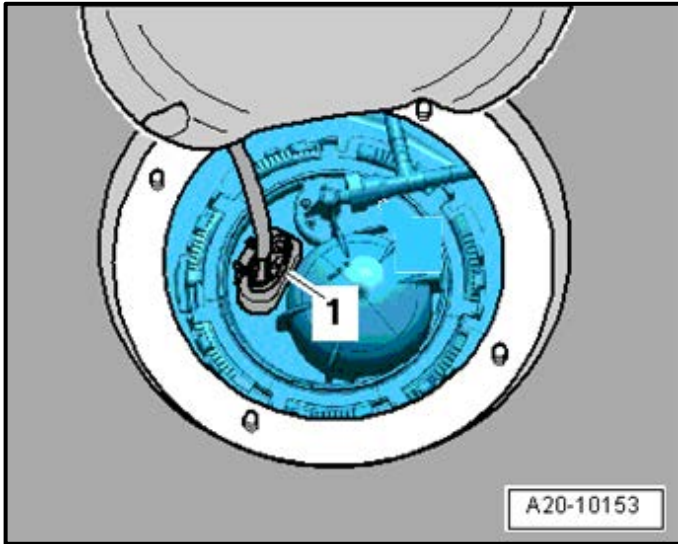
- Disconnect connector <1>.

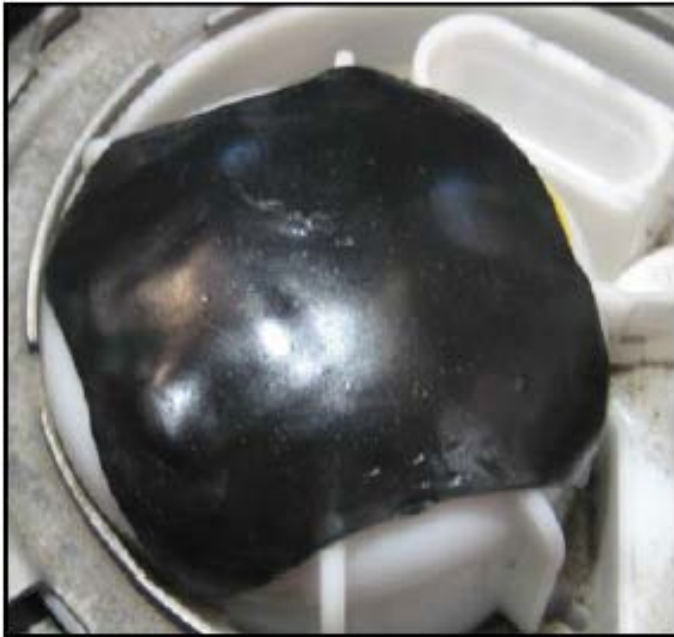
- Apply protective film as shown. Start application from the center and work the protective film towards the outside edges of the fuel pump flange taking care to eliminate air gaps or bubbles under the film.

- Use care when applying protective film so that no dust or dirt comes in contact with the adhesion side of the film.

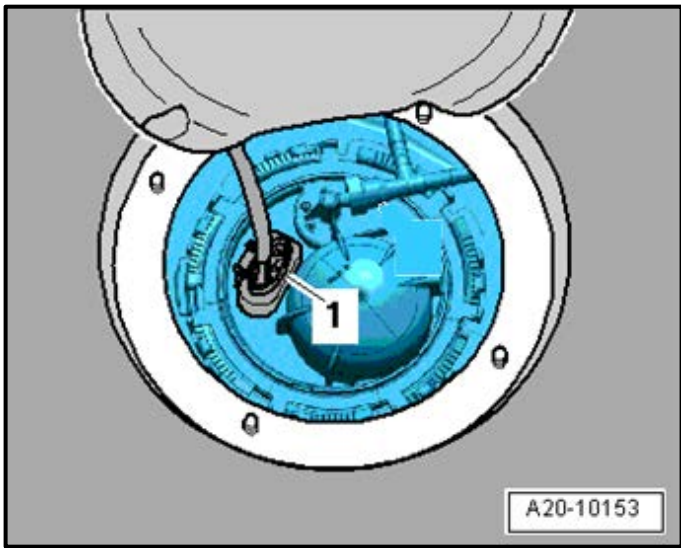
- Reconnect connector <1>.

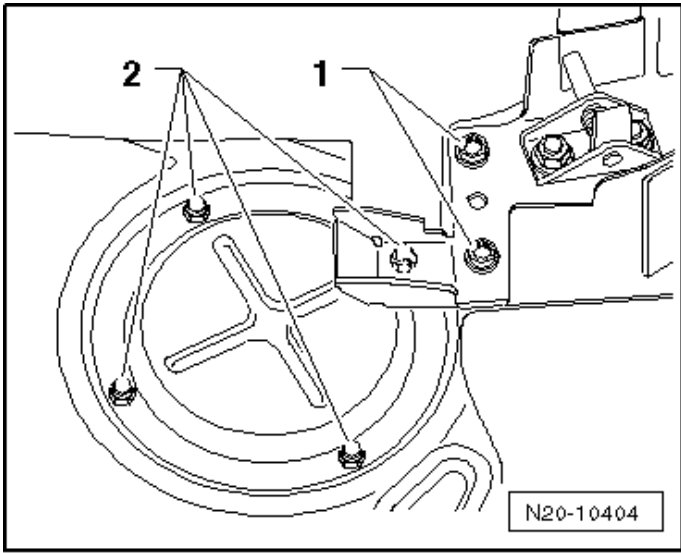
- Install flange cover and nuts <2>.

- Clean the threads in the body for bolts <1> before installing bolts.
- Install new bolts <1> and torque to 20 Nm.

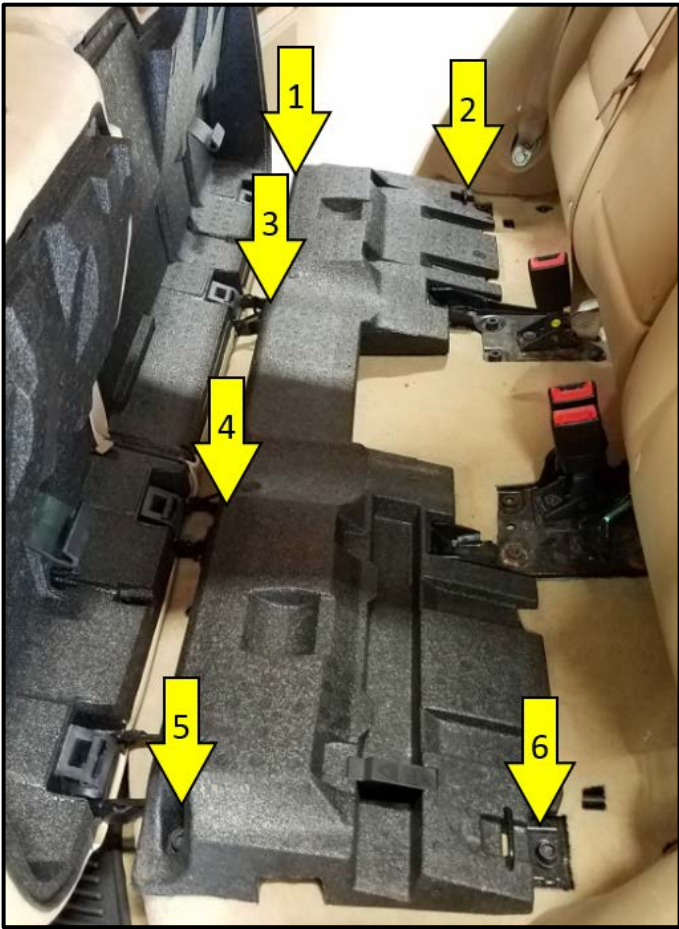
- Install rear bench seat and torque bolts <1 through 6> to 55 Nm.
- On vehicles equipped with seat heating, connect the seat heating wiring harness on both bench seats.

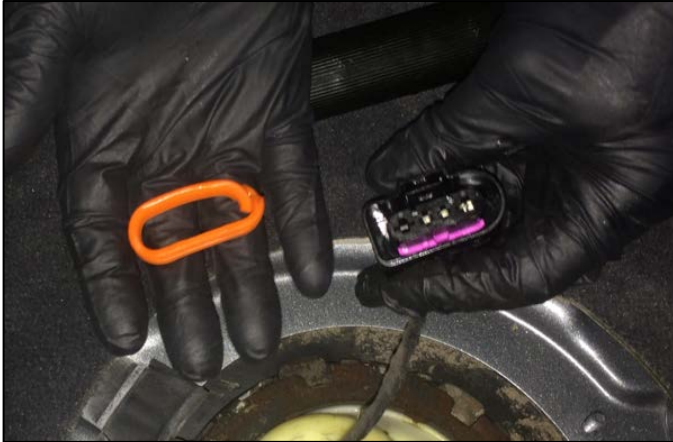
- If the fuel filter flange was leaking fuel, inspect the wiring harness connector carefully for damage due to fuel wicking into the weather pack seals.
- If damage to the weather pack seal and/or wiring harness is discovered, be sure to order the appropriate wires, seals and connector to correctly repair the damaged harness.

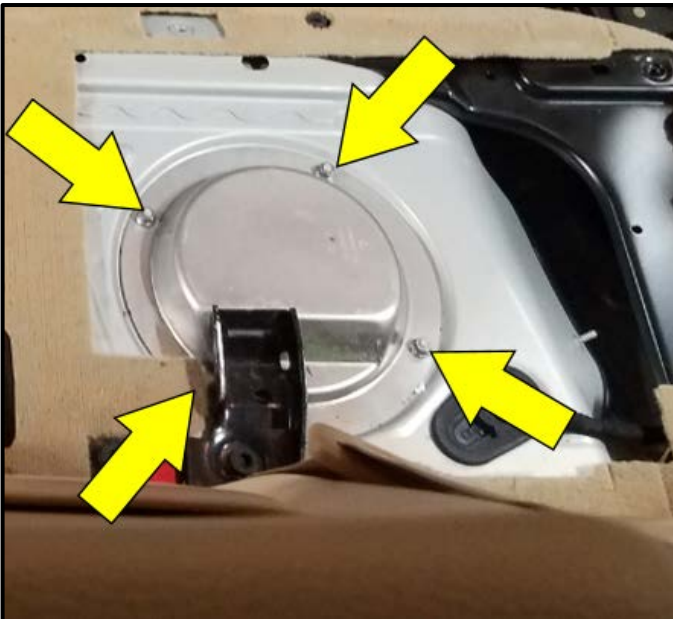
- Remove nuts <arrows> from the fuel delivery unit cover located on the passenger side of the vehicle.

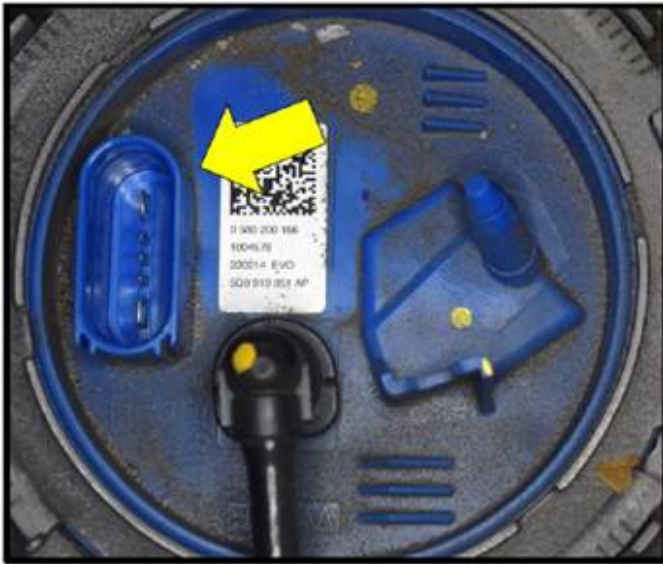
- At the fuel delivery unit, unlock and disconnect the connector <arrow>.

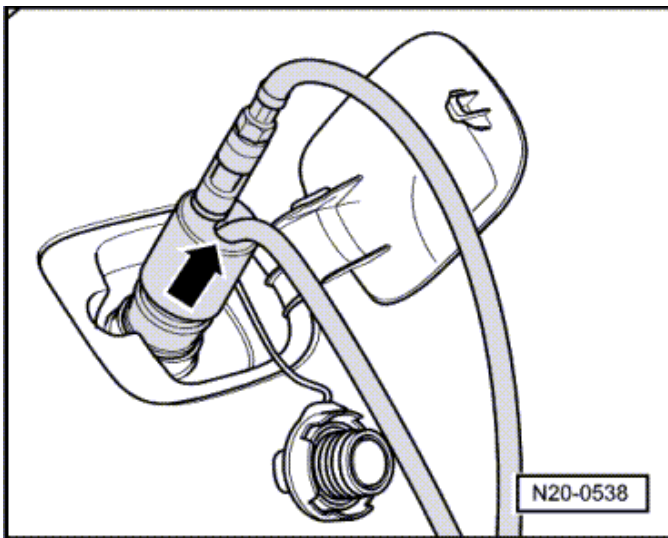
- If necessary, drain the fuel tank using Fuel Extracting Device -VAS5190A-.
- Open the fuel tank flap.
- Insert the suction hose <arrow> from the Fuel Extracting Device -VAS5190A- about 170 to 180 cm into the fuel filler neck and extract the fuel.

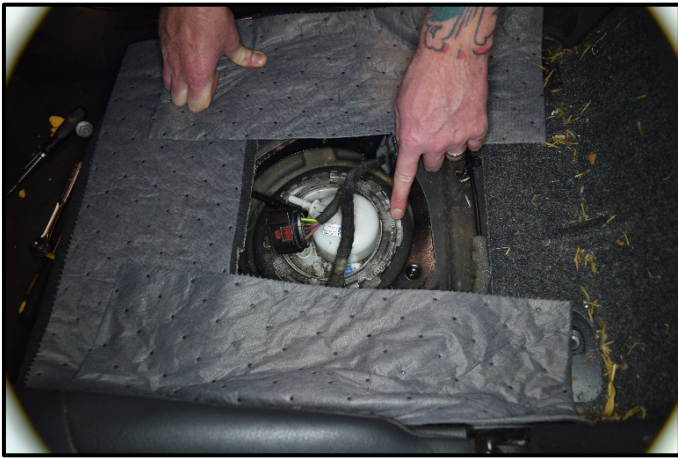
When no more fuel can be extracted, the tank is emptied enough for the fuel filter flange to be removed.

There is a risk of fuel leaking out from the filled fuel filter flange. Lay cloths, rags, or other absorbent material below to catch the leaking fuel.

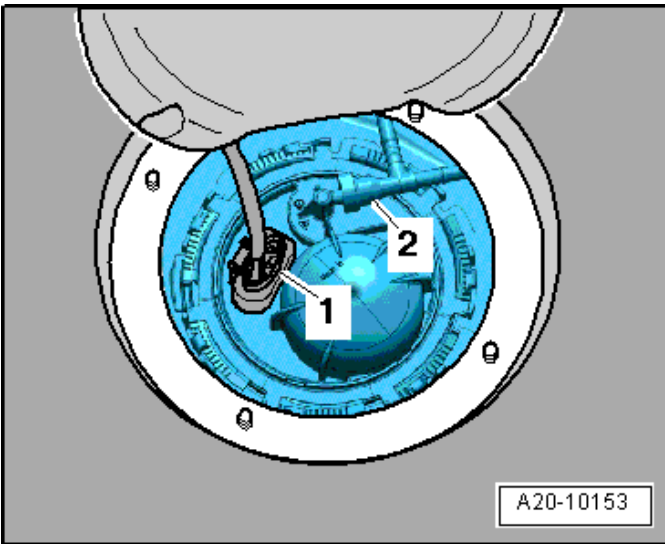
- Clean and/or vacuum the area around the fuel filter flange opening to ensure no debris falls into the fuel tank during the repair.
- Disconnect filter flange electrical connector <1> and fuel tank vent line <2>.

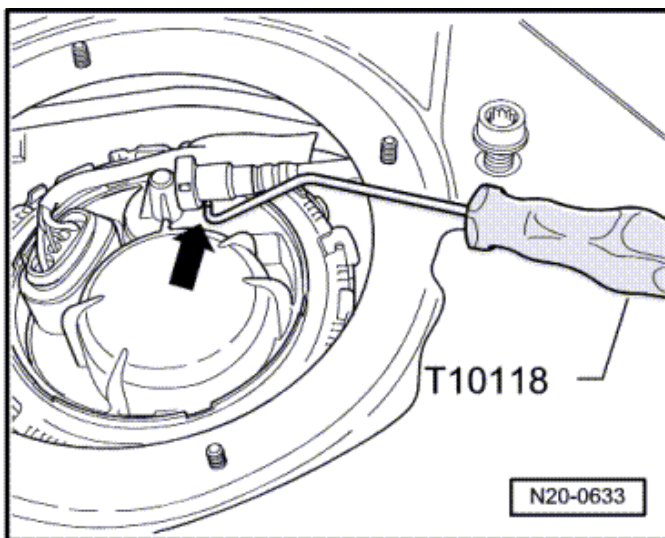
When disconnecting the ventilation line, the release tab often cannot be pressed in. In that case, use the Elbow Assembly Tool -T10118- <arrow>.

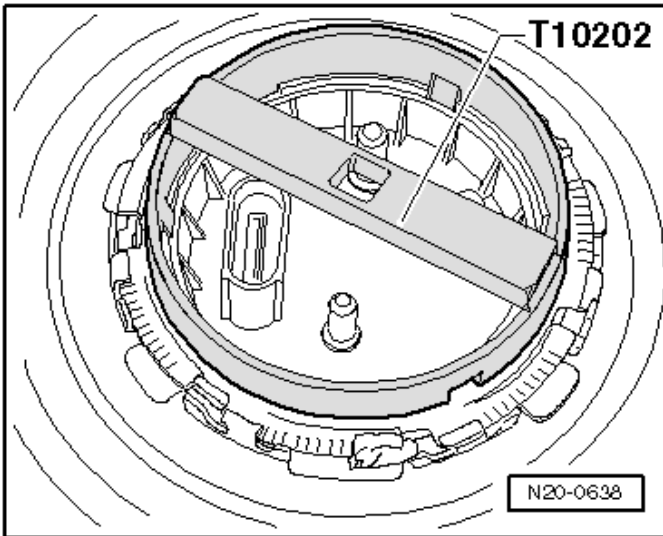
- Remove the locking ring from the fuel filter flange using the Wrench -T10202-.
- Carefully pry out the fuel filter flange and raise it slightly.

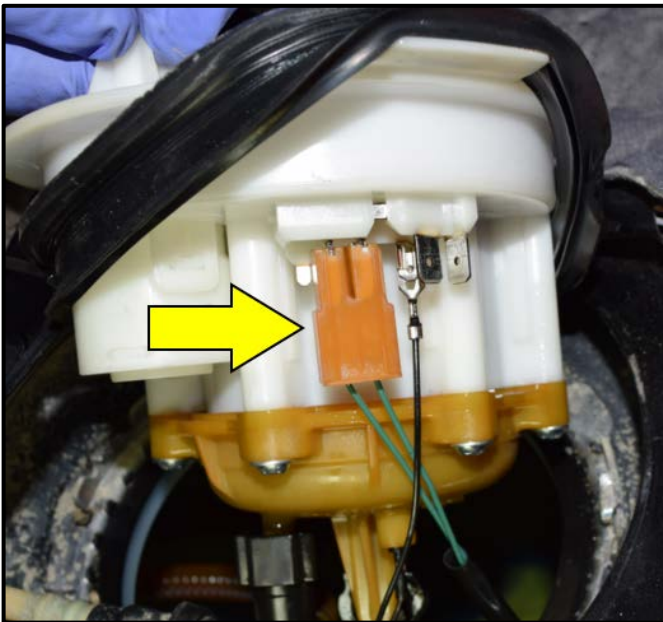
- Disconnect fuel level sensor connector <arrow>.

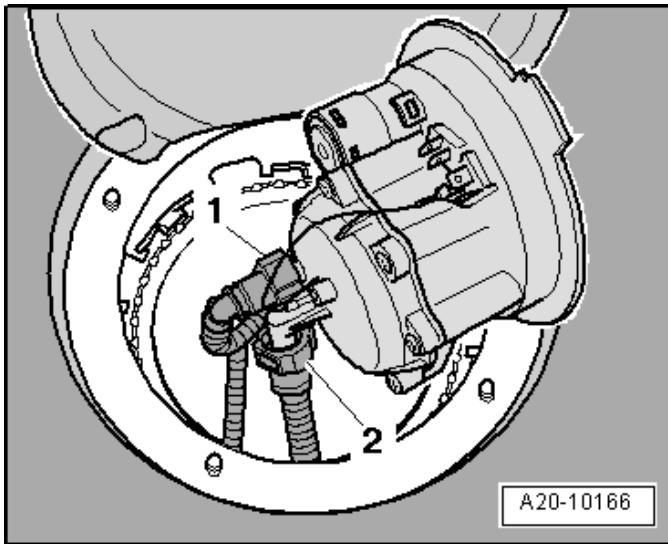
- Disconnect fuel lines <1> and <2> from fuel filter flange by squeezing the release tabs between the finger and thumb, pushing IN on the connector, then pulling OFF.
- Remove fuel filter flange and seal.

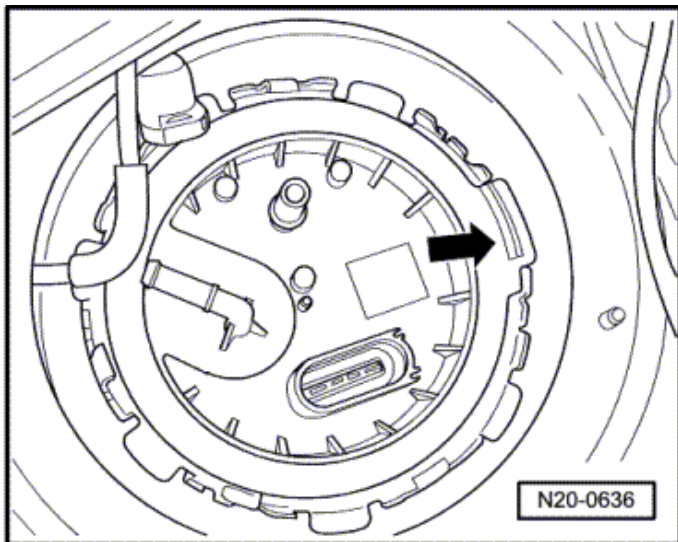
- Install the new fuel filter flange seal ring into the fuel tank opening.
- Reconnect fuel lines and fuel level sensor connector.
- Install the new fuel filter flange into the fuel tank.

- Verify the locating tab <arrow> is in the correct position before reinstalling the locking ring.

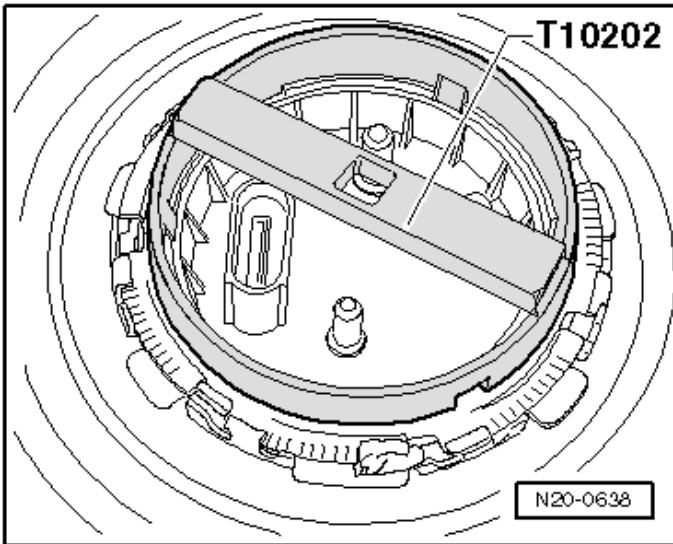
- Reinstall the locking ring onto the fuel filter flange using the Wrench -T10202- and torque the locking ring to 110 Nm.

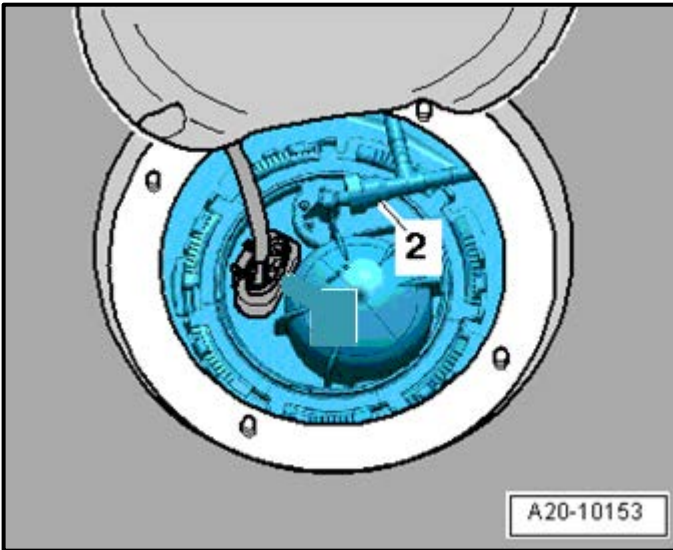
- Reconnect the fuel vent line <2>.

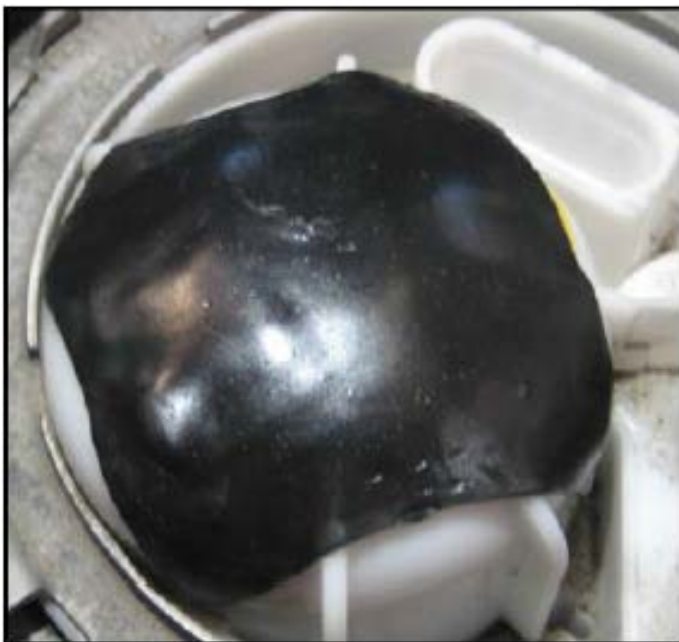
- Apply protective film as shown. Start application from the center and work the protective film towards the outside edges of the fuel pump flange taking care to eliminate air gaps or bubbles under the film.

- Use care when applying protective film so that no dust or dirt comes in contact with the adhesion side of the film.

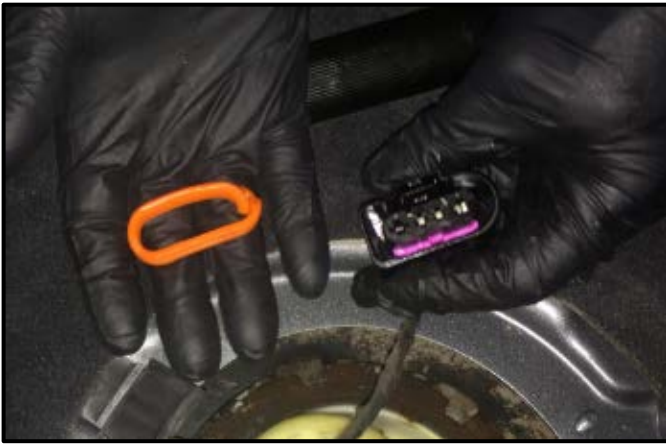
- If required, repair the wiring harness connector, wiring, and weather pack seals before reconnecting the connector to the fuel filter flange.

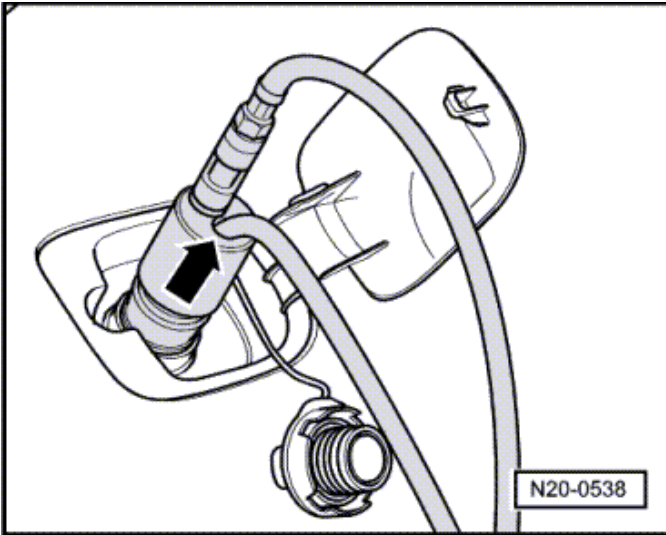
- If fuel was removed due to replacement of the fuel filter flange, dispense recovered fuel contained in the -VAS5190A- Fuel Extracting Device back into the vehicle fuel tank at this time.

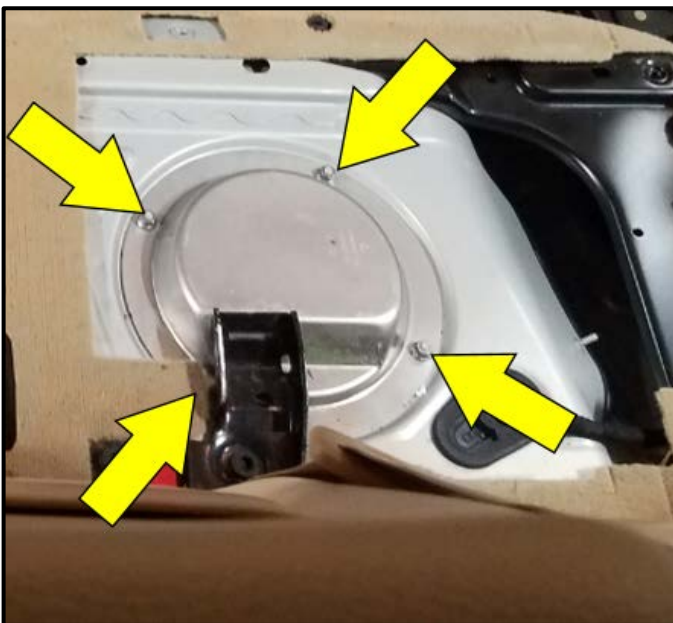
- Reconnect fuel delivery unit connector and engage the lock.
- Install fuel delivery unit cover and nuts <arrows>.

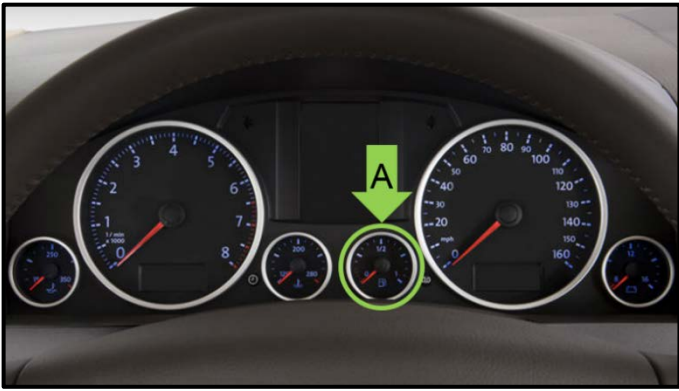
- Turn on the ignition.
- Cycle the ignition four to five times to prime the fuel system.
- Start the vehicle to verify fuel system functionality and check for leaks.
- If any fuel was removed, check the vehicle fuel level displayed on the instrument cluster <A>.
- Refer to the vehicle fuel level on the repair order and verify the proper operation of the fuel level gauge, and that the correct amount of fuel has been returned to the vehicle from the Fuel Extracting Device -VAS5190A-.

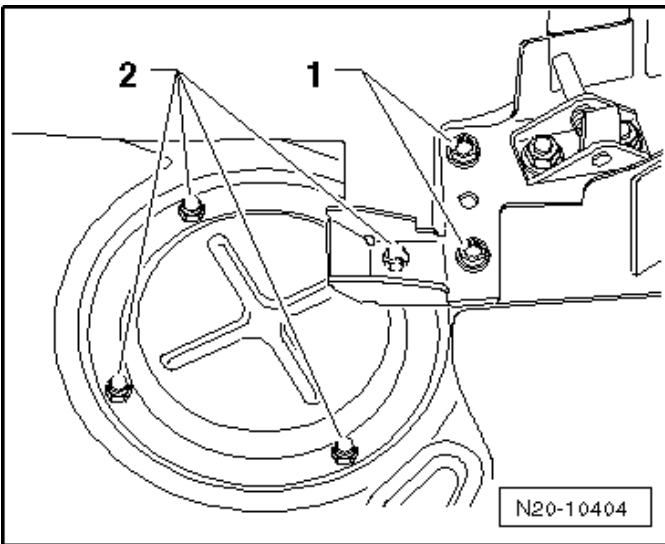
- Install fuel filter flange cover and nuts <2>.

- Clean the threads in the body for bolts <1> before installing bolts.
- Install new bolts <1> and torque to 20 Nm.
