Technical Service Bulletin

GROUP RECALL	NUMBER 17-01-025
DATE MARCH 2017	MODEL(S) Sonata (YF) Sonata Hybrid (YF HEV)

SUBJECT: 2011-2014 SONATA (YF) AND 2011-2015 SONATA HYBRID (YF HEV)
ANCHOR PRETENSIONER INSPECTION (RECALL CAMPAIGN 160)

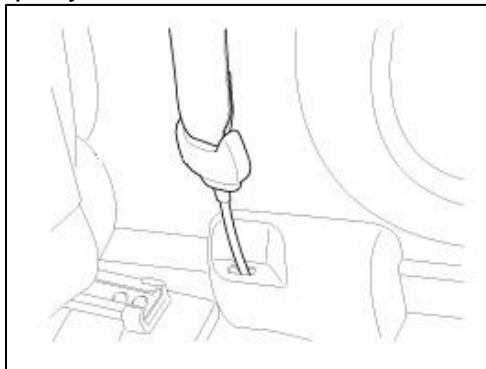
The front seat belt assembly incorporates a seat belt anchor pretensioner fastened to the vehicle's inner sill structure. During vehicle assembly, the anchor pretensioner is fastened to the sill prior to being connected to the seat belt linkage. If, during vehicle assembly, the connector did not fully latch when the linkage was pressed onto the connector, the seat belt can detach from the anchor pretensioner. If the seat belt linkage detaches from the anchor pretensioner in a collision, the risk of injury to the occupant is increased.

This bulletin describes the procedure to inspect the driver's and passenger's anchor pretensioner assemblies to confirm they are properly latched.

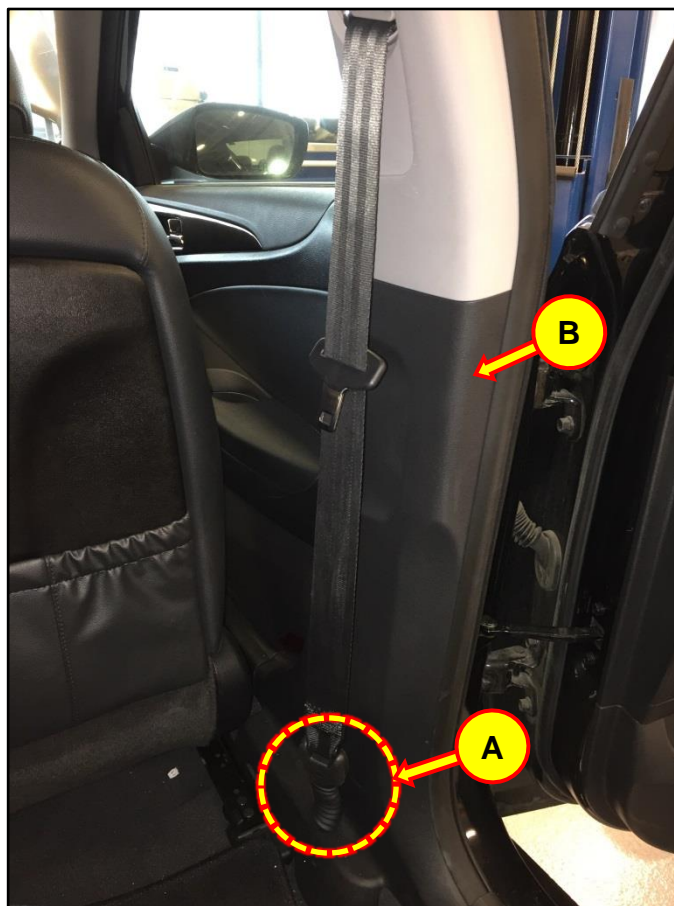
1. Move the passenger seat forward and locate the passenger anchor pretensioner (A) near the lower B pillar trim (B).

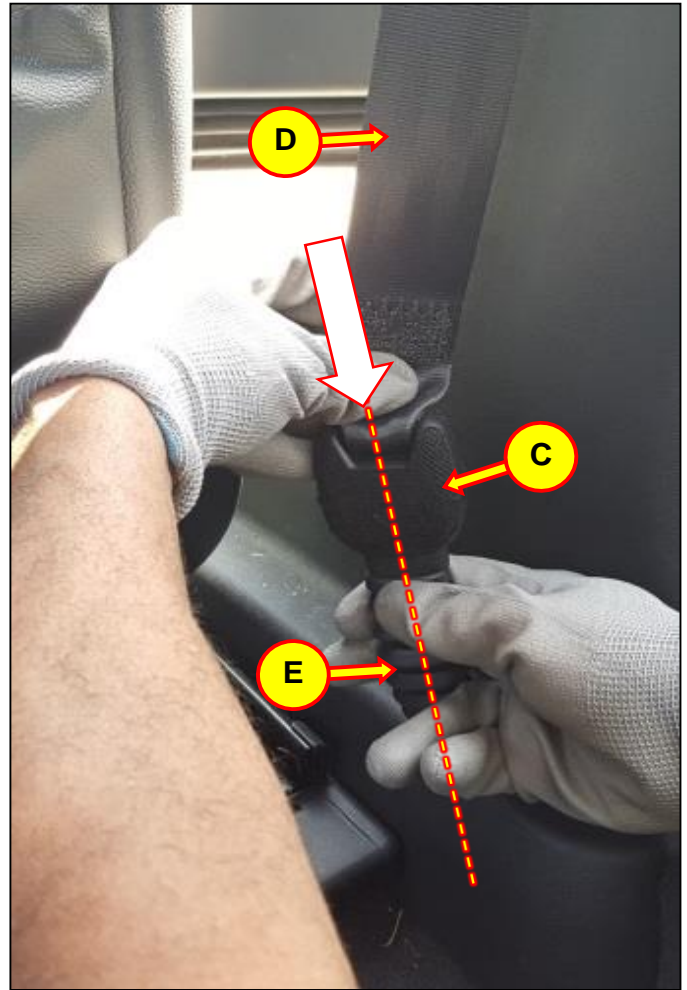
2. Push the linkage element (C) in the seat belt assembly (D) down along the anchor pretensioner cable (E), while firmly holding the anchor pretensioner cable (E).

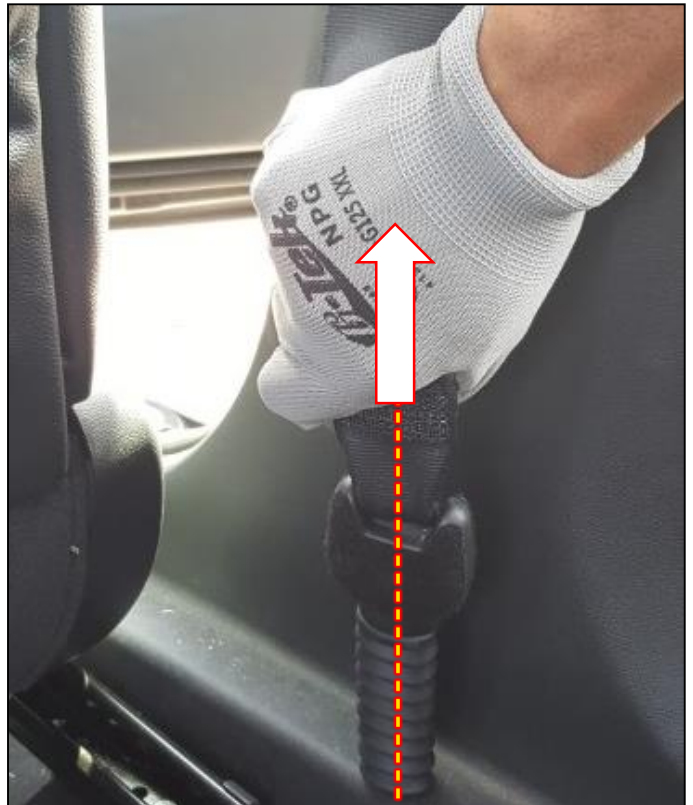
3. Pull the linkage element up in order to verify that it is fully locked.

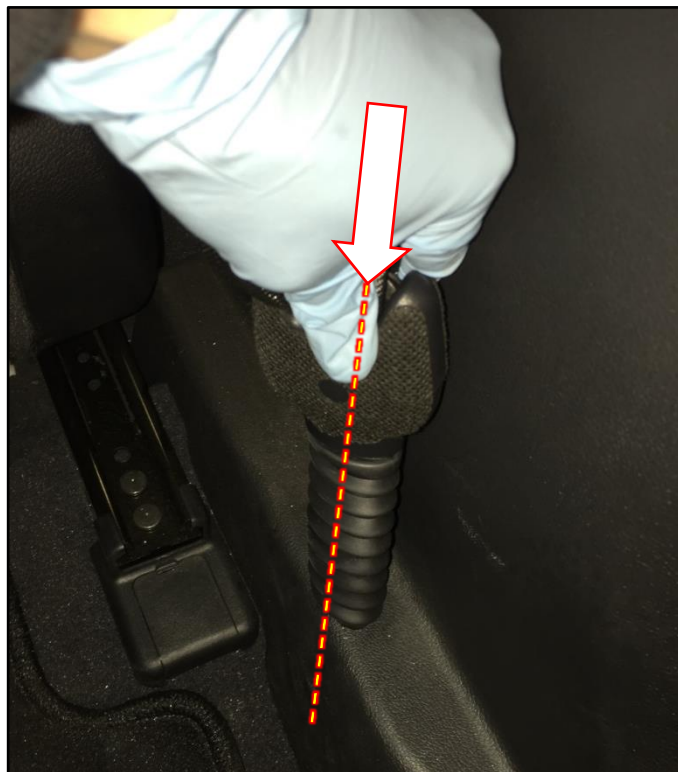
4. Push the linkage element down again.

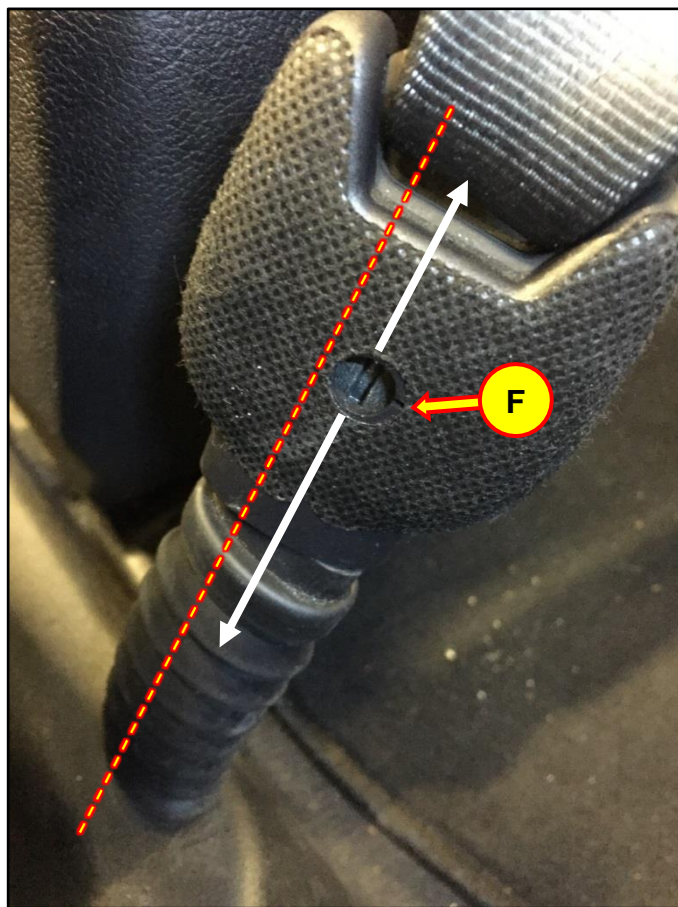
5. Visually inspect the center hole (F) on the outboard side of the linkage element to confirm that it is fully locked.
Note: When fully locked, the latch slot in the center hole is parallel to the anchor pretensioner cable.
