GROUP
Safety Recall

MODEL
2017MY
Niro (DE)

NUMBER
SC145 (Rev 1, 4/11/2017)

SUBJECT: MOTOR DRIVEN POWER STEERING (MDPS)
MOTOR REPLACEMENT (SC145)

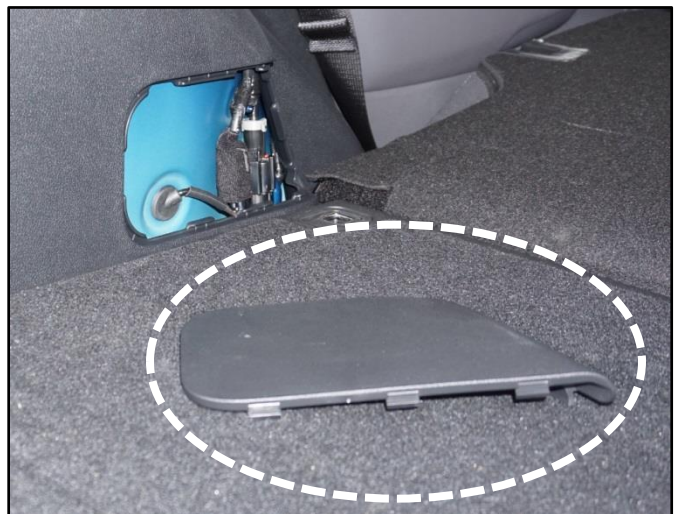
4. Remove the cover using a trim removal tool.

Use a non-marring trim removal tool (Such as Snap-on® Part Number PBN5 or equivalent).

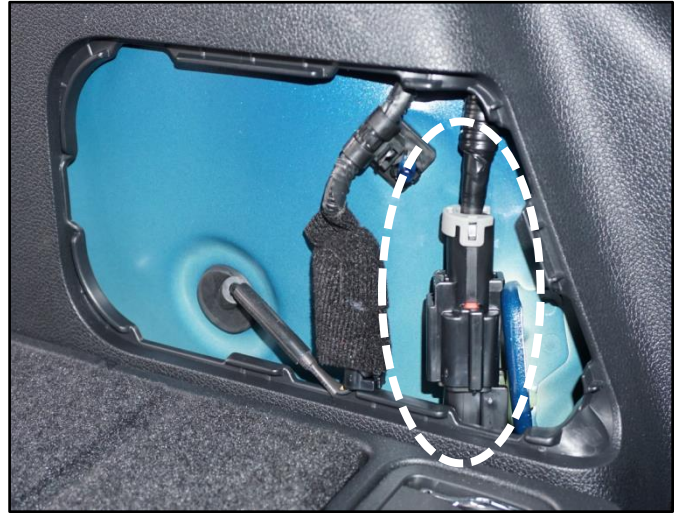
5. Disconnect the negative (-) battery cable.

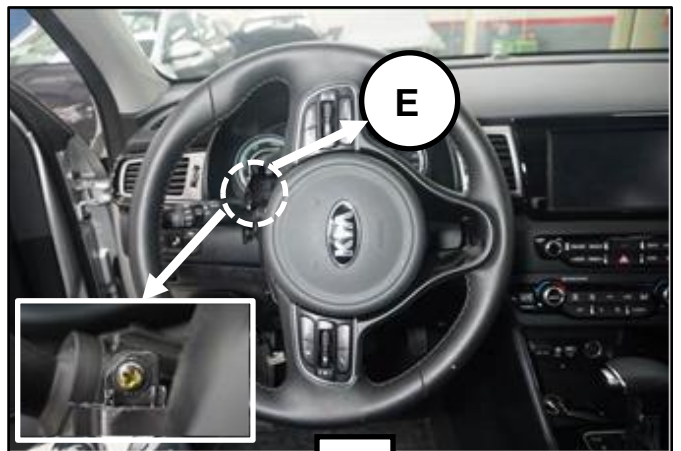
10. Remove the three (3) lower steering wheel shroud mounting screws (E).

When loosening the steering column shroud mounting screws, turn the steering wheel sideways by 90° to the right/left from aligned position.

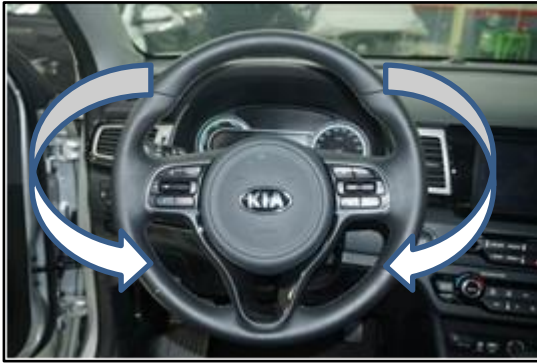
Turn the Steering Wheel

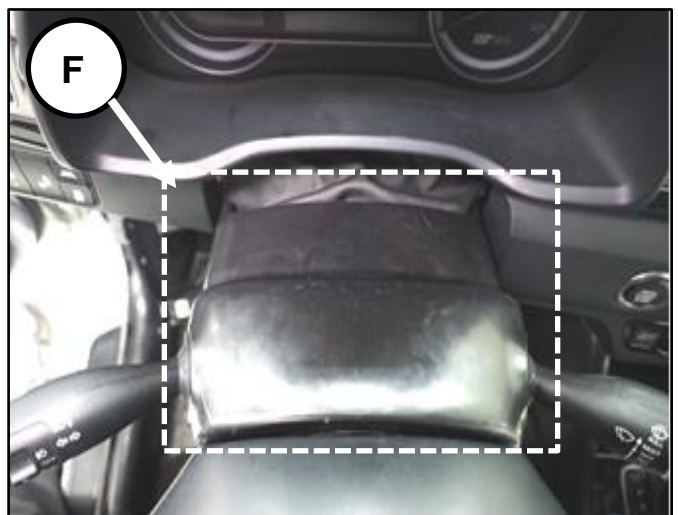
11. Separate the upper side of the steering wheel shroud (F).
