Thor Motor Coach Recall Repair Instructions

Recall # **17V-163**

Description/Title: **2017 Aria 3601 Seatbelt Length**

Affected Product Line(s): **Certain 2017 Aria 3601 Motor Homes**

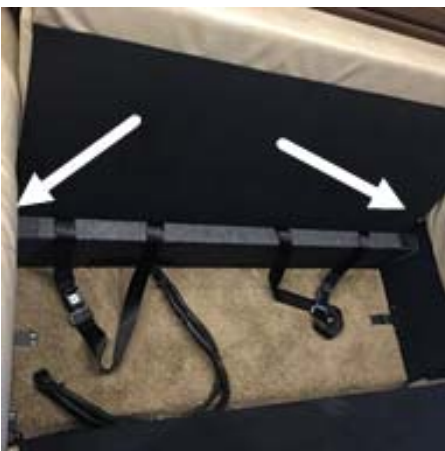
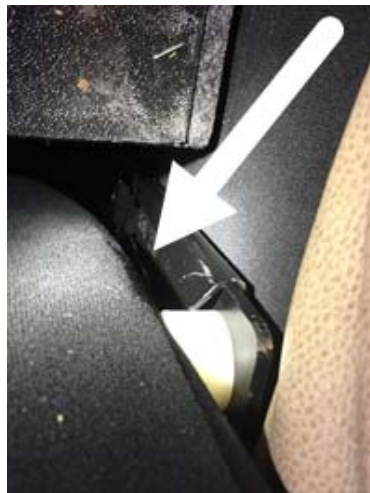
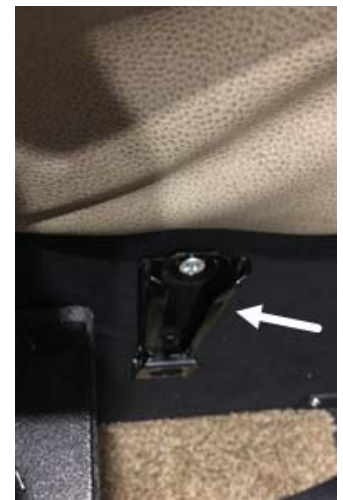
1. Deploy the slide out.
2. Remove the sofa's seat cushions and put them in a safe place.
3. Remove the back of the sofa by releasing the latches on the sides of the sofa back where it meets the seat frame.

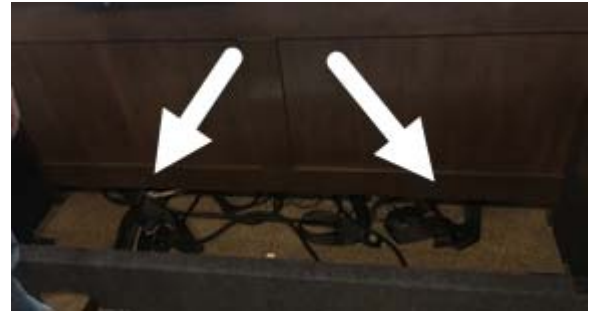
4. Locate the seat belt anchor bolts.

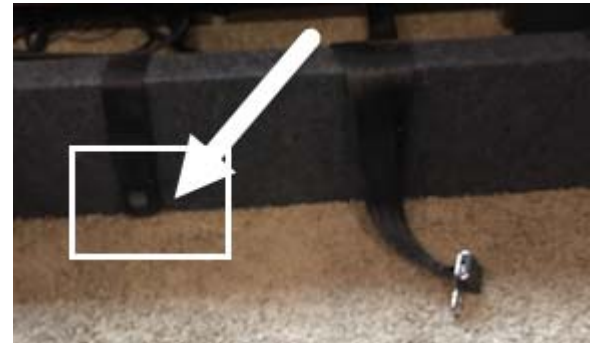
5. Locate the receiver side of the seatbelt.

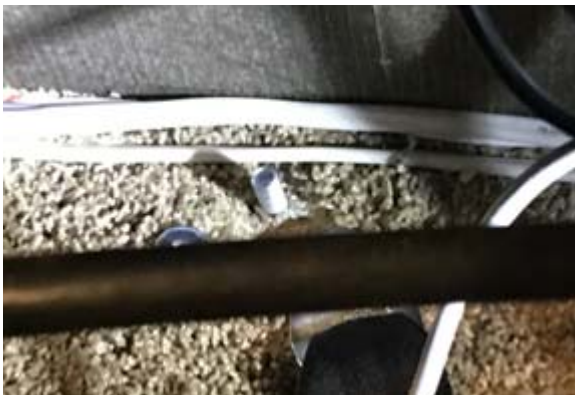
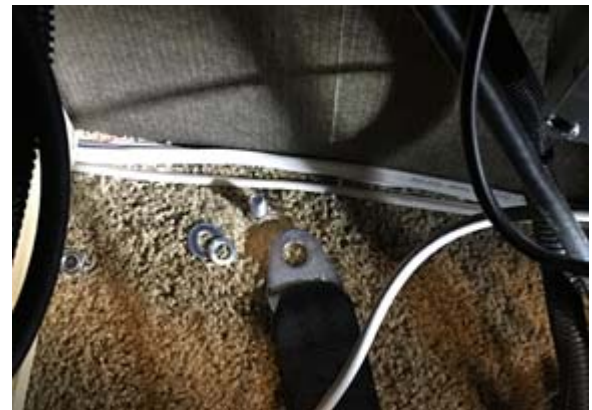
6. Remove ONLY the existing receiver side of the seat belt from its anchor bolt. Retain the washers and nut for later use. Repeat the other set.

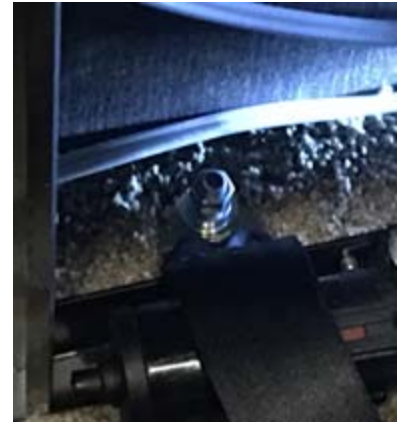
7. Install the new seatbelt receivers by putting the tongue of the belt assembly on the bolt first, then the flat washer, the split lock washer, and finally securing everything with the nut. Repeat for the other seatbelt receiver.

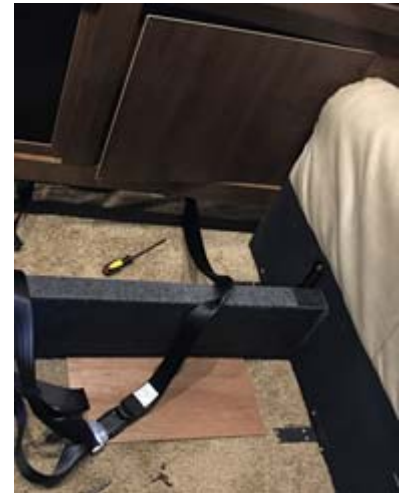
8. Drape the installed seatbelts over the carpeted cross bar.

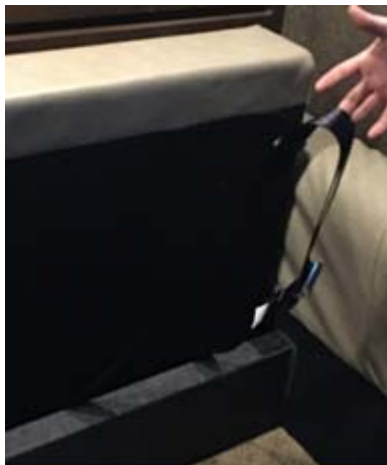
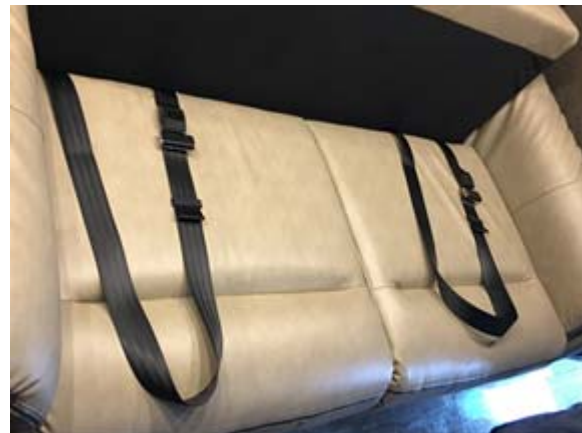
10. Hold or drape the seatbelts so that they are up off the floor and reinstall the sofa seat. The seatbelts should be laying on the seat once this step is complete.

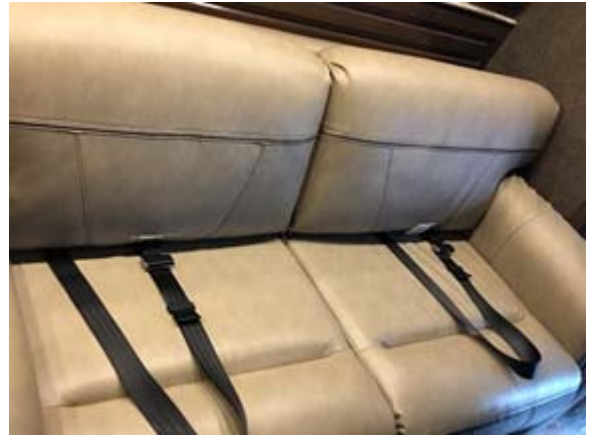
11. Reinstall the sofa back cushions.
