Thor Motor Coach Recall Repair Instructions

Recall # 17V-166

Description/Title: **30D/30FE Missing Middle Sofa Seatbelt**

Affected Product Line(s): **Certain 30D and 30FE Class C Motorhomes**

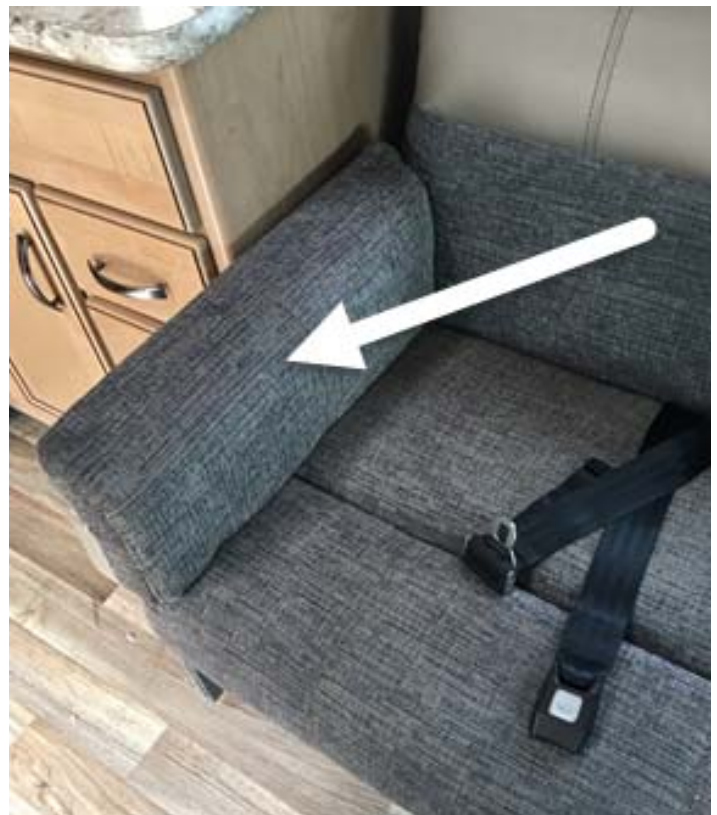
- 1. Remove both arm rests and set them aside.**
- 2. Put the sofa into the bed position**

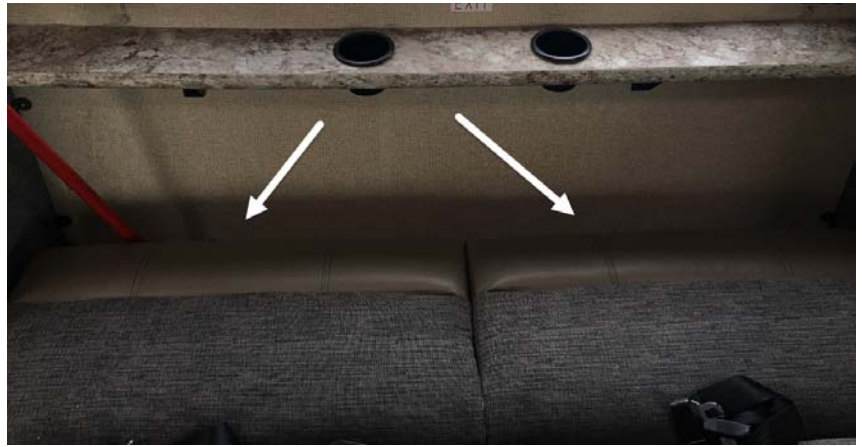
- 3. The seat belt bolts are along the sidewall and accessible once the sofa is flat.**

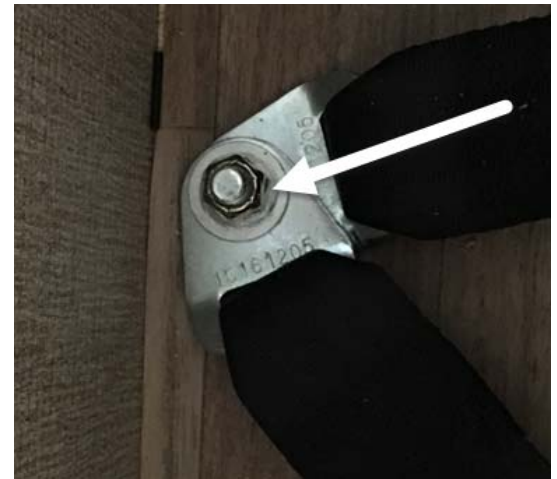
- 4. Remove the hardware from the two seat belt bolts closest to the middle of the sofa. Install the male end of the seatbelt onto the right hand (as you are looking at it) seatbelt bolt and the female end on the left hand (as you are looking at it) seatbelt bolt.**

- 5. Reinstall the hardware.**

- 6. Make sure that the seat belt does not interfere with the heat ducting or any other lines or cables that may run under the sofa.**

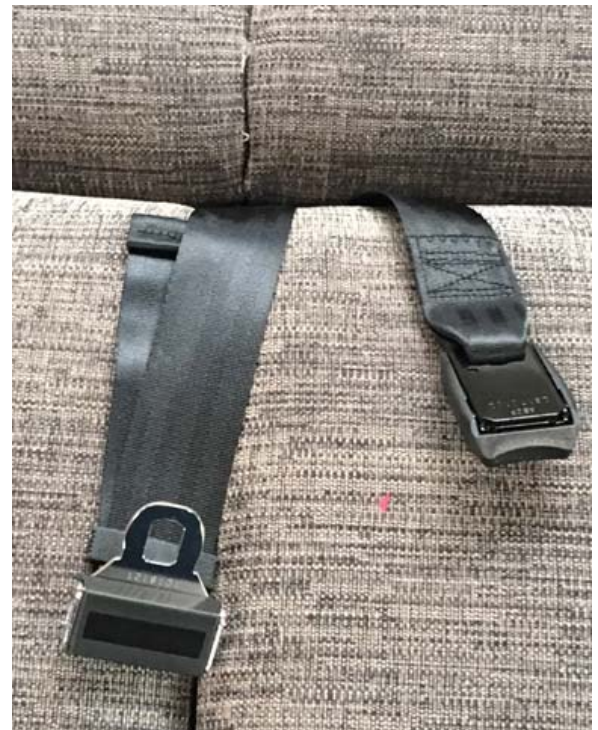
- 7. Fish the ends of the seatbelt through the crack in between the sofa seat and back.**

- 8. Return the sofa into the seating position.**

- 9. Reinstall the armrests.**
