SAFETY RECALL

SR17-80

I-START DUAL BATTERY SYSTEM - WRONG CONNECTION OF GROUND CABLES GND11 & GND11A 9700 US/CAN (B13R)

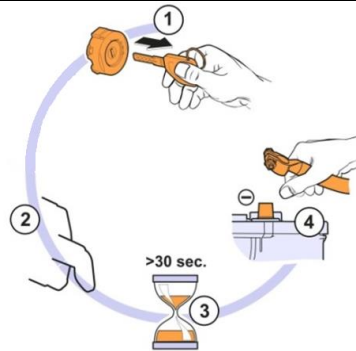
FIGURE 1

- 1) Turn off the vehicle electrical system, by following these steps:
 - Remove ignition key;
 - Turn off battery switch;
 - Wait at least 30 seconds;
 - Disconnect **NEGATIVE** cable from vehicle battery.

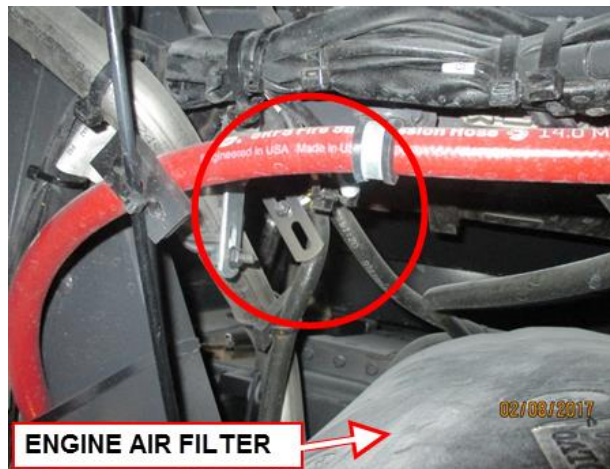
FIGURE 2

- 2) Locate the ground connection point above the engine air filter (FIGURE 2).

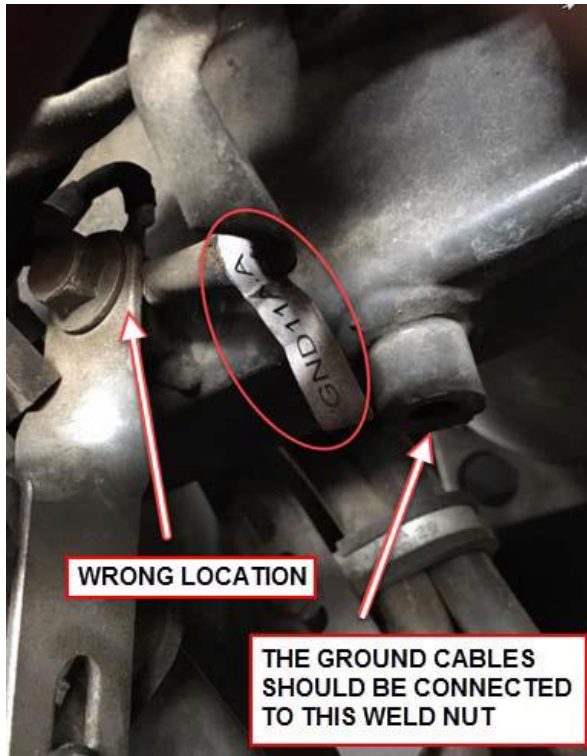
- 3) Make sure that both ground cables (GND11 & GND11A) are connected together on the proper ground connection point (FIGURE 3). If not, perform steps 4 & 5.

WELD NUT DESCRIPTION: part number #1136923 M8x18mm.

FIGURE 3: WRONG CONNECTION OF GROUND CABLES

- 4) Thoroughly clean the weld nut and the cable ring terminals to ensure good electrical conductivity.
- 5) Fasten the ground cable terminals to the connection point using flange screw #946440, torque 20 ± 4 lbf-ft (28 ± 5 N-m) (FIGURE 4).

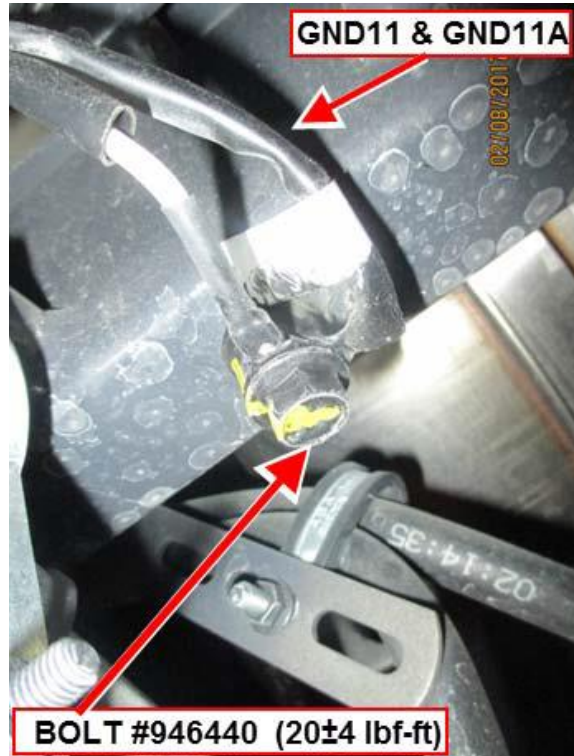
FIGURE 4: PROPER CONNECTION OF GROUND CABLES

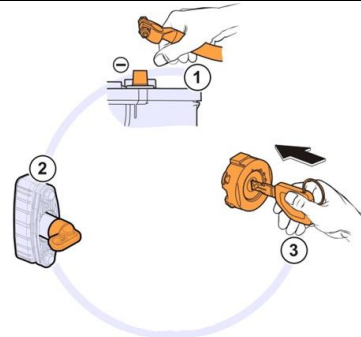
FIGURE 5

- 6) Turn on the vehicle electrical system. Follow these steps:

- Connect NEGATIVE cable to the vehicle battery;
- Turn on battery switch;
- Insert vehicle key.
