Recall Service Bulletin

DATE: April 12, 2017

NHTSA/TC Id: **17V-160**

CONDITION: The central steering system ball joints may not have been properly torqued, or secured with **Loctite® 242®**, as installed into the pitman arms.

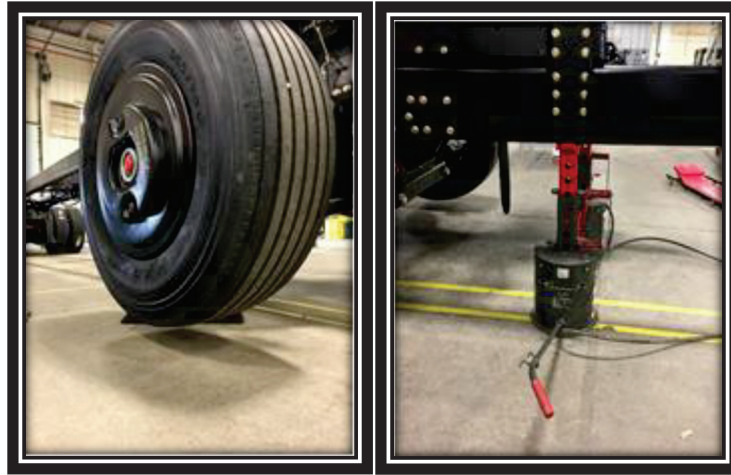
1. Ensure park brake is set and place wheel chocks behind rear wheels.
2. Lift front of vehicle until front wheels are off of the ground. Properly support vehicle with 10t – 12t jack stands.

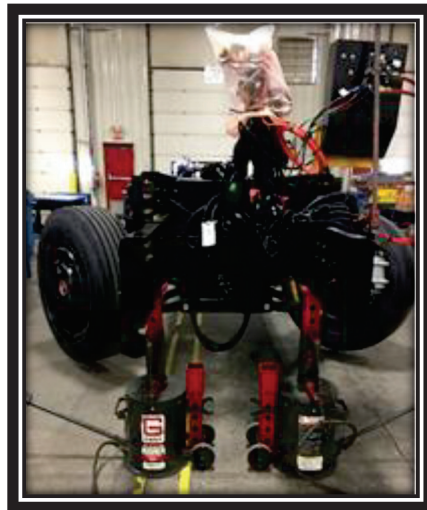
3. Steer wheels completely to the left.

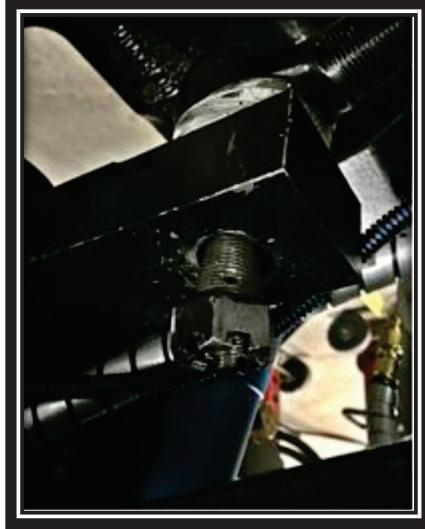
4. Beginning on the right side of the vehicle, remove castle nut from tie rod end that is connected to the relay rod.

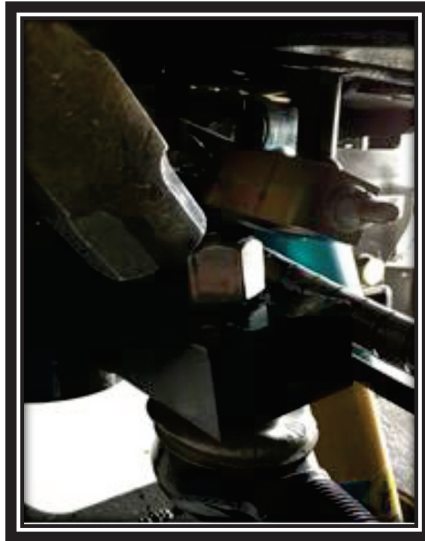
5. Place sacrificial 7/8"-14 nut on rod end stud and strike with hammer to un-seat tapered connection.

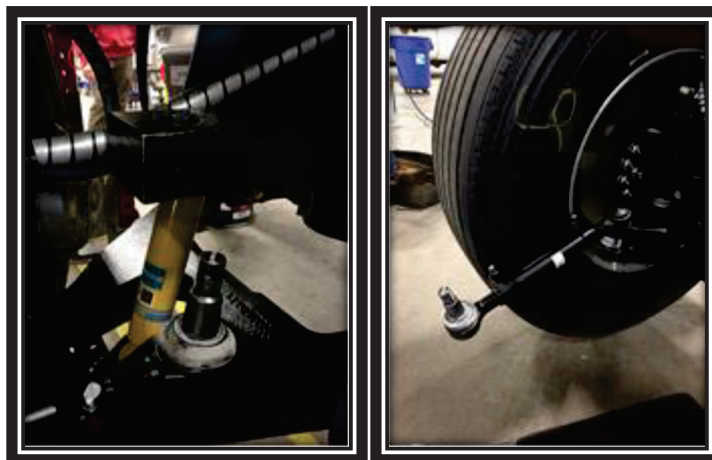
6. Remove tie rod end from relay rod assembly and position tie rod against wheel.

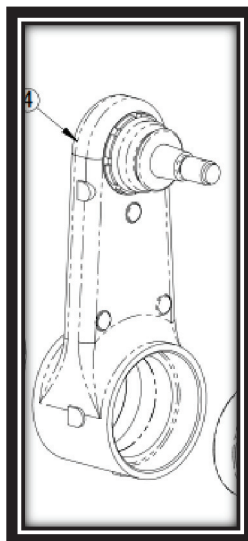
7. The following steps shown pertain to IFS18KS3 and IFS20KS3 (twin gearbox versions). All other units will have an idler arm assembly instead of a slave gear, but the removal of the idler arm equipped units will be similar.

The idler arm assembly is connected via a clevis mount with a 1" bolt/nut, which has to be removed to disconnect the idler arm assembly.

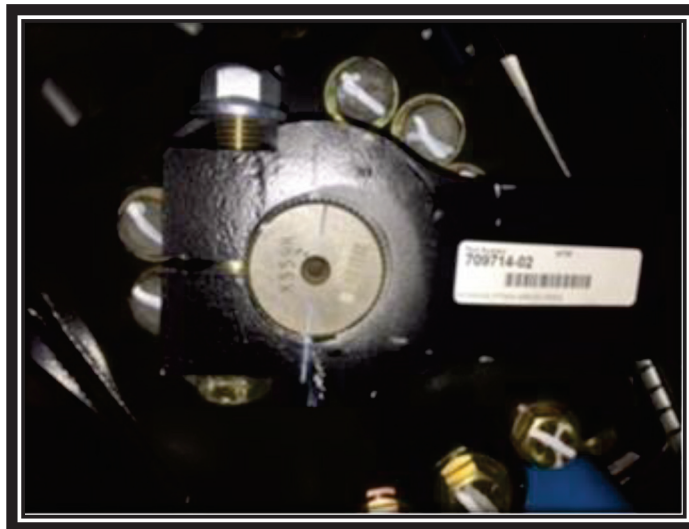
8. Mark the pitman arm to steering box output shaft as shown, to ensure correct alignment when re-assembling.

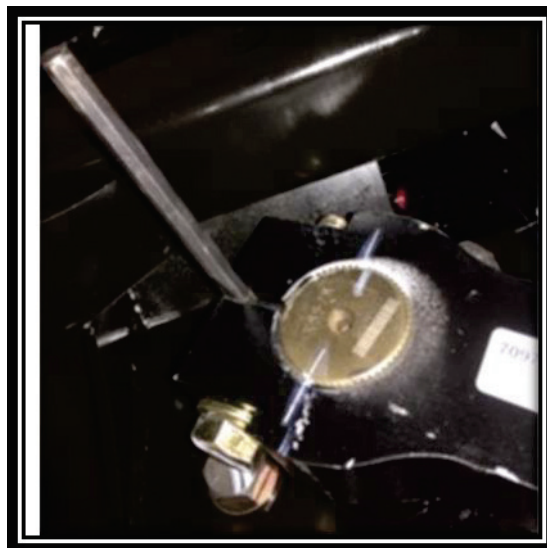
9. Remove pinch bolt nut from right pitman arm (leaving pinch bolt in pitman arm to prevent pitman arm from falling from Sector Shaft.)
10. Using a small chisel, spread pitman arm end.

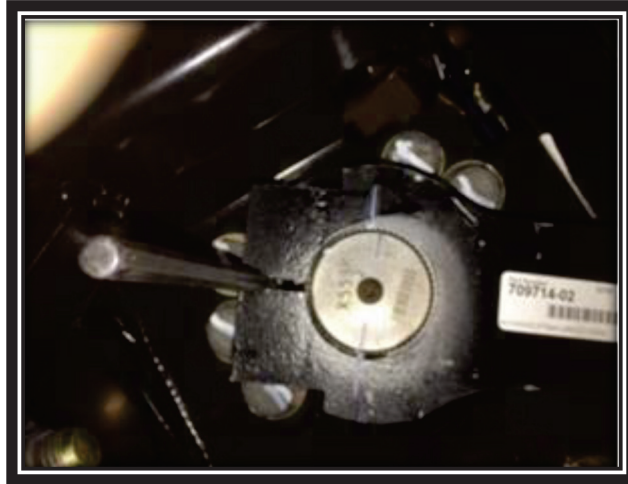
11. Remove pinch bolt from pitman arm.

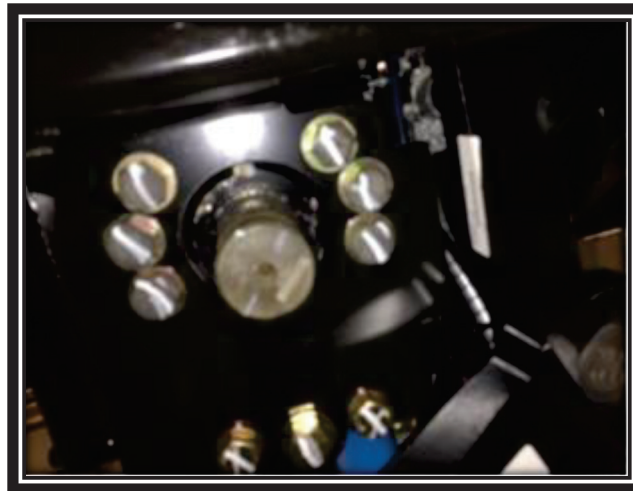
12. Lower pitman arm and position arm to where it is parallel with the relay rod.

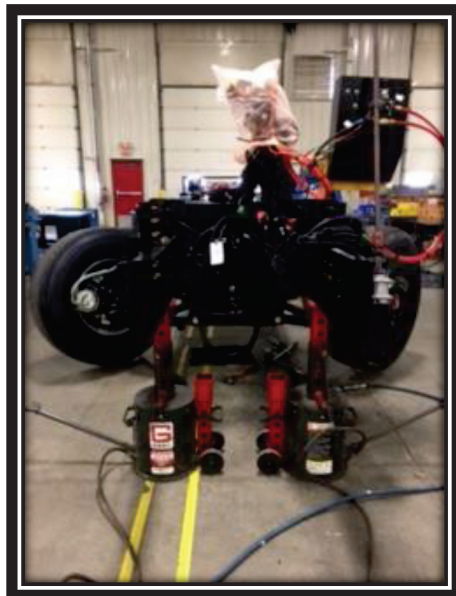
13. Slowly steer wheels completely to the right.

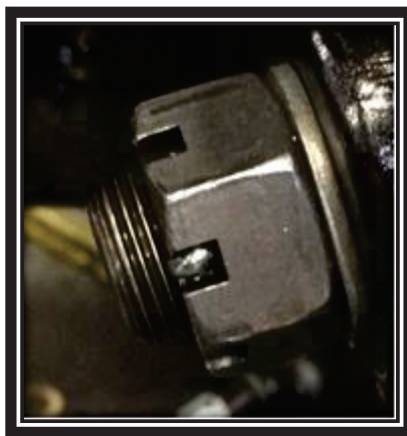
16. Remove the cotter pin from the ball joint stud.

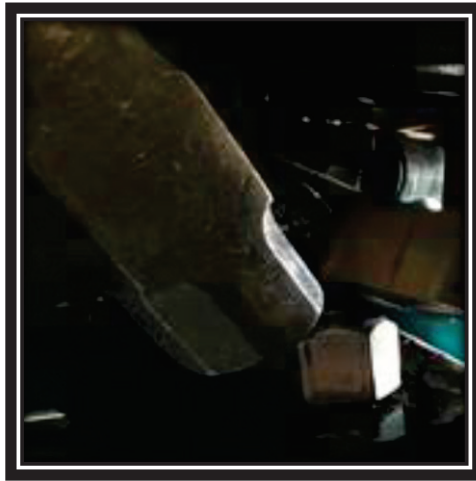
17. Remove the castle nut from the ball joint stud, retain for reinstallation. Ensure all washers found under castle nuts are re-installed in their original position.
18. Place sacrificial M20 1.5 nut on ball joint stud. Roll assembly over so sacrificial nut is on bottom resting on a solid surface. Strike relay rod downward with hammer to un-seat tapered connection.

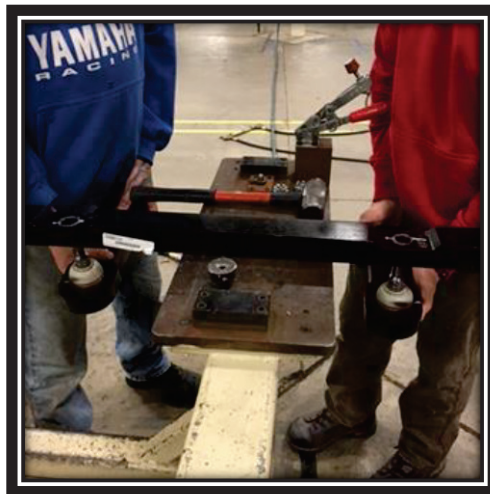
19. Remove ball joints from the relay rod.

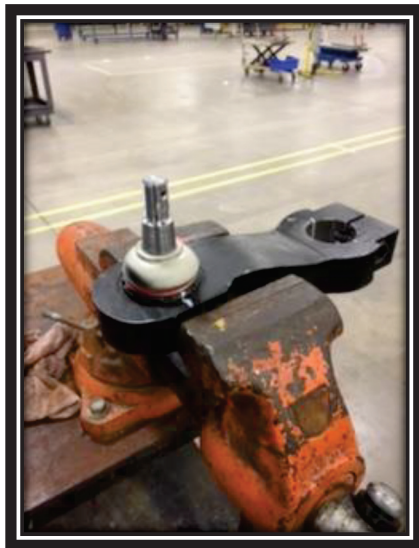
20. Place pitman arm (or idler/bell crank) assembly in a vice.

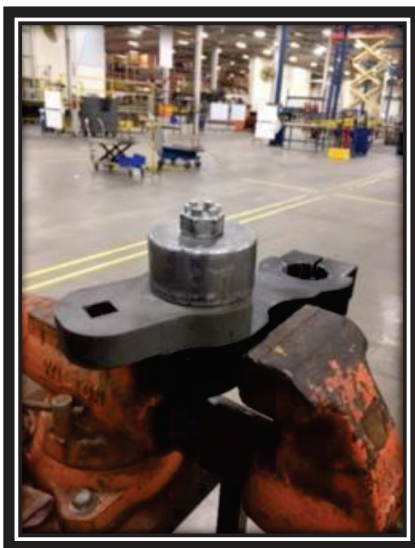
21. Using 40 mm ball joint tool and castle nut, place over ball joint.

USE CAUTION TO NOT TEAR BOOT

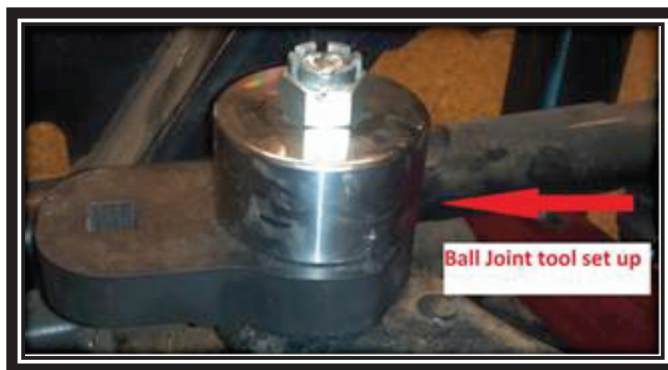
22. For each ball joint, run castle nut down, leaving castle nut slightly loose. **DO NOT RUN DOWN TIGHT**

Note: Tool 708116-05 is used with castle nut to hold tool 708116-02 loosely on the ball joints. Be sure that tooling set up is not binding when loosening, castle nut should come off freely after ball joint is loose.

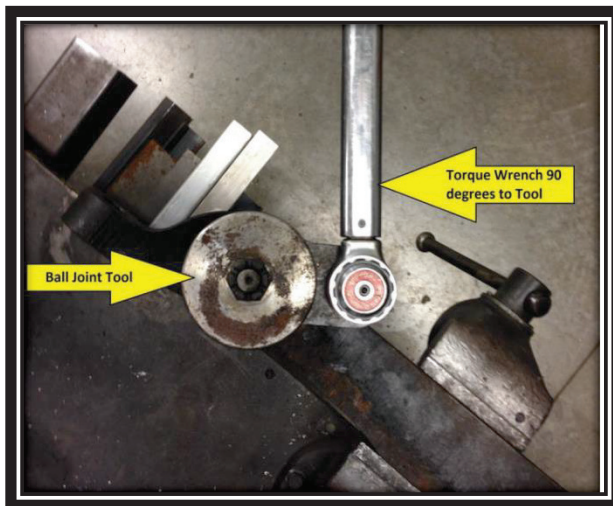
23. Set torque wrench to 500 lbf-ft. Insert torque wrench in ball joint tool as shown, and apply 500 lbf-ft. of breakaway torque. Torque wrench must be oriented as shown below.

24. If ball joint does not move, begin to reassemble by skipping to Line #34.

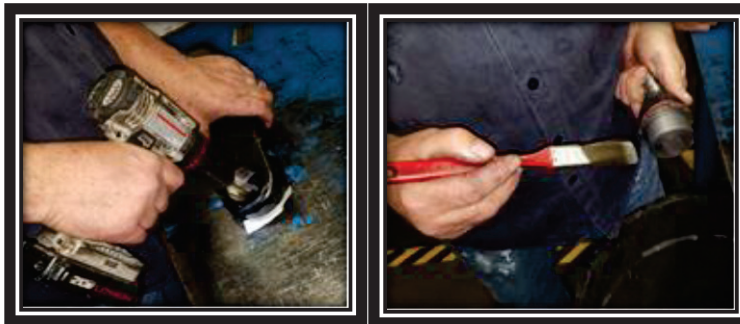
25. If ball joint moves (Breaks loose) before reaching required torque (500 lbf-ft) remove ball joint from pitman arm and clean threads on ball joint and pitman arm using a wire wheel. Clean with denatured alcohol.

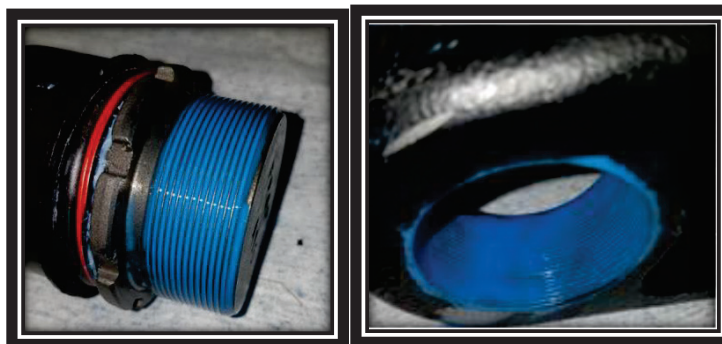
27. Using **Loctite® 242®** apply generously to the external threads of both ball joints and internal threads of the pitman arms. (Ensure that all threads are covered)

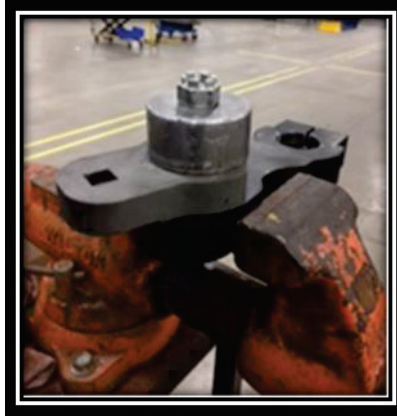
30. Using 50 mm ball joint tool and castle nut placed over ball joint (Use caution to not tear boot) torque the ball joint to 350 lbf-ft.

31. Be sure that tooling set up is not binding when tightening.
32. Castle nut should come off freely after ball joint is torqued.
33. Ensure that the ball joint is fully seated into the pitman arm.
34. Reinstall the relay rod to the front suspension in reverse order to removal using new cotter pins and the following torque specs:
- Tie rod castle nut – 90-100 lbf-ft.**
 - Ball joint castle nut – 155-170 lbf-ft.**
 - Pitman arm attachment bolt – 295-315 lbf-ft.**
 - If applicable the drag link castle nut – 90 - 100 lbf-ft.**
35. When tightening castle nuts ensure specified torque is achieved. Advance the nut to align the castle slot with the thru hole to allow cotter pin to be installed. **DO NOT BACK CASTLE NUTS OFF TO INSTALL COTTER PINS.**
