GROUP Safety Recall Campaign	MODEL 2017MY Cadenza (YG)
	NUMBER SC146	DATE April 2017
SAFETY RECALL CAMPAIGN		
SUBJECT: BRAKE VACUUM HOSE INSPECTION / REPLACEMENT (SC146)

SUBJECT: BRAKE VACUUM HOSE INSPECTION / REPLACEMENT (SC146)

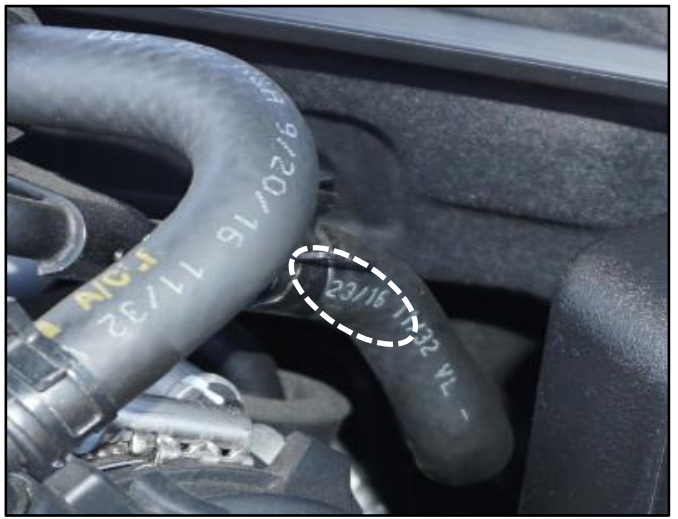
- 3. Locate a date formatted as **mm/dd/yy** or **yy/mm/dd** on the front or back of the hose.

There are two (2) date formats on the hose.

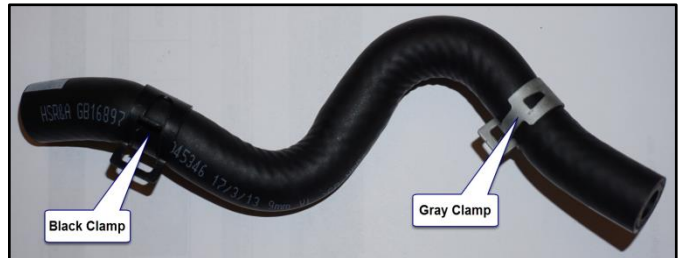
To ensure proper direction and placement of the check valve in the hose, install the hose with the black clamp end connected to the engine vacuum line and the gray clamp end connected to the brake booster.

- 3. Install the new brake booster vacuum hose using the two (2) new hose clamps included with the new hose.
