# Campaign Service

BULLETIN NUMBER:  
**CB17-F-001**

## IMPORTANT SAFETY RECALL

### LEFT REAR WHEEL BEARING HUB LOCKING BOLTS

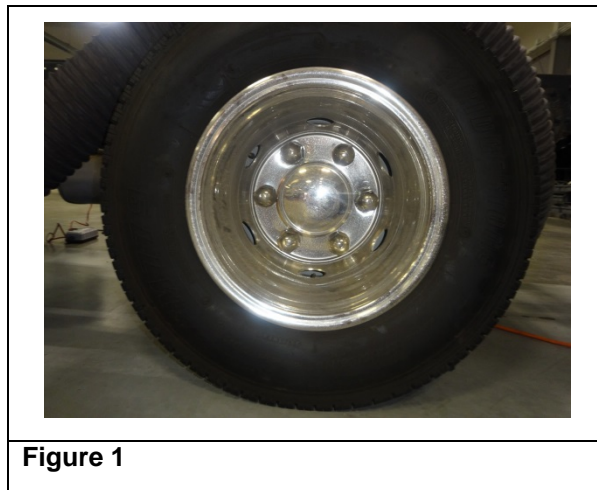
1. Park the vehicle, set the parking brake, turn off the engine and block the tires. Make sure that your tire block is adequate, so that the vehicle does not move suddenly when the left axle shaft is removed.
2. If the vehicle is equipped with wheel simulators (RPO IK0) (See Figure 1), remove the wheel nut covers on the left rear wheel. Remove the three (3) wheel nuts holding on the wheel simulator center cover and remove the center cover.

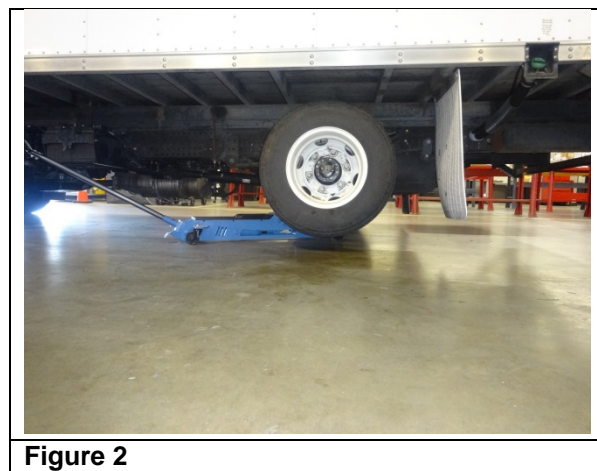
3. Using a jack, raise the left tire of the rear axle off the ground approximately 4 inches (100mm). This is to avoid rear axle oil loss during this procedure (See Figure 2).

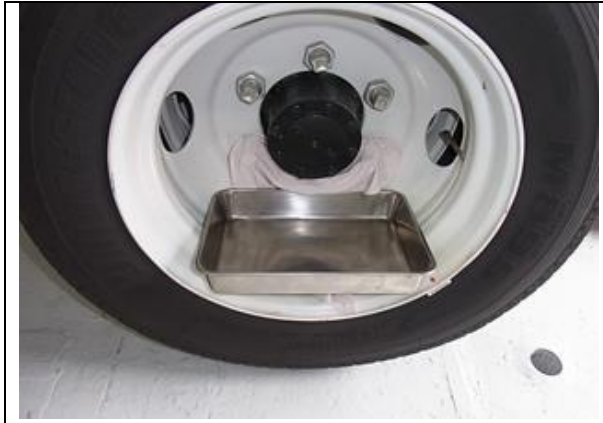
**Figure 3**

4. Place a catch pan or cloth under the rear axle shaft inside the lifted rear wheel to catch any oil that may drain while removing the axle shaft (See Figure 3).

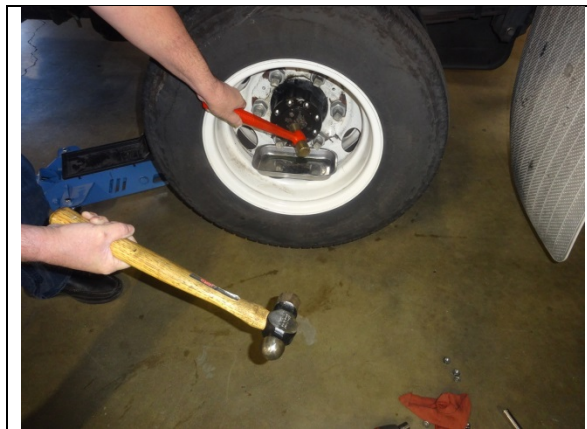
**Figure 4**

5. Loosen the eight (8) nuts holding the axle onto the hub. Leave the eight (8) nuts screwed onto the hub studs two (2) turns to catch the cone washers.
6. Place a brass hammer on the face of the axle and strike the brass hammer with another hammer until the axle shaft is loosened (See Figure 4). Make sure to wear safety glasses while striking the hammers together.

***Do not use a chisel or wedge to loosen the shaft because this could damage the hub or the shaft.***

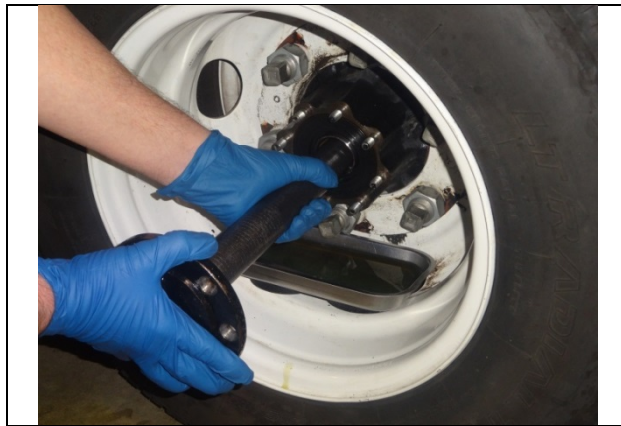
**Figure 5**

8. Remove the axle shaft (See Figure 5).

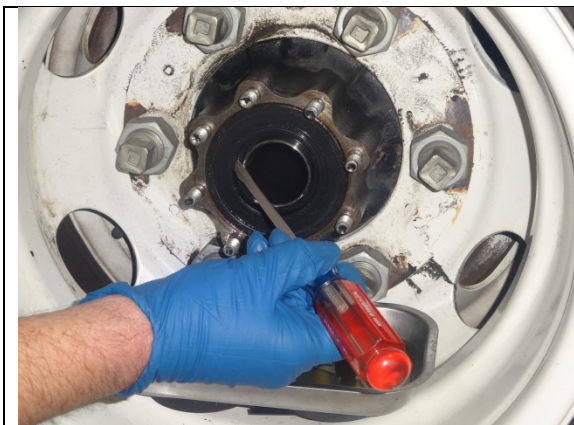
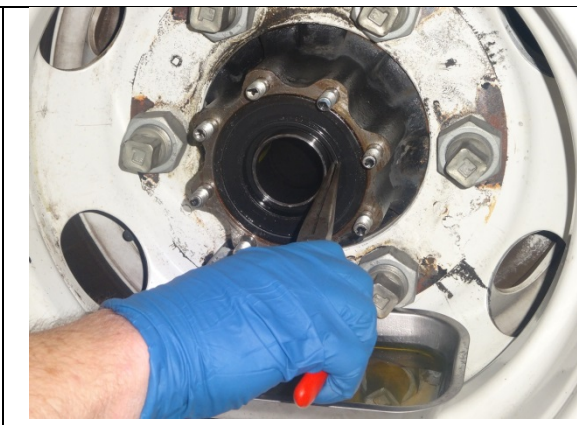
**Figure 6**

9. Using a screwdriver or a pair of needle nose pliers, remove the outer oil seal (See Figures 6 and 7). Discard the old outer oil seal.

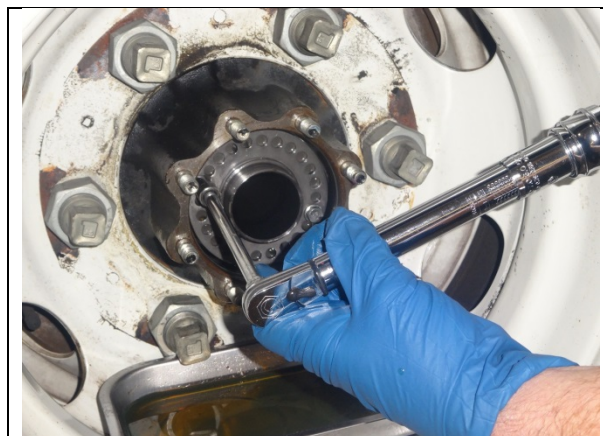
**Figure 8**

10. Torque the two (2) locking bolts to 10 Nm (87 lb in) (See Figure 8).

Isuzu dealers will inspect the affected vehicles' left rear wheel bearing hub locking bolts for proper torque and, as necessary, tighten the bolts to the specified torque level.

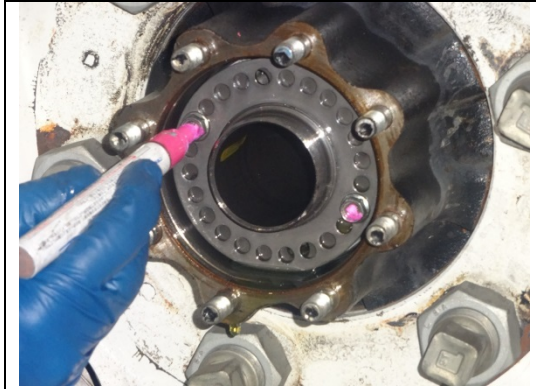
Figure 9

11. Clean each bolt head with brake cleaner and a towel. Paint each bolt head with a paint marker pen as verification the bolt has been torqued (See Figure 9).

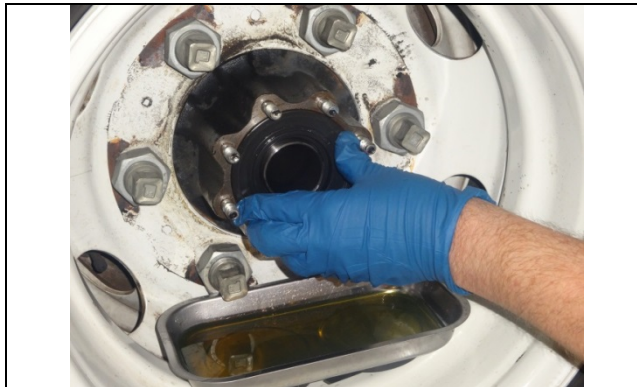
Figure 10

12. Install a new outer oil seal (See Figure 10).

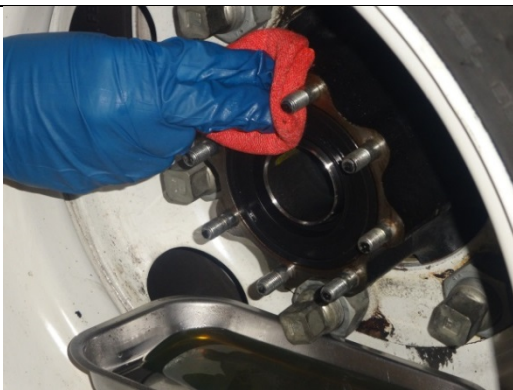
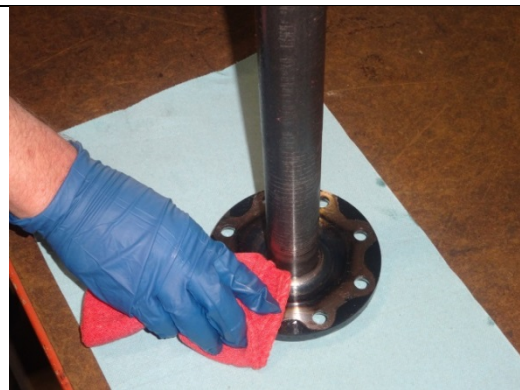
Figure 11

- Wipe the axle shaft off so that foreign matter is not introduced into the axle housing.
- Clean the hub mating surface of the axle shaft and the hub (See Figures 11 and 12).

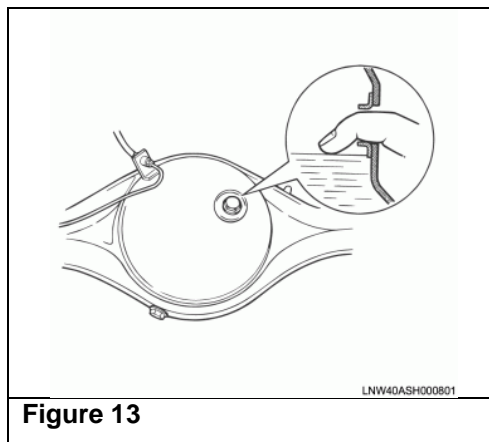
16. Remove the carrier oil fill plug and check the fluid level. Add lubricant to within 0 to 0.4 inch (10 mm) of bottom edge of the filler hole, if necessary (See Figure 13). Install the carrier oil fill plug and torque to 84 Nm (62 lb ft).
