# Safety Recall

## Code: 69Q3

<b>Subject</b>	<b>Airbag System Software</b>
<b>Release Date</b>	April 4, 2017
<b>Affected Vehicles</b>	<b>U.S.A. &amp; CANADA: Certain 2017 MY Audi A3/S3 Sedan</b> <i>Check Campaigns/Actions screen in Elsa on the day of repair to verify that a VIN qualifies for repair under this action. Elsa is the <u>only</u> valid campaign inquiry &amp; verification source.</i> <ul style="list-style-type: none"><li>✓ Campaign status must show "open."</li><li>✓ If Elsa shows other open action(s), inform your customer so that the work can also be completed at the same time the vehicle is in the workshop for this campaign.</li></ul>
<b>Problem Description</b>	In lower-speed crash situations with an out-of-position occupant, the airbag control module software may classify the crash incorrectly. If this happens, the system may trigger a more forceful passenger frontal airbag deployment than necessary, increasing the risk of injury to a front seat occupant.

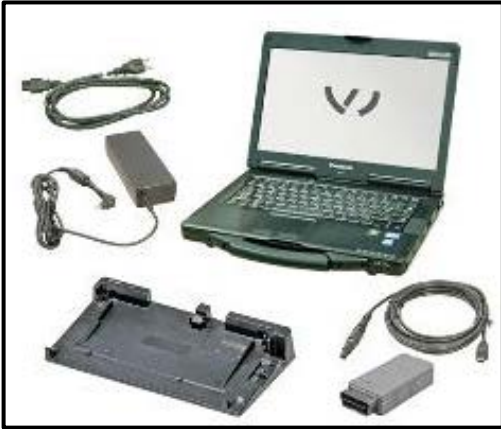
- VAS6150D - Diagnostic Tester (or equivalent)
- VAS5054A – Remote Diagnosis Head (or equivalent)

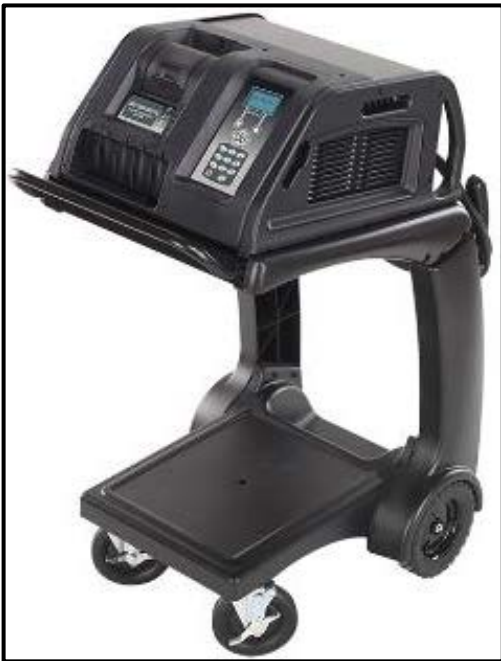
- GRX3000VAS – Battery Tester/Charger (or equivalent)

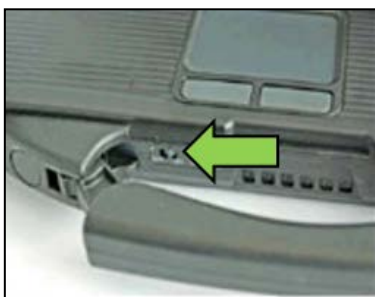
**VAS 6150 & VAS 6150A**  
(Front panel behind handle)

- Performing a software update using a Bluetooth connection increases the risk of losing connection during the update, which could result in damage to the control module. It also greatly increases the time required to perform the update. Requests for additional time or parts will be denied if the GFF log shows the update was performed using Bluetooth.
- ✓ **The Bluetooth function of the scan tool is physically switched off <see pictures below>.**

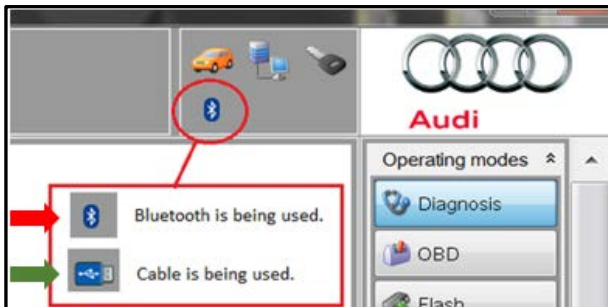
- Open the hood.
- Open the battery cover.
- Attach the GRX3000VAS Tester/Charger (or equivalent) to the vehicle battery.
- Connect the VAS6150D Diagnostic Tester (or equivalent) to the vehicle.
- Start the ODIS program.
- Confirm that scan tool is communicating with the diagnostic head by USB <Green Arrow>.
  - If the Bluetooth symbol is shown <Red Arrow> then disconnect the diagnostic head from the vehicle and reconnect the USB cable to the diagnostic head and then reattach to the vehicle.

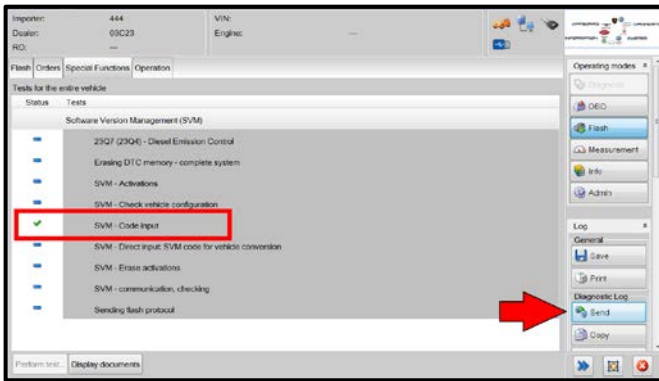
- When the flash is completed, the tester will return to this screen.
- Select “Send” <arrow> to send the GFF Diagnostic log to GFF paperless.

The green check mark indicates the flash was performed successfully.
