March 31, 2017

06110 Version 1

Safety Recall: Front Passengers Airbag Assembly May Contain a Takata Inflator That Can Be Over-Pressurized

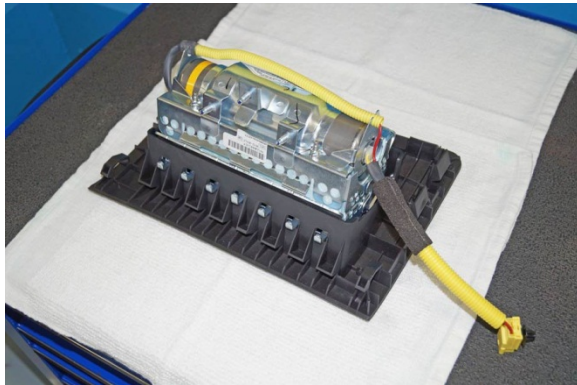
8. Place the airbag, face-down, on a clean shop towel.

- The orientation of the airbag is critical because if the inflator is installed incorrectly, the harness will be too short when you reinstall the airbag.
- The brackets between the various models are similar but may differ from the example shown.

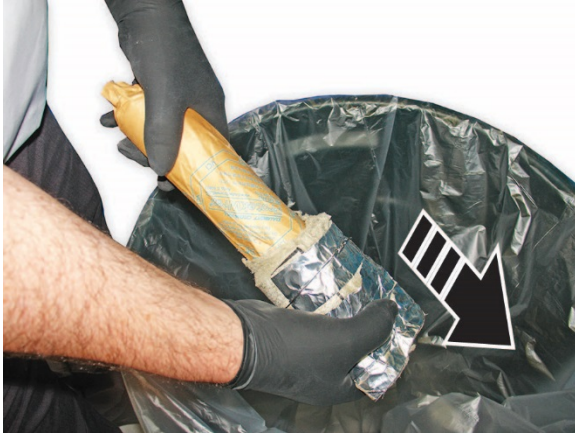
- Hold the paper wrapping the inflator with one hand and slide the insulation off into the trash.
NOTE: The insulation is securely wrapped around the inflator. You may have to use some force to slide the insulation off. Do not cut the insulation and be careful that you do not move the white or orange plastic ends.

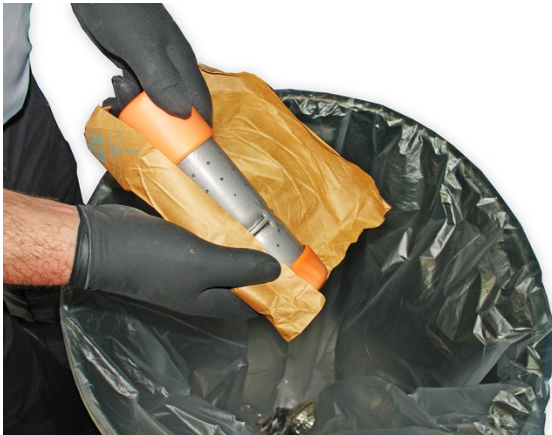
- Remove the wrapping paper and drop it into the trash.

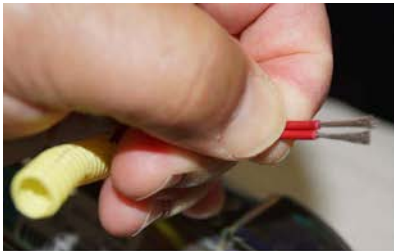
- Strip away about 1 inch of the wire insulation, then twist the wires together.

- Tape the twisted ends with electrical tape.
