**Title:** Reyco Granning Suspension Safety Recall

**Problem:** Potential Improper Securement of Central Steering Ball Joints Recall No. 17E013

<b>DATE</b>	03/27/2017 REV. 004
<b>APPLIES TO</b>	FIRE APPARATUS INDEPENDENT FRONT SUSPENSIONS MODELS: IFS2400S-FT & IFS2000S-FT IFS20-XXXXX, IFS24-XXXXX
<b>SUBJECT</b>	IFS BALL JOINTS – RECALL NHTSA ID: 17E013
<b>CONDITION</b>	The central steering system ball joints located in the relay rod may not have been properly torqued, or secured with Loctite 242.
<b>CORRECTION</b>	Check central steering system ball joints breakaway torque, and repair if found loose, as per instructions below
<b>LABOR ALLOCATION</b>	3.0 hours for removal and repair (two people for 1.5 hrs.) 1.0 additional hour if ball joints are damaged and need to be replaced (two people for 0.5 hrs.)
<b>TOOLS REQUIRED</b>	Side Cutter, Vice Grip, Pliers, 3lb hammer 30mm, 1 5/16" and 1 1/8" socket with 1/2" drive 1 1/2" socket with 3/4" drive 1 1/8" end wrench Hook style pry-bar and small dull chisel 1/2" clicker style torque wrench (90-100 lbf-ft) 1/2" clicker style torque wrench (155-170 lbf-ft) 1/2" clicker style torque wrench (295-315 lbf-ft) 3/4" clicker style torque wrench (

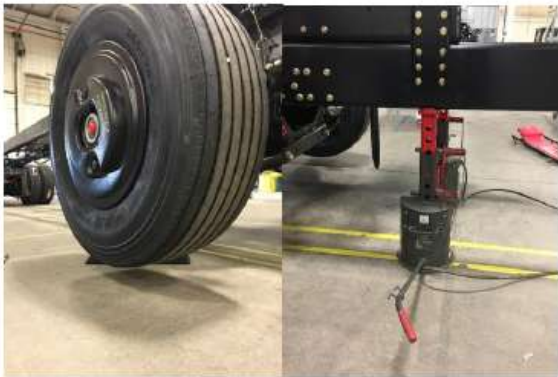
Step	Instruction	Illustration
1	Safely lift vehicle until the wheels are off the ground. Properly support vehicle with 10t to 12t jack stands.

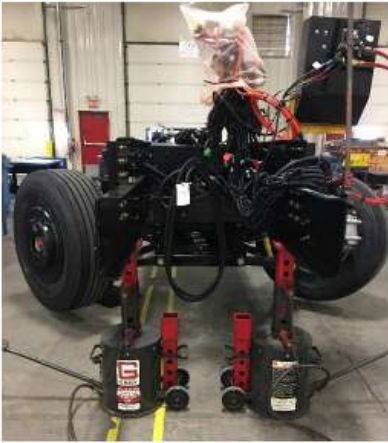
2	Steer wheels all the way to the left

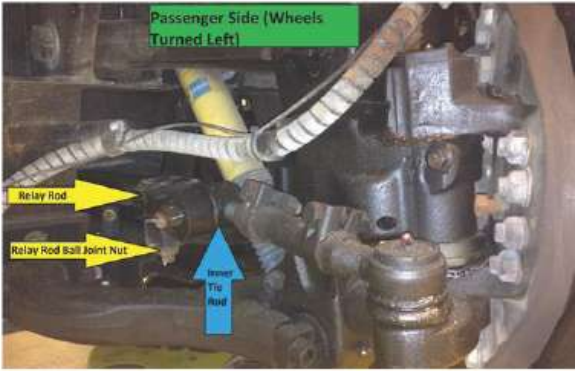
3	Starting on the right hand side (passenger), remove cotter pin and castle nut from tie rod end that is connected to the relay rod.

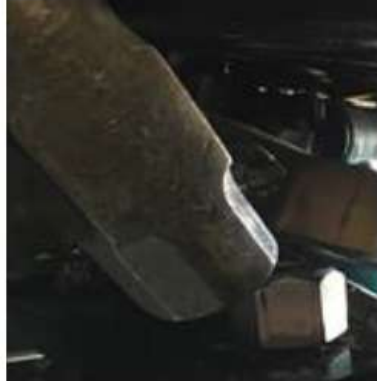
4	Place sacrificial 7/8"-14 nut on rod end stud and strike with hammer to un-seat tapered connection.

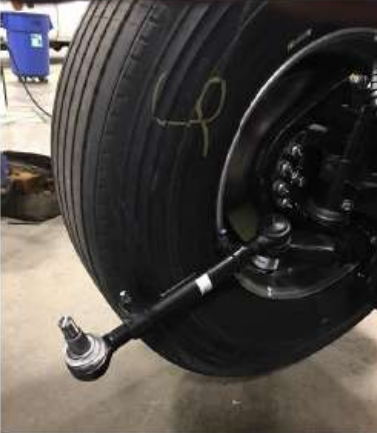
5	Remove tie rod end from relay rod assembly and position tie rod against wheel

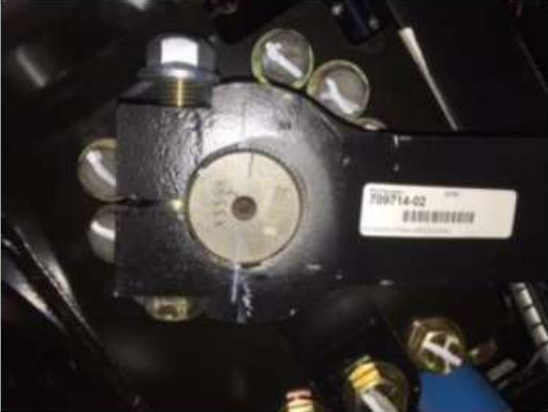
6	Mark the pitman arm to steering box output shaft as shown, to ensure correct alignment when re-assembling. Remove pinch bolt nut from right pitman arm (leaving pinch bolt in pitman arm to prevent pitman arm from falling from steering box output shaft)

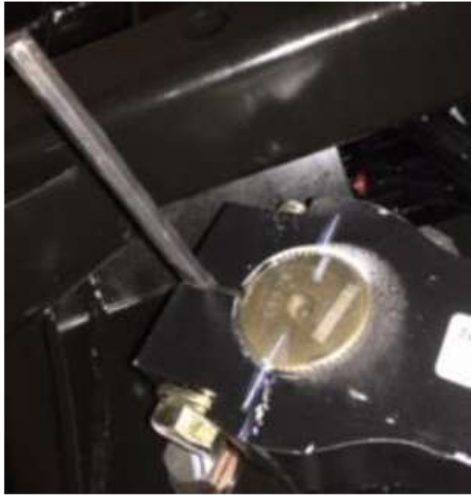
7	Using small chisel, spread pitman arm end

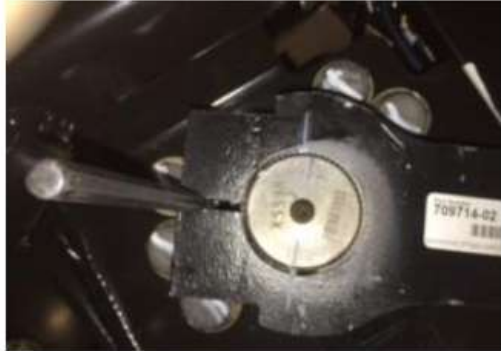
8	Remove pinch bolt from pitman arm

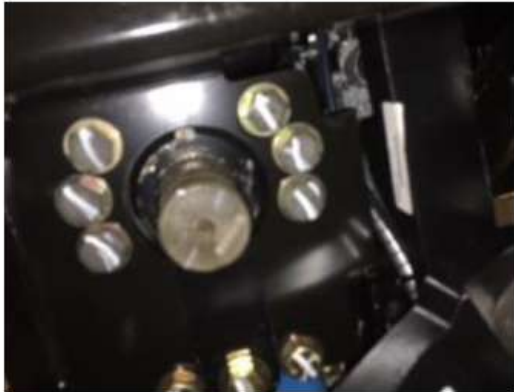
9	Lower pitman arm and position pitman arm to where it's parallel with the relay rod

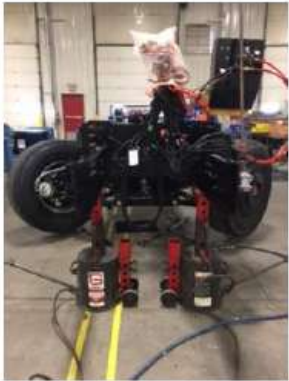
10	Steer wheels all the way to the right and switch sides

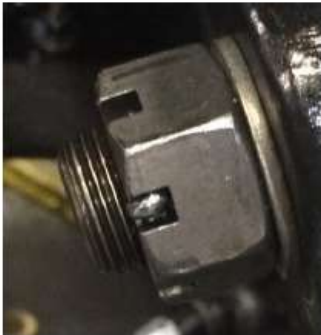
11	Repeat steps for the left hand side (driver side). Remove relay rod assembly. (Slide relay rod assembly out towards the left side of the vehicle)	
12	Remove the cotter pin from the ball joint stud.  Remove the castle nut from the ball joint stud, and retain for re-install.  <b><i>Ensure that all washers found under castle nuts are re-installed in their original position</i></b>

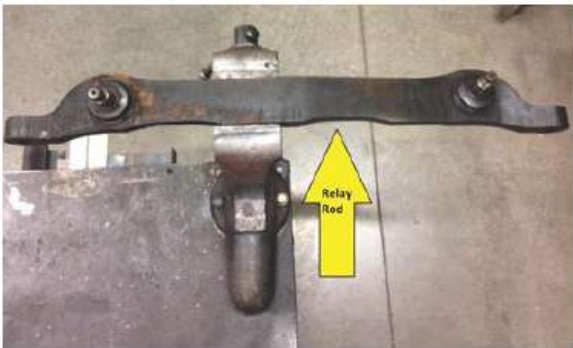
13	Place relay rod assembly in vice as shown.  Remove pitman arms from the ball joints, using sacrificial nuts.

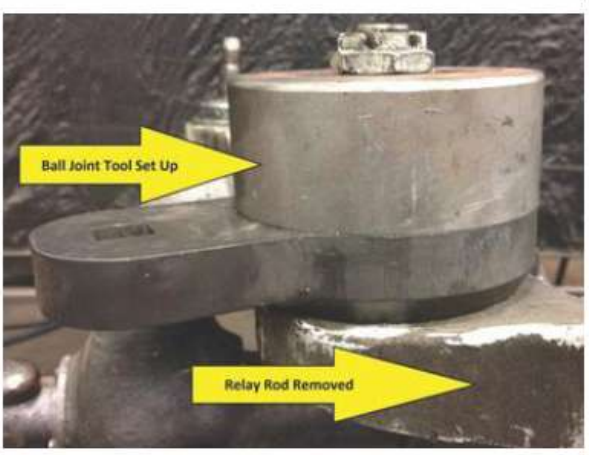
14	<p>Using 50 mm ball joint tool and castle nut, place over ball joint (Use caution do not tear boot)</p> <p>Run castle nut down, leaving castle nut slightly loose ("DO NOT RUN DOWN TIGHT")</p> <p>Note: Tool 708116-03 is used with castle nut to hold tool 708116-06 loosely on the ball joints. Be sure that tooling set up is not binding when loosening, castle nut should come off freely after ball joint is loose.</p>

3. Improperly torquing the castle nut when using the ball joint tools (This can result in improper torque application.)
  - a. For removal, nut should be tightened until tool is almost seated, with no gaps above or below

- i. Nut should never be more than hand tight.
  - b. For installation, run the ball joint down until the flange touches, then put the ball joint tool in place.

- i. Run nut down to contact and back off slightly.
    - ii. If another repositioning of the ball joint tool is required, reset the nut as above *each* time.

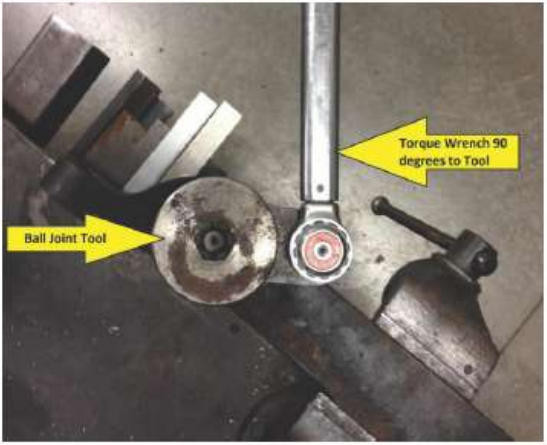
15	<p>Using torque wrench (Set at 500 ft.lb) place in ball joint tool and apply 500 ft.lb of breakaway torque to the ball joint.</p> <p>Repeat this for the other ball joint.</p>

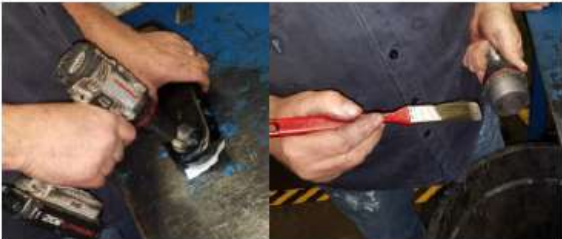
16	<p>If ball joint moves (Breaks loose) before reaching required torque (500 lbf-ft), remove ball joint from pitman arm and clean external thread on ball joint and internal thread on pitman arm using a wire wheel. Clean threads with denatured alcohol.</p>

1. Failure to completely clean the threads of the pitman arm / ball joints prior to application of Loctite 242.
  - a. Remove all debris from threads.
  - b. Remove any oil or other residue from threads using Denatured Alcohol.

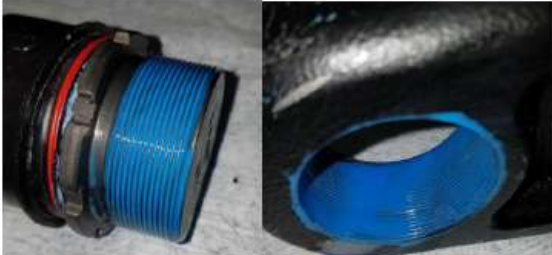
17	<p>Ensure threads are clean and dry.          Ensure that the Loctite242 is not expired.          Using Loctite, 242 apply generously to the external threads of both ball joints and internal threads of the relay rod.          (Ensure that all threads are covered)</p>

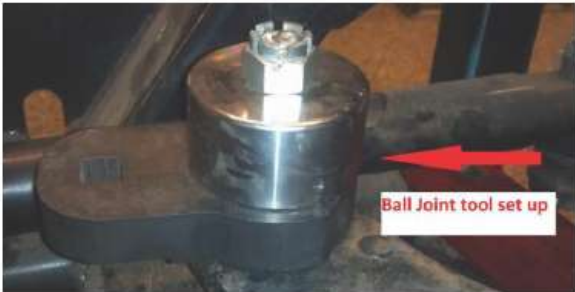
18	<p>Install ball joint with Loctite 242 applied, into the relay rod. Screw in by hand, until properly seated.          Using 50 mm ball joint tool and castle nut, placed over ball joint (Use caution do not tear boot), torque the ball joint to 325-375 lbf-ft. Be sure that tooling set up is not binding when tightening.          Castle nut should come off freely after ball joint is torqued.          Ensure that the ball joint is fully seated into the relay rod.          Repeat for opposite side.</p>
