| | <b>GROUP</b><br><b>Safety Recall Campaign</b> | <b>MODEL</b><br><b>2011-2014MY Optima (QF/TF)</b><br><b>2012-2014MY Sorento (XMa)</b><br><b>2011-2013MY Sportage (SL)</b> |
| | <b>NUMBER</b><br><b>SC147 (Rev 12, 07/09/2020)</b> | <b>DATE</b><br><b>June 2017</b> |

**SUBJECT: THETA II ENGINE INSPECTION AND/OR REPLACEMENT**

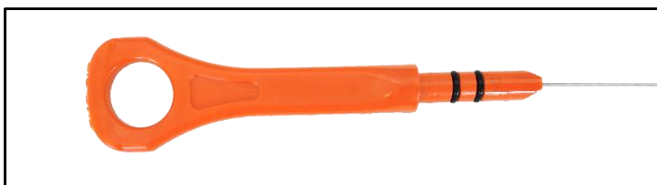
**Orange Dipstick (P/N: 26611 2G050QQK)**

21. Disconnect the engine noise tester from the KDS and carefully remove the adapter (B) from the dipstick tube by grasping the engine noise tester adapter.
22. For 2011-2013MY vehicles only: If the vehicle is equipped with a YELLOW dipstick, discard the dipstick and replace it with a new ORANGE one.

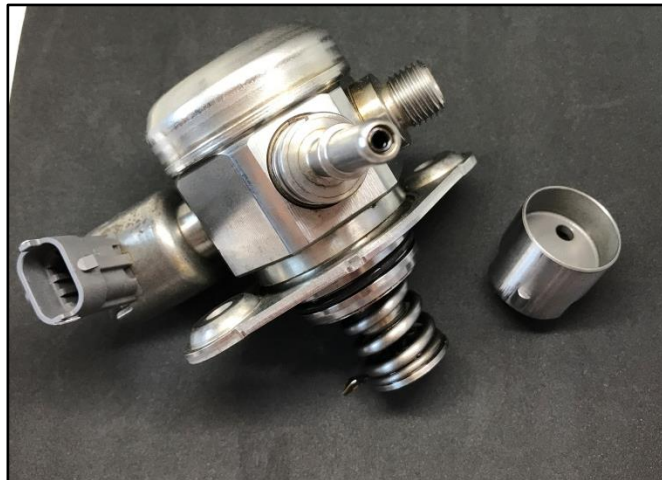
**Tightening torques of pump bolts:**  
 9.4 – 10.9 lb.ft (12.8 – 14.7 N.m,  
 1.3 – 1.5 kgf.m)

**Tightening torques of pipe flare nut:**  
 19.5 – 23.9 lb.ft (26.5 – 32.4 N.m,  
 2.7 – 3.3 kgf.m)
