GROUP Safety Recall Campaign	MODEL 2011-2014MY Optima (QF/TF) 2012-2014MY Sorento (XMa) 2011-2013MY Sportage (SL)
NUMBER SC147	DATE June 2017

SUBJECT: THETA II ENGINE INSPECTION AND/OR REPLACEMENT (SC147)

This bulletin provides the procedure to inspect, and if necessary, replace the engine long block assembly on the following vehicles:

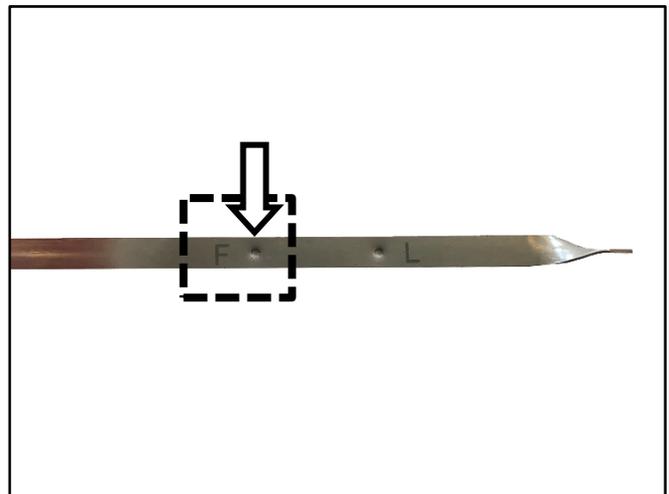
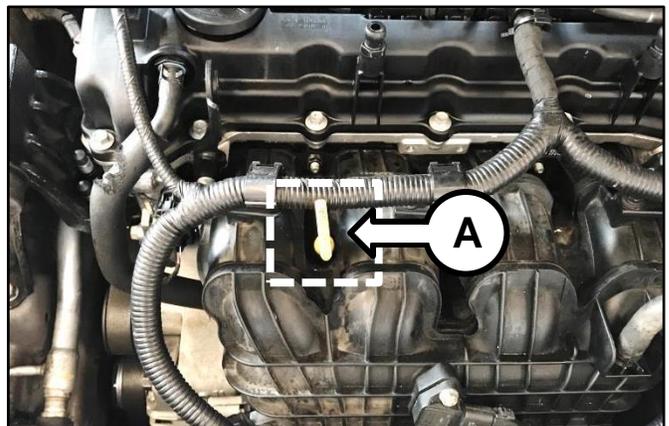
2. With the engine off, remove the dipstick (A).

Engine cover removed in images for demonstration-only purposes.

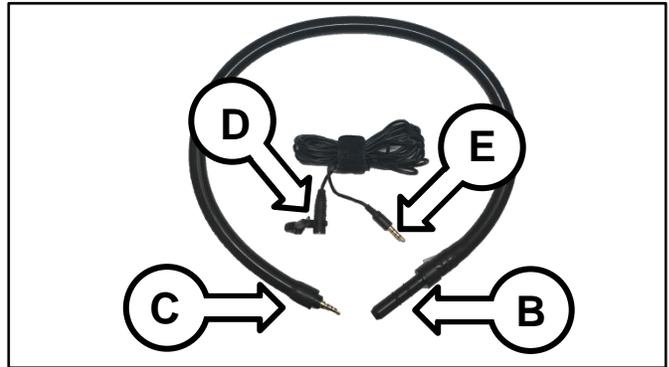
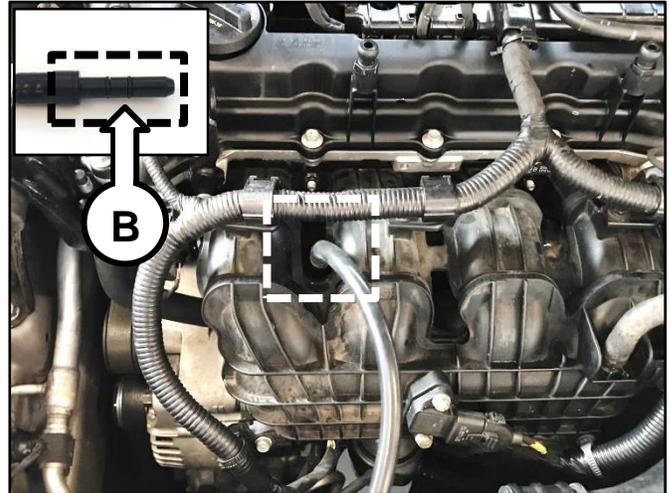
3. Insert the engine noise tester SST adapter (B) into the dipstick tube and start the engine.

Ensure the adapter (B) is properly inserted into the dipstick tube and avoid contact with the intake manifold.

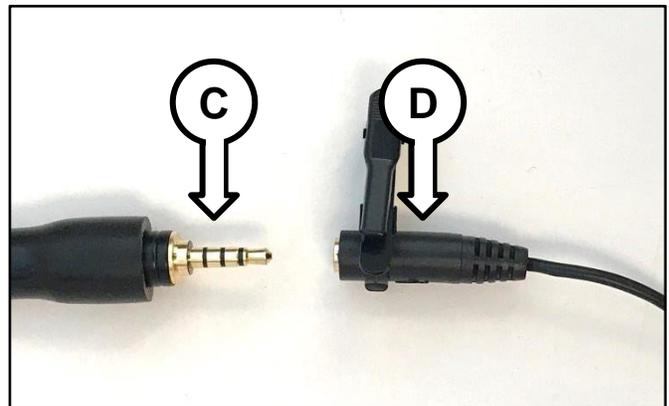
4. Connect the 3.5 mm male end of the engine noise tester SST (C) to the 3.5 mm female end of the extension cable (D).

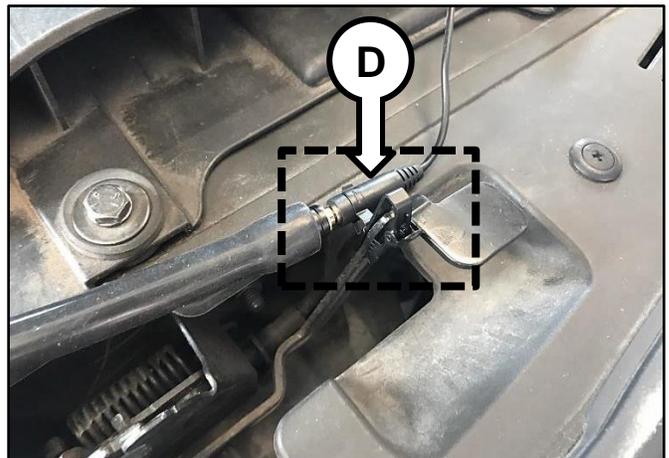
5. Attach the SST clip of the extension cable (D) to the hood latch.

Make sure to route the extension cable away from moving parts (pulleys, fan, and belts and be careful not to get it pinched between door and body or window, etc.).

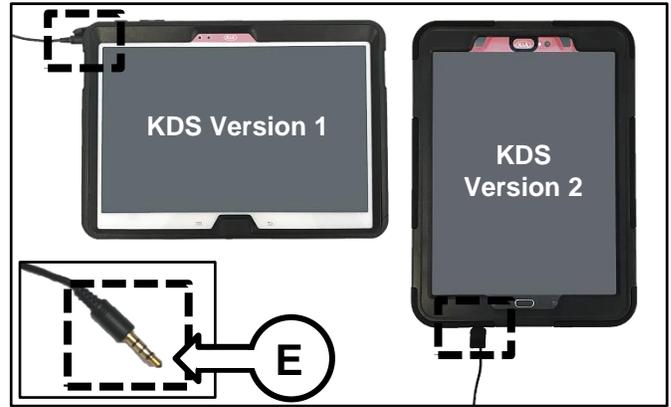
- Connect the 3.5 mm male end (E) of the extension cable to the headphone port located at the upper left corner (KDS version 1.0) or at the bottom of the tablet (KDS version 2.0), then start and idle the engine.

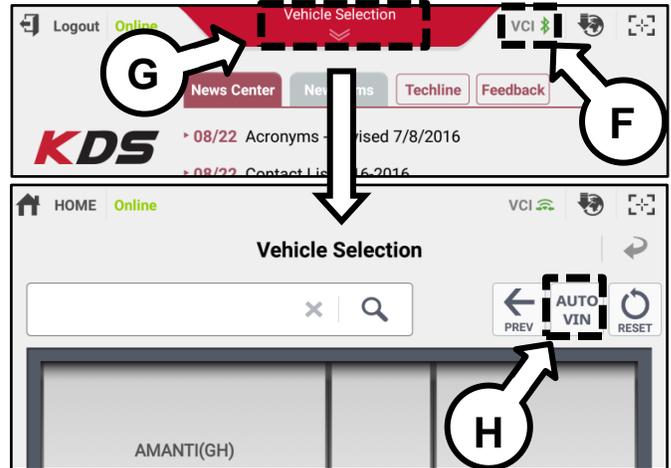
- Confirm communication with VCI (F) and then configure the vehicle (G) using the **AUTO VIN** (H) feature.

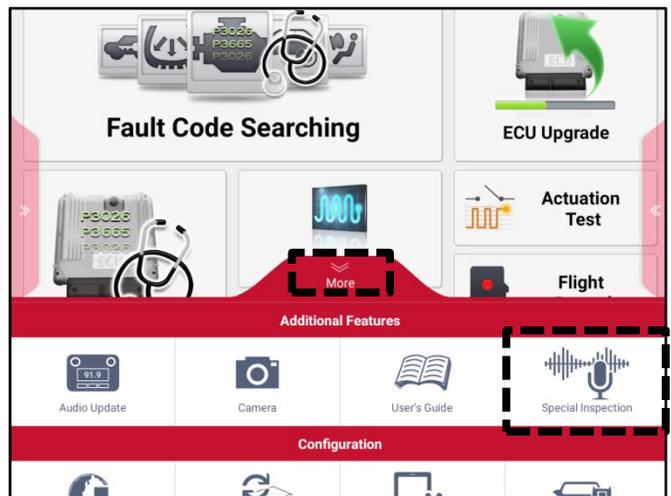
- Drag up the "More" tab from the lower screen of the KDS and select "Special Inspection".

If the vehicle model/model year does not qualify for this campaign, a message will pop up; if so, verify that the vehicle is included in the list of affected VINs for SC147.

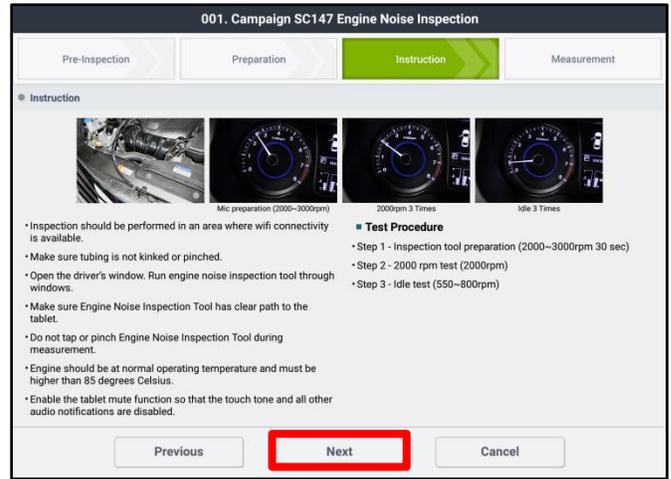
13. Follow the instructions on the screen then select “Next”.

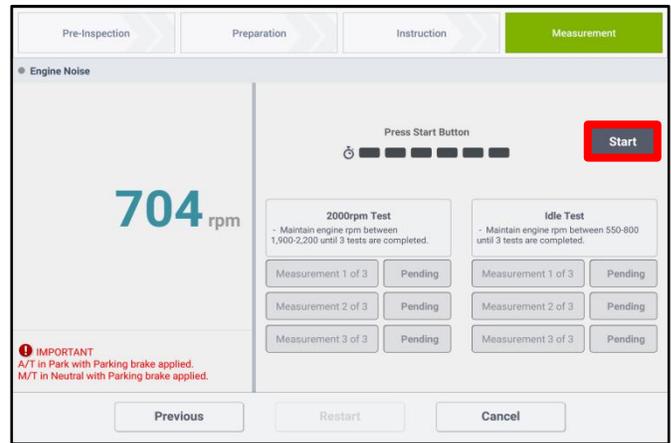
14. Prior to the initial measurement, the program will automatically check if the engine noise tester is installed and operating correctly at engine idle and perform an internal diagnosis.

Begin the second part of the engine noise tester check by selecting “Start”.

If the measured noise level is too low or abnormally high, an engine noise tester inspection message will pop up. Check and correct as necessary and start again.

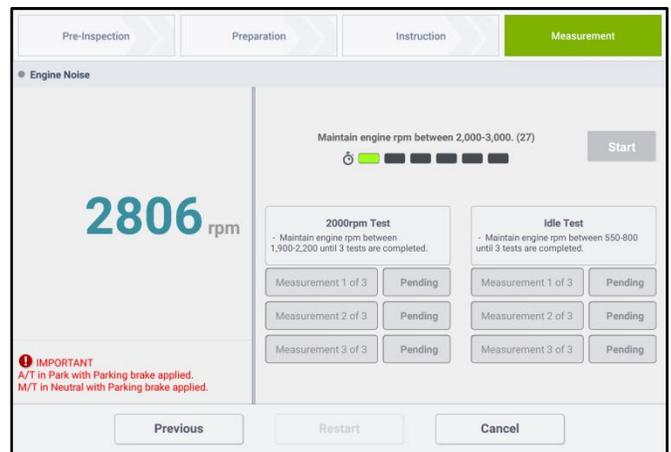
15. With the vehicle in Park (A/T) / Neutral (M/T), increase and maintain the engine speed at 2000-3000 RPM for thirty (30) seconds.

The program will automatically proceed to the next step when the engine noise tester is ready.

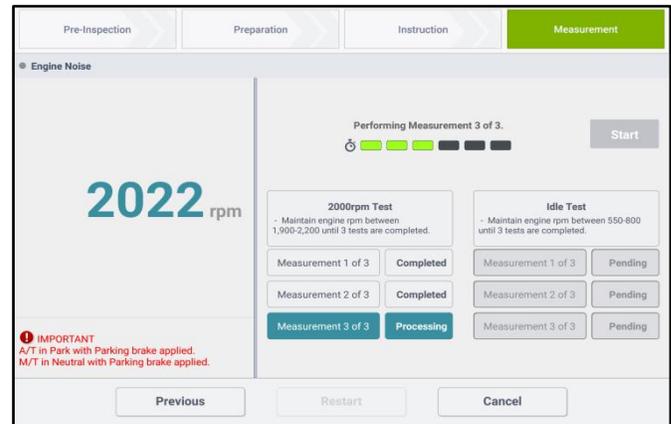
16. With the vehicle in Park (A/T) / Neutral (M/T), begin the “2000rpm Test” by increasing and maintaining engine speed between 1900-2100 (2.4L) or 1900-2200 (2.0T) RPM until all three (3) measurements are complete.

Once the RPM is in the specified range, the time count (green bars) will be initialized.

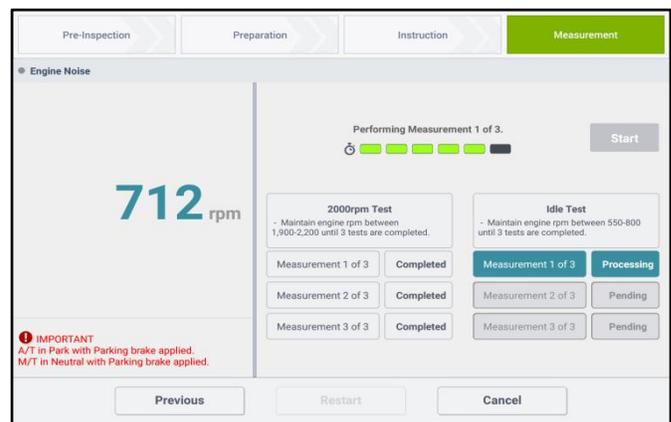
17. When the “2000rpm Test” is complete, release the accelerator pedal so that engine maintains idle state for the “Idle Test”.
18. The “Idle Test” will automatically begin. Keep the engine at idle and wait until all three (3) measurements are complete.

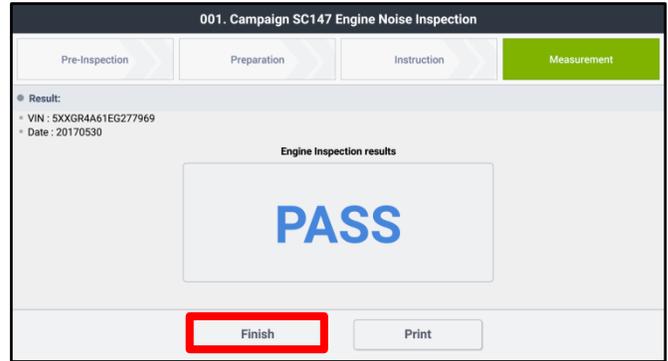
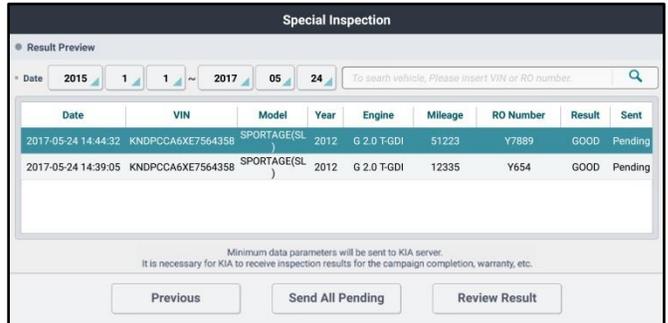
20. Select “Finish” to complete the engine noise inspection. Ensure the KDS is connected to the internet and the “Special Inspection” KDS application is open to automatically submit the results to the Kia Server. To save and/or print the results as PDF, select “Print”.

If the KDS is not connected to the internet, up to five (5) results will stay pending in the queue until the KDS is connected to the internet with the “Special Inspection” application open.

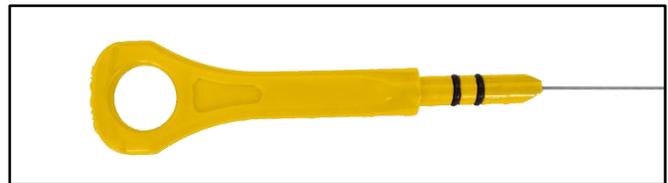
Yellow Dipstick

22. For 2011-13MY vehicles only: If the vehicle is equipped with a YELLOW dipstick, discard the dipstick and replace it with a new ORANGE one.

On all vehicles with an inspection result of “PASS”: Change the oil and filter. Use the new (ORANGE) or verified (RED) dipstick to verify proper oil level after oil change and if applicable, reset the maintenance reminder on the instrument cluster.
